TMS320F2837xD Dual-Core Delfino™ MCUs

Silicon Revisions C, B, A, 0

This document describes the silicon updates to the functional specifications for the TMS320F2837xD microcontrollers (MCUs).

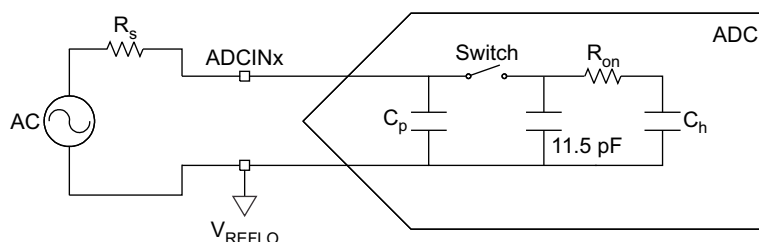
Figure 3. Single-Ended Input Model

Advisory	ADC: 12-Bit Input Capacitance When Switching Channel Groups
Revision(s) Affected	0, A, B
Details	The ADC input model should be used to select the sample-and-hold (S+H) duration for each ADC input. For the revisions affected, if the currently converting channel is an even-numbered channel and the previously converted channel was an odd-numbered channel (or vice versa), then the 12-bit input model will not accurately predict ADC input performance. Under these conditions, an additional capacitance should be added to the model. This capacitance has a value of 11.5 pF and should be placed between the S+H switch and R_{on} as shown in Figure 3 .

Workaround(s)	For the revisions affected, when subsequent conversions switch between channel groups, the S+H duration should be chosen to account for the additional capacitance.
----------------------	---

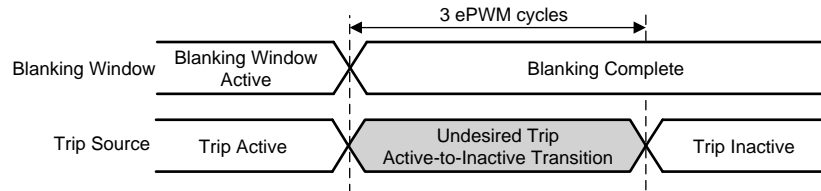
Figure 8. Undesired Trip Event and Blanking Window Expiration

The blanking window is typically used to mask any PWM trip events during transitions which would be false trips to the system. If an ePWM trip event remains active for less than three ePWM clocks after the end of the blanking window cycles, there can be an undesired glitch at the ePWM output.

Figure 8 illustrates the time period which could result in an undesired ePWM output.
