MSP430F5528 Device Erratasheet

1 Revision History

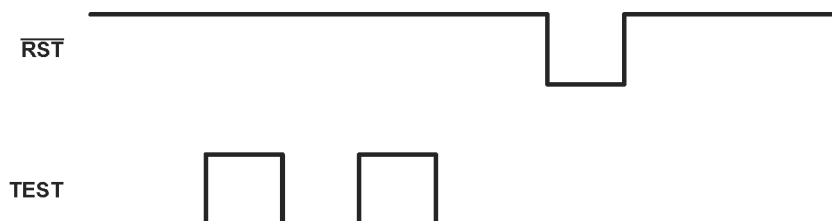
- Toggle the TEST pin twice when nRST is high and then pull nRST low.

Note: This sequence is not subject to timing constraints and the appropriate level transitions are sufficient to trigger an exit from BSL mode.
