NETWORK RAIL INFRASTRUCTURE PROJECTS (WALES)

INSPECTION REPORT

Kidwelly Viaduct

Issue Date: 03/06/2019
Report No: 152092-ARC-REP-ECV-000001
ELR: SWM2
Mileage: 234m 40.25ch
OS Ref.: SN 398 066
Revision: A02
Page: 1 of 17

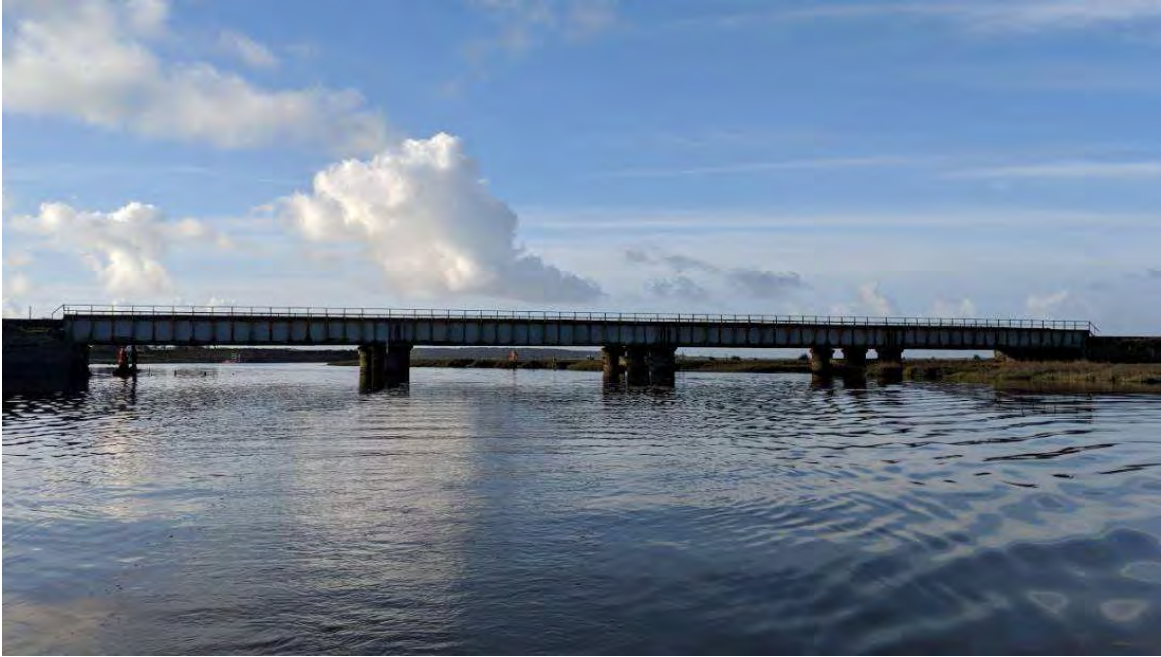
Photograph 1: Downside Elevation

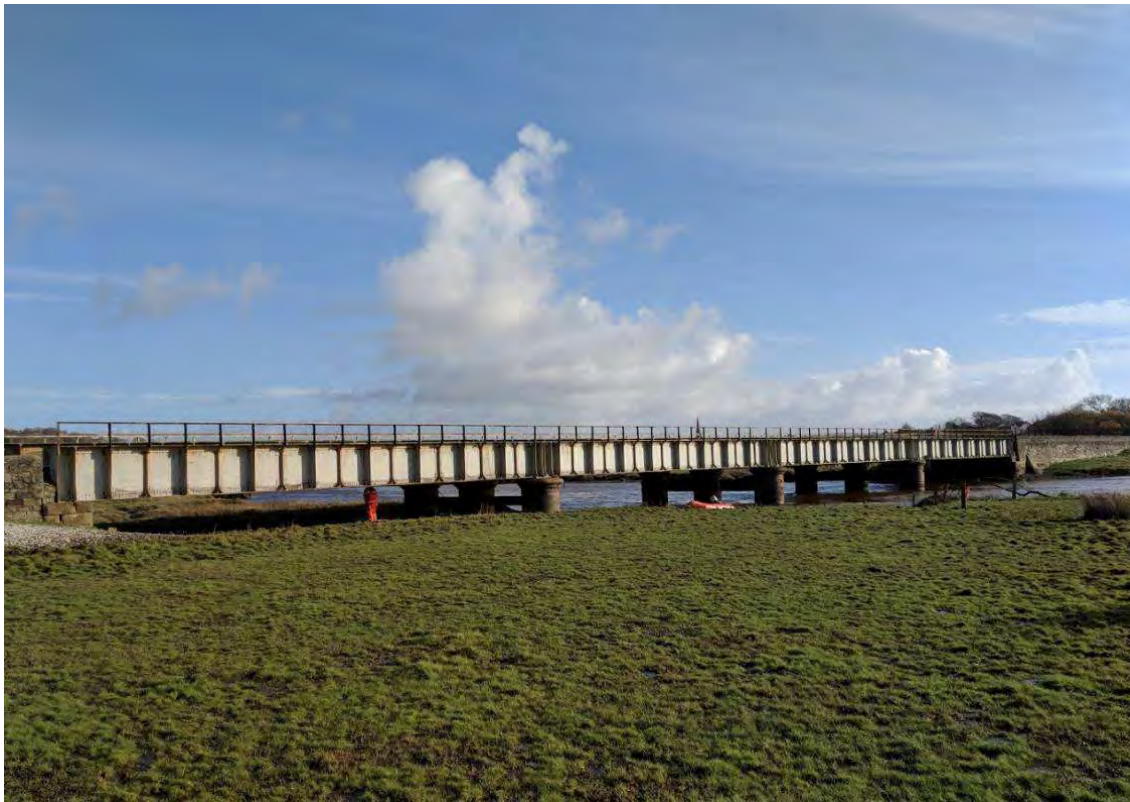
Photograph 2: Upside Elevation

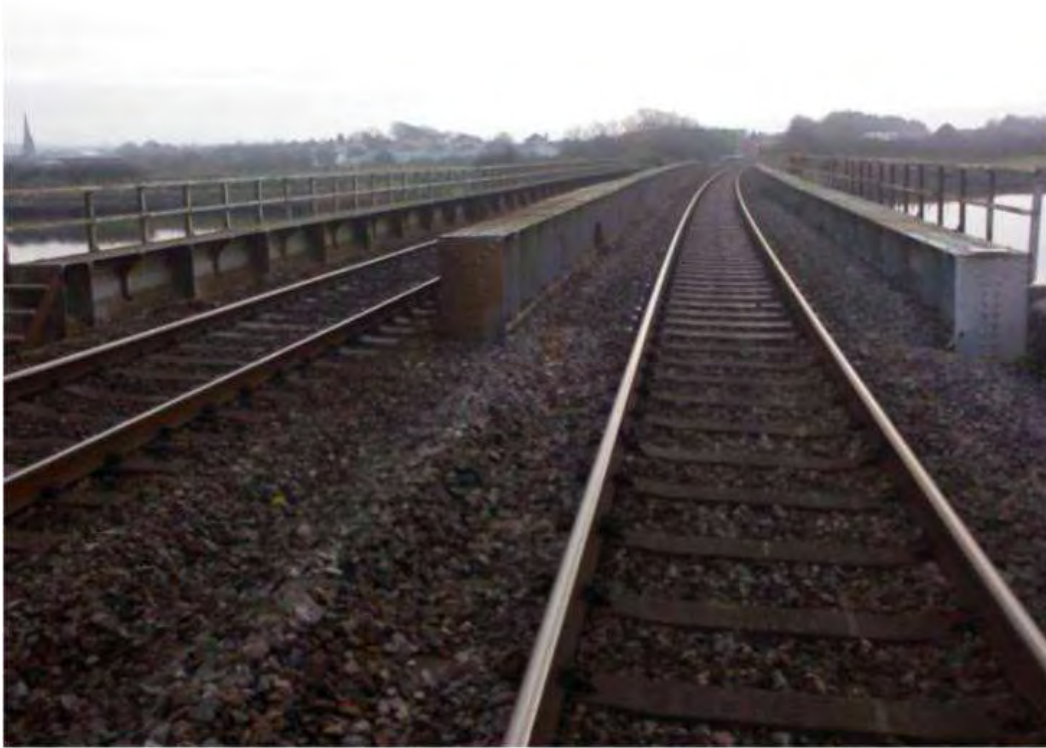
Photograph 3: Trackside, photo looking towards low mileage

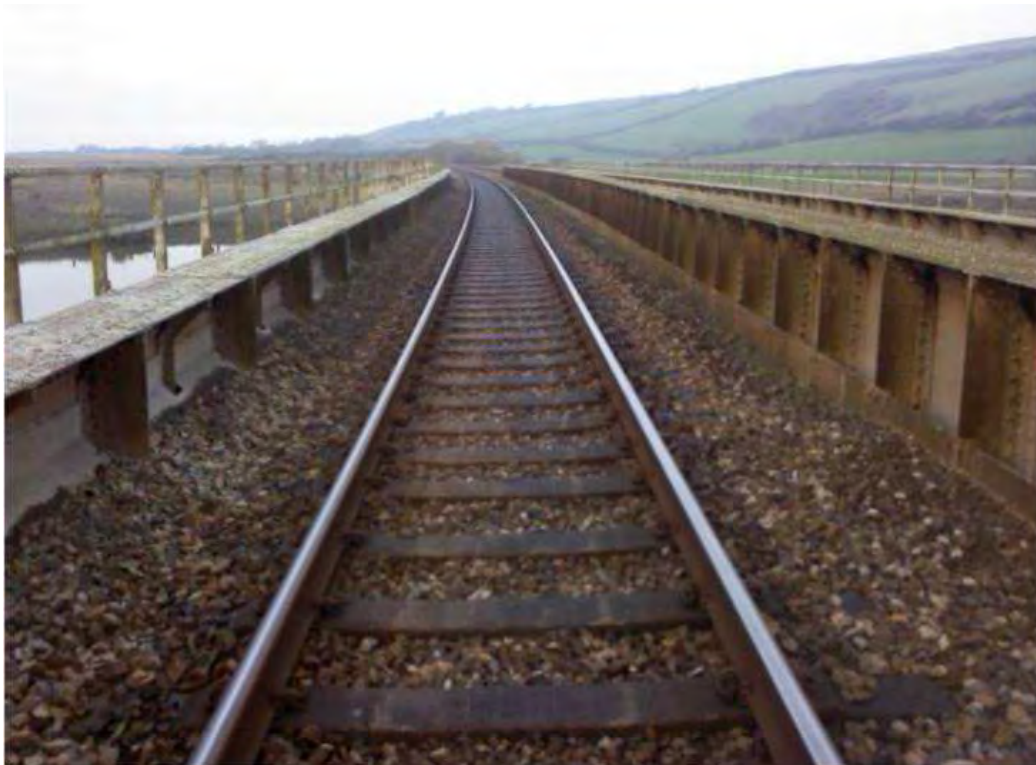
Photograph 4: Trackside, photo looking towards high mileage

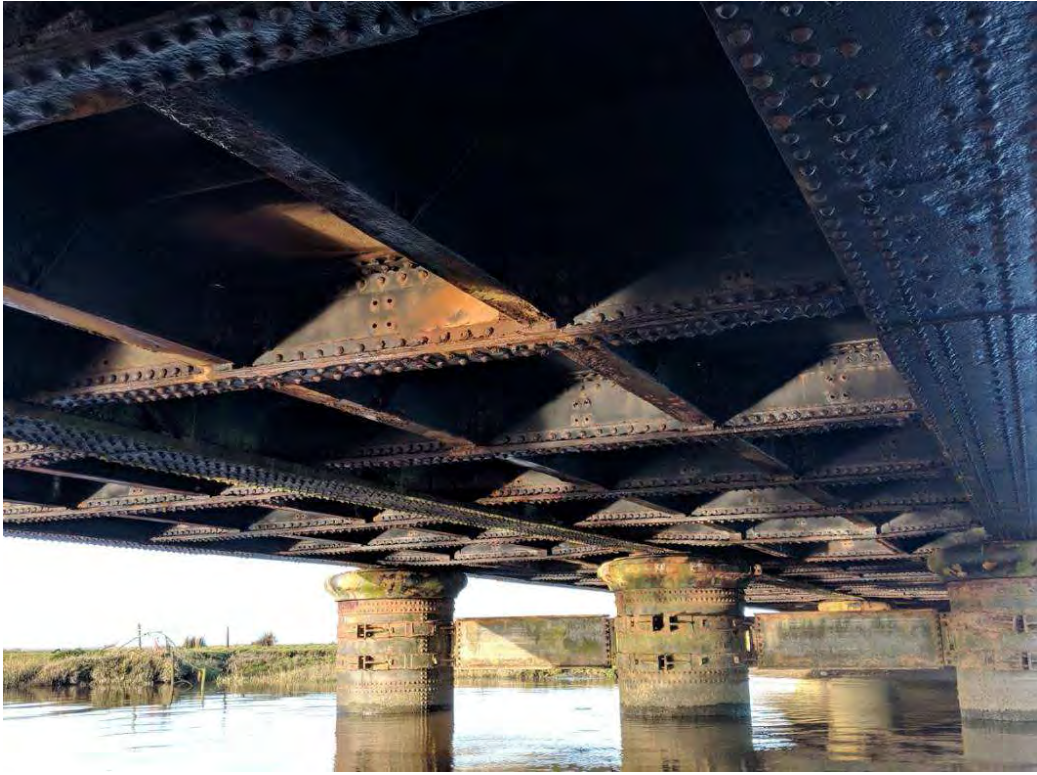
Photograph 5: General soffit view

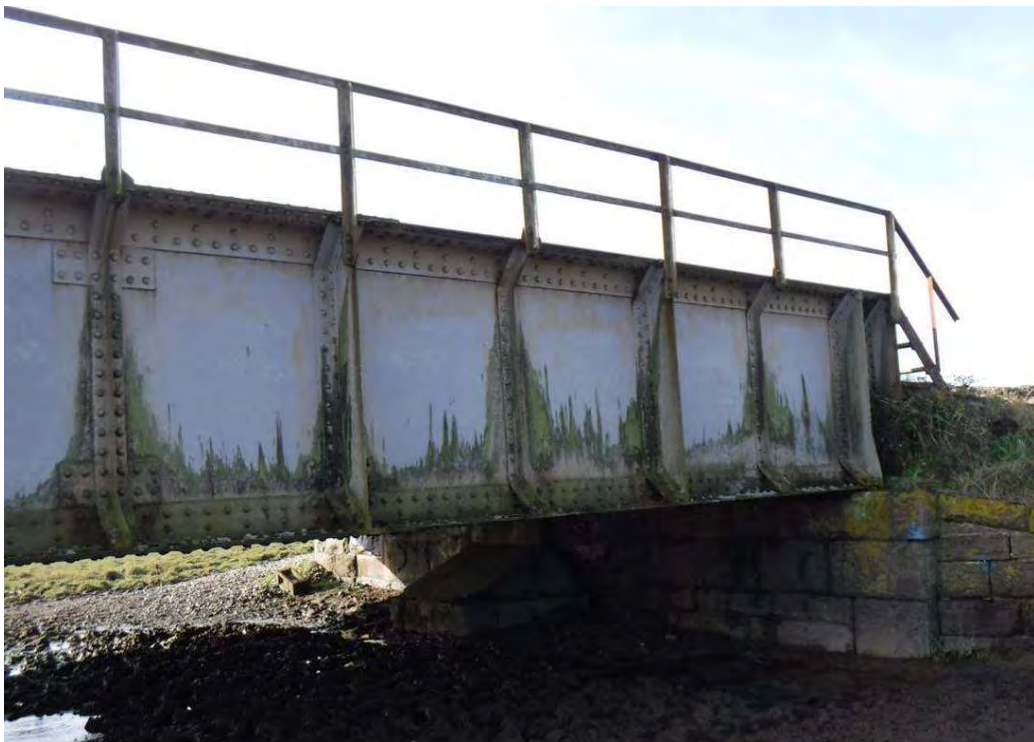
Photograph 6: General view of external main girder (MGE) bankside

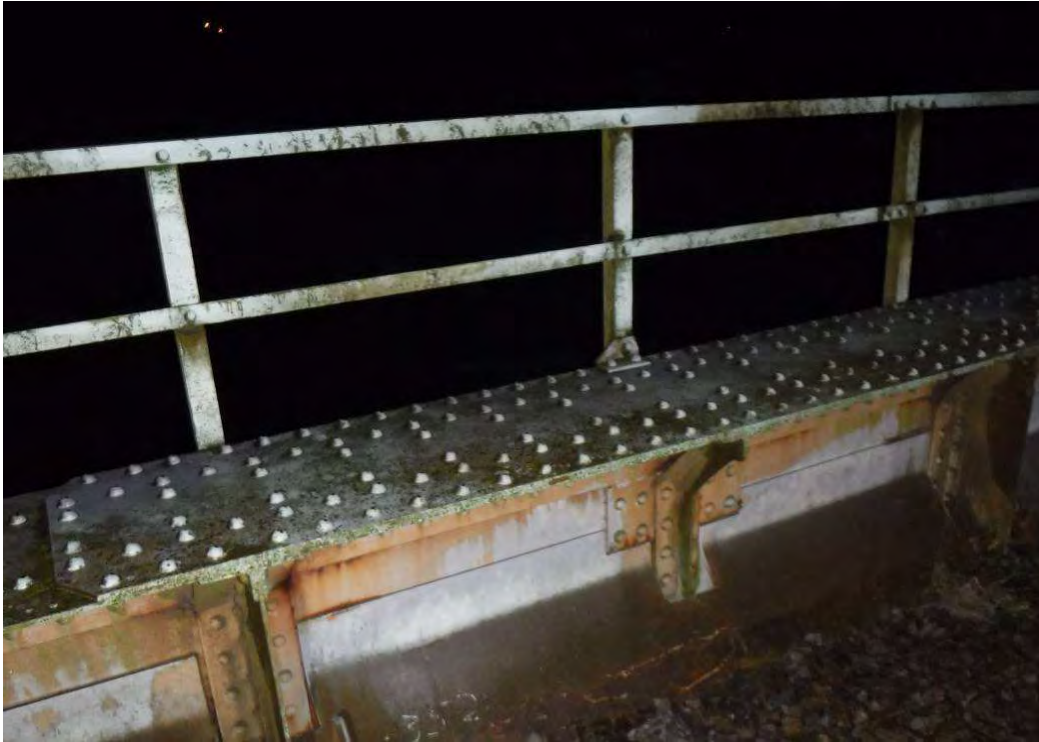
Photograph 7: General view of external main girder (MGE) trackside

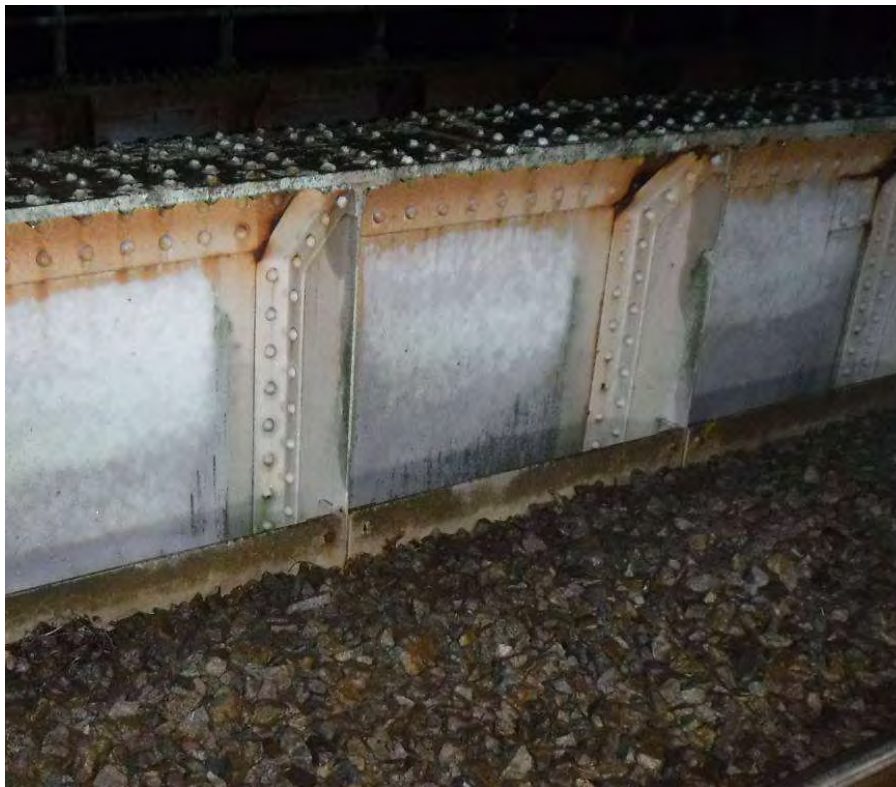
Photograph 8: General view of internal main girder (MGI) trackside

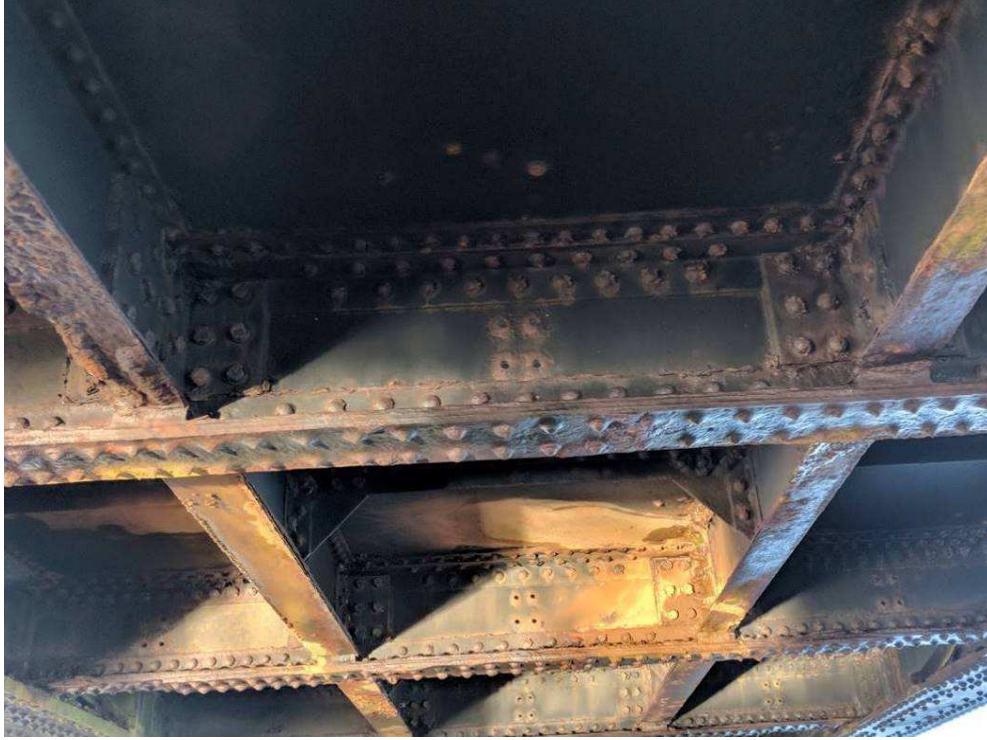
Photograph 9: General view of internal cross girders (XGI)

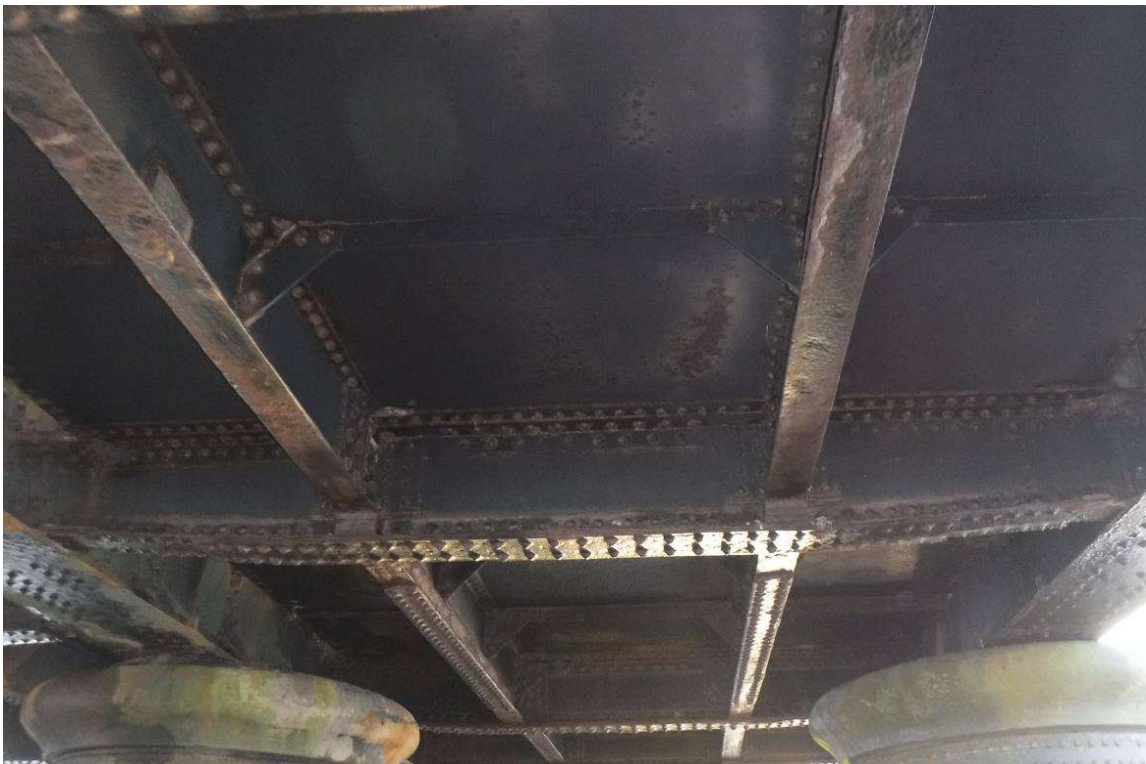
Photograph 10: General view of fish bellied external cross girders (XGE) and strengthened rail bearers above caissons

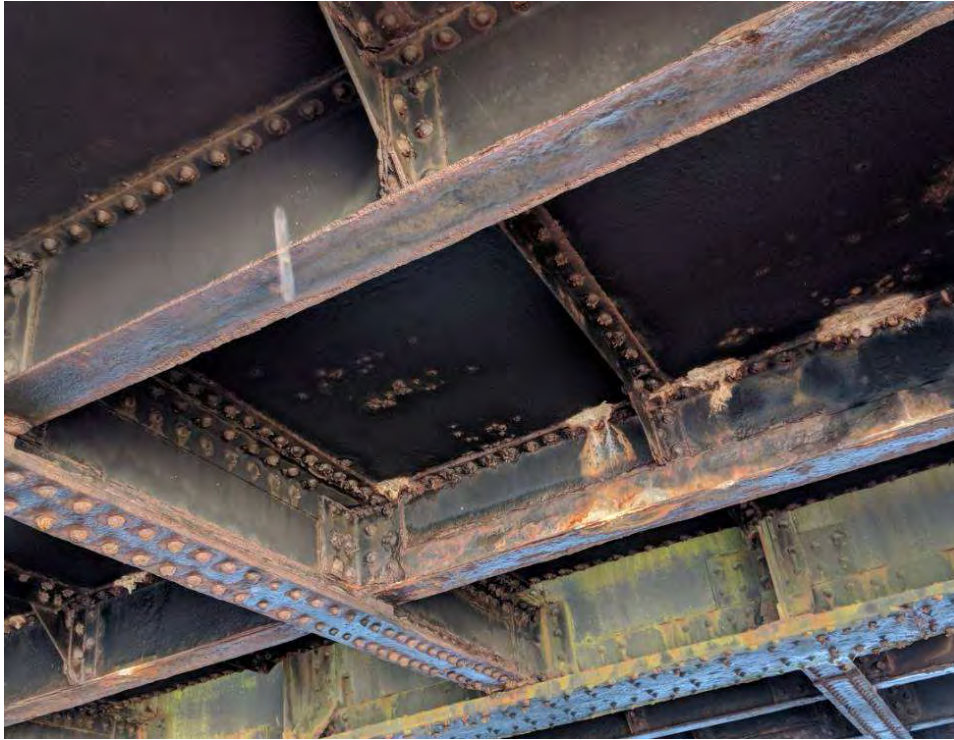
Photograph 11: General view of rail bearers (LSI)

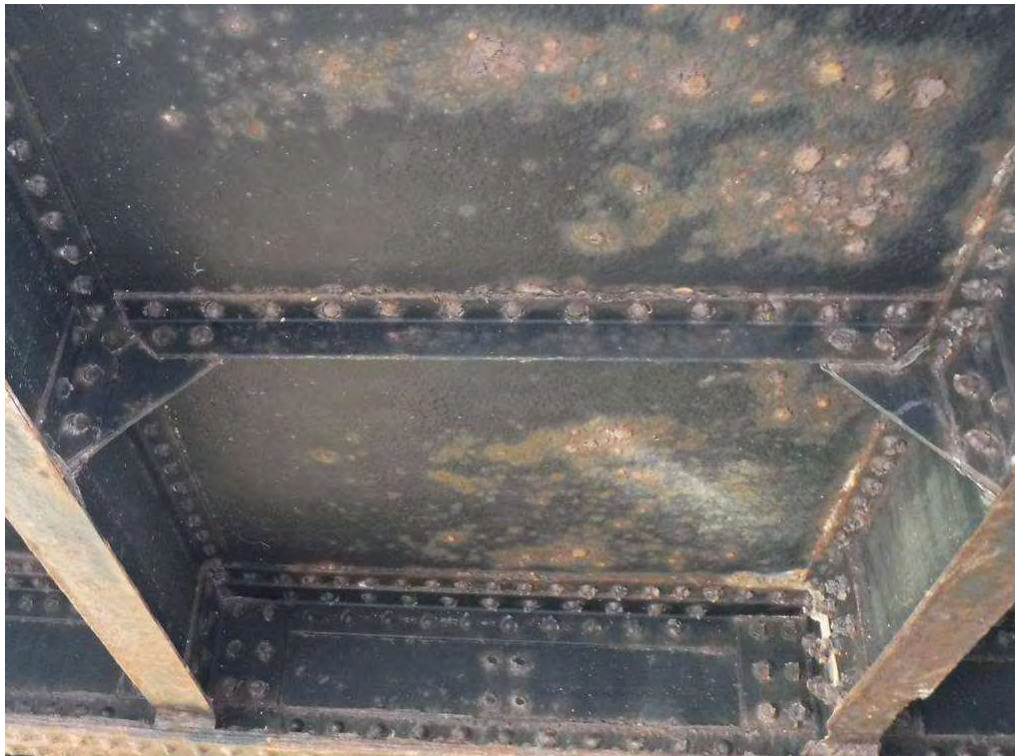
Photograph 12: General view of deck plates and stiffeners (DCK)
