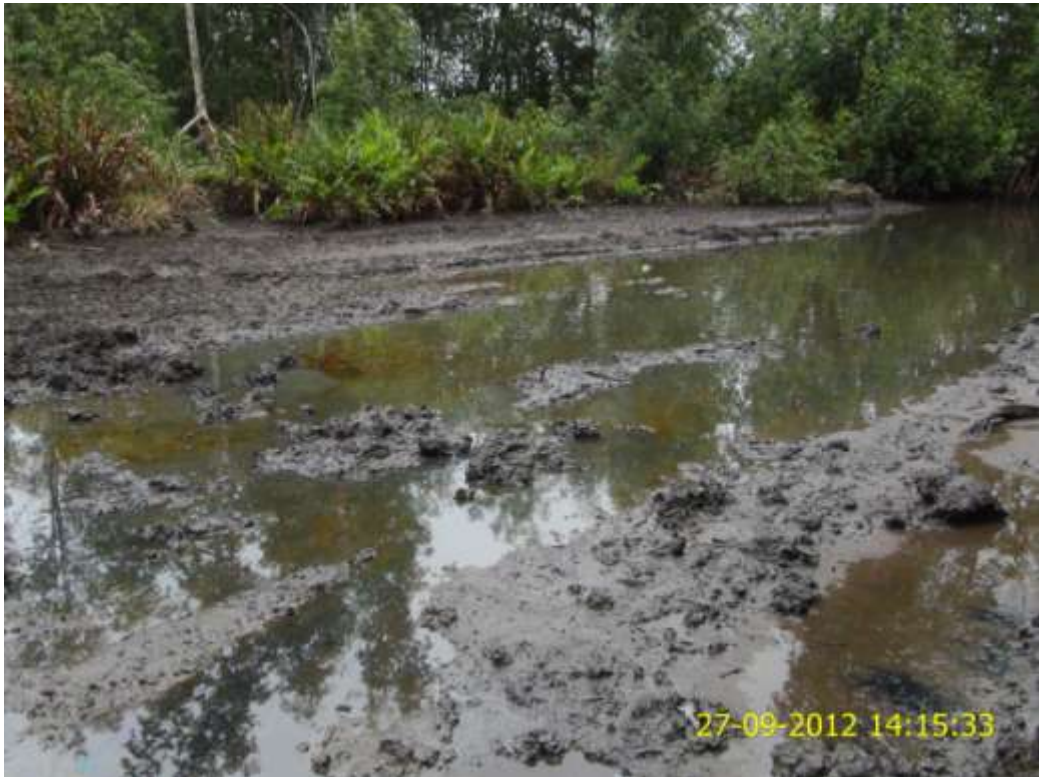
Overview: Part of spill impact on 4" Santa Barbara Well 11T flowline right of way at Ikegimakiri. Picture was taken during Joint Investigation of 27<sup>th</sup> September 2012.

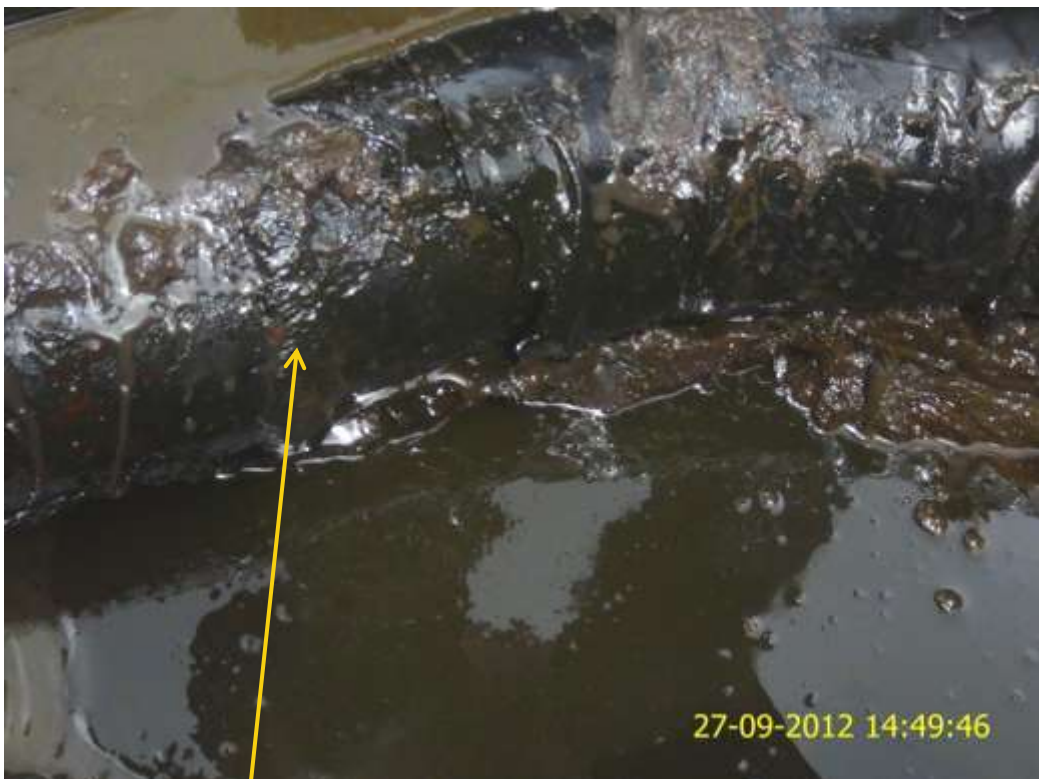
Close up: Failed weld on 4" Santa Barbara Well 11T flowline at Ikegimakiri. Picture was taken during Joint Investigation of 27<sup>th</sup> September 2012.
