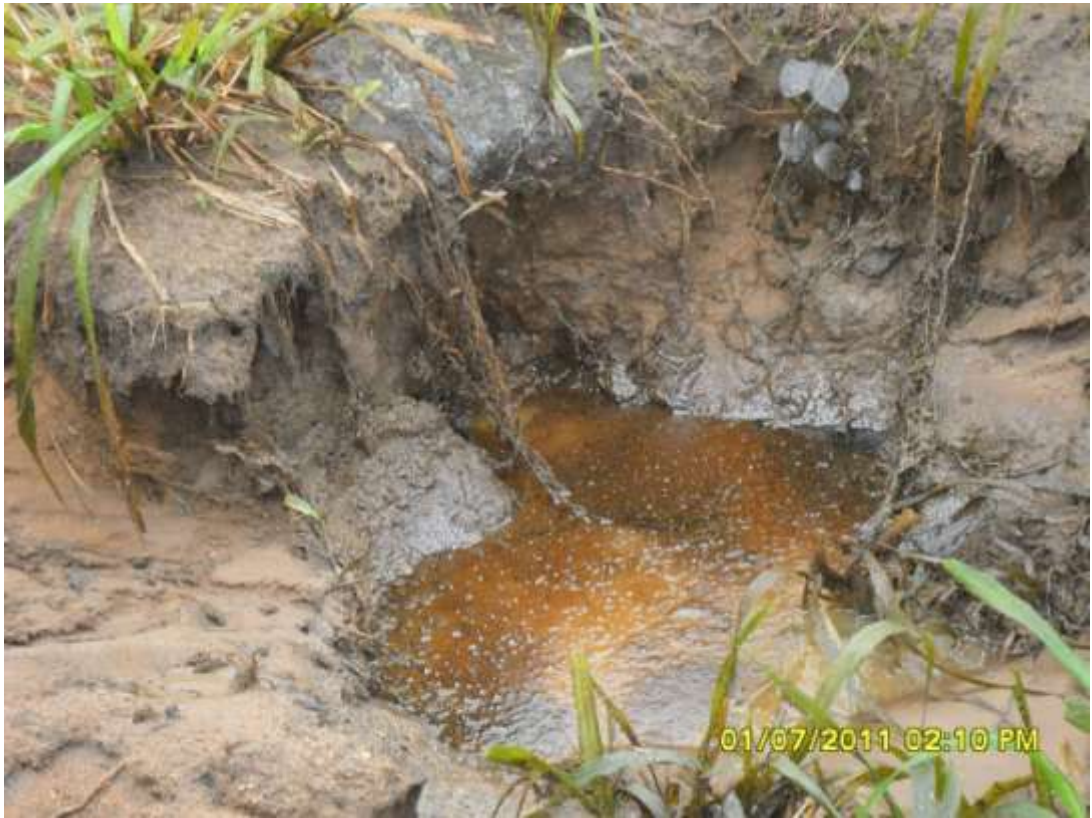
Overview: Part of the spill impact on Imoriver2 Well28L flowline at Umuedeokware.
Picture taken during Joint Investigation of 1st July, 2011

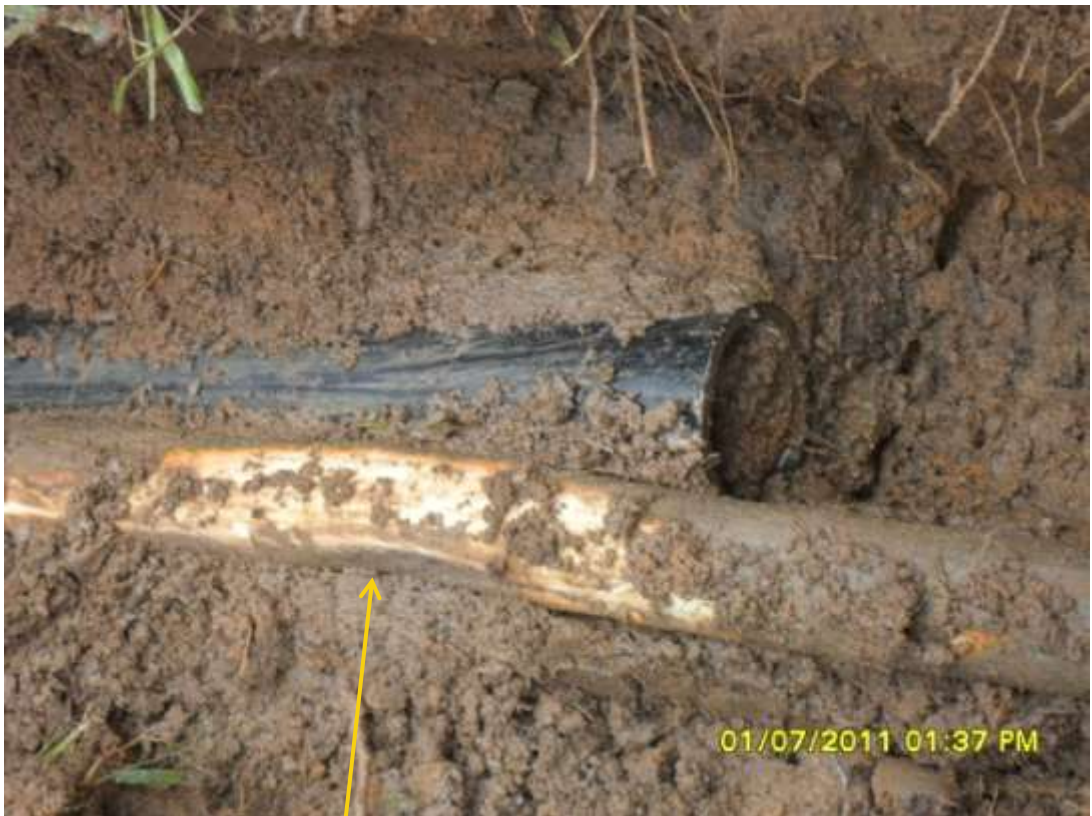
Close-up: Spill due to cut pipe on Imoriver2 Well28L flowline at Umuedeokware. Picture taken during Joint Investigation of 1st July, 2011
