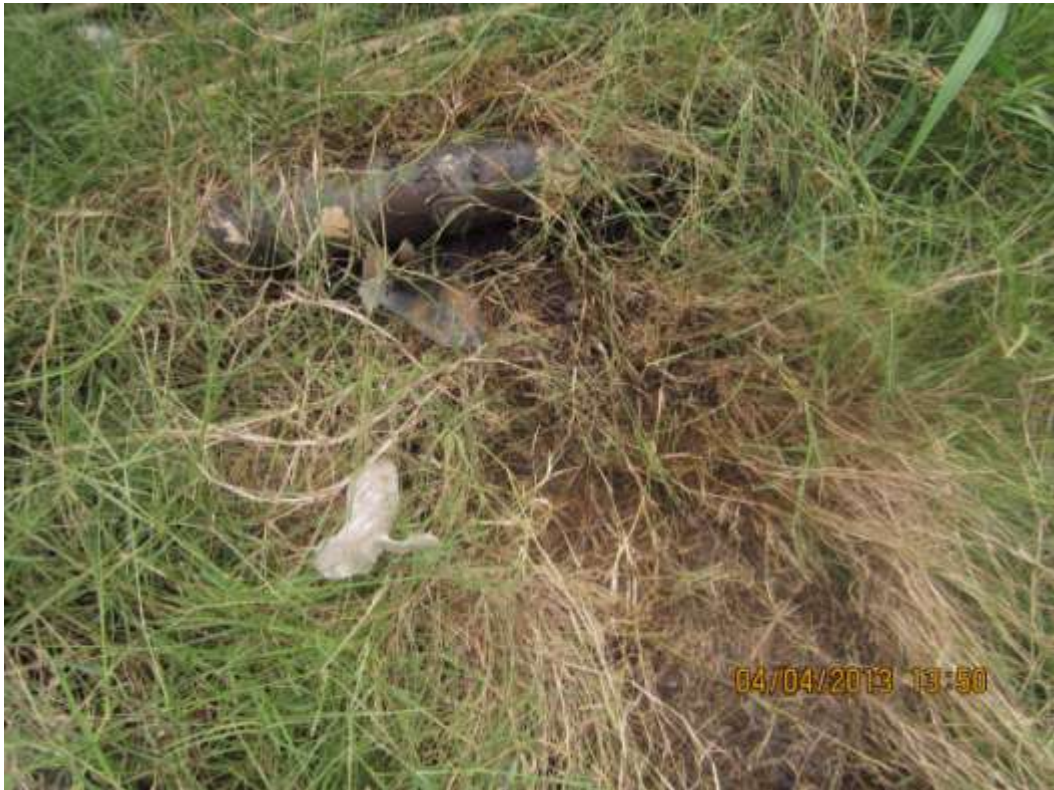
Overview: Part of spill impact on Oguta Well6S flowline at Umuashichi. Picture was taken during Joint Investigation of 4th April 2013.

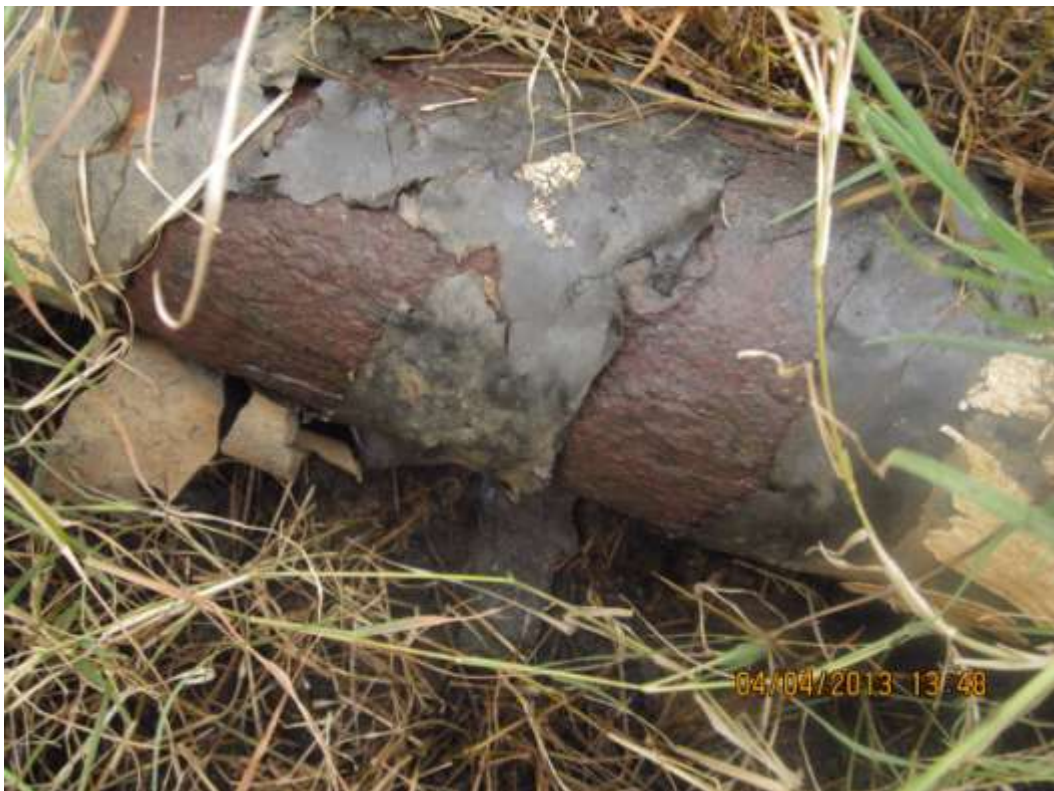
Close up: Spill due to corrosion on Oguta Well6S flowline at Umuashichi. Picture was taken during Joint Investigation of 4th April 2013.
