Overview: Part of spill impact on 36" Rumuekpe-Nkpoku pipeline at Aluu. Picture taken during Joint Investigation of 20<sup>th</sup> June, 2011

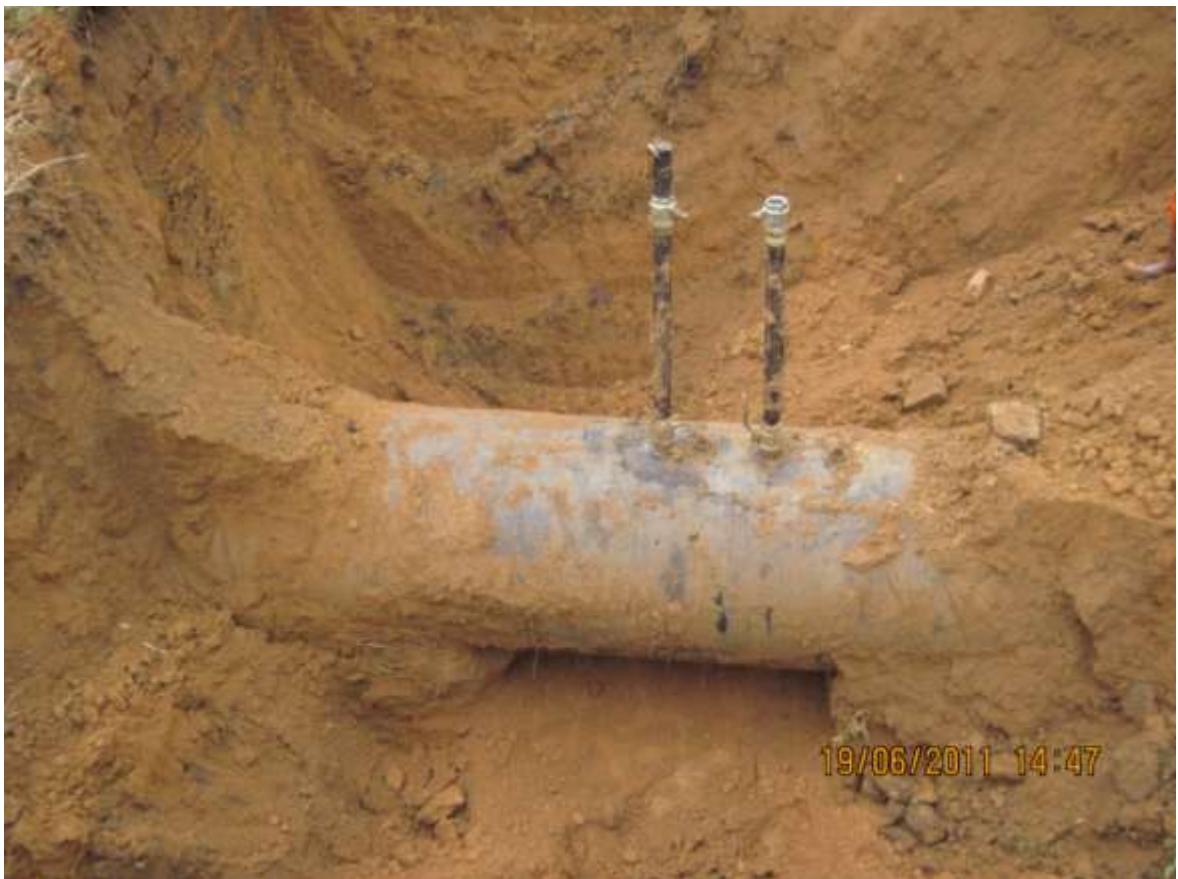
Close-up: Illegally welded fittings on 36" Rumuekpe-Nkpoku pipeline at Aluu. Picture taken during Joint Investigation of 19<sup>th</sup> June, 2011
