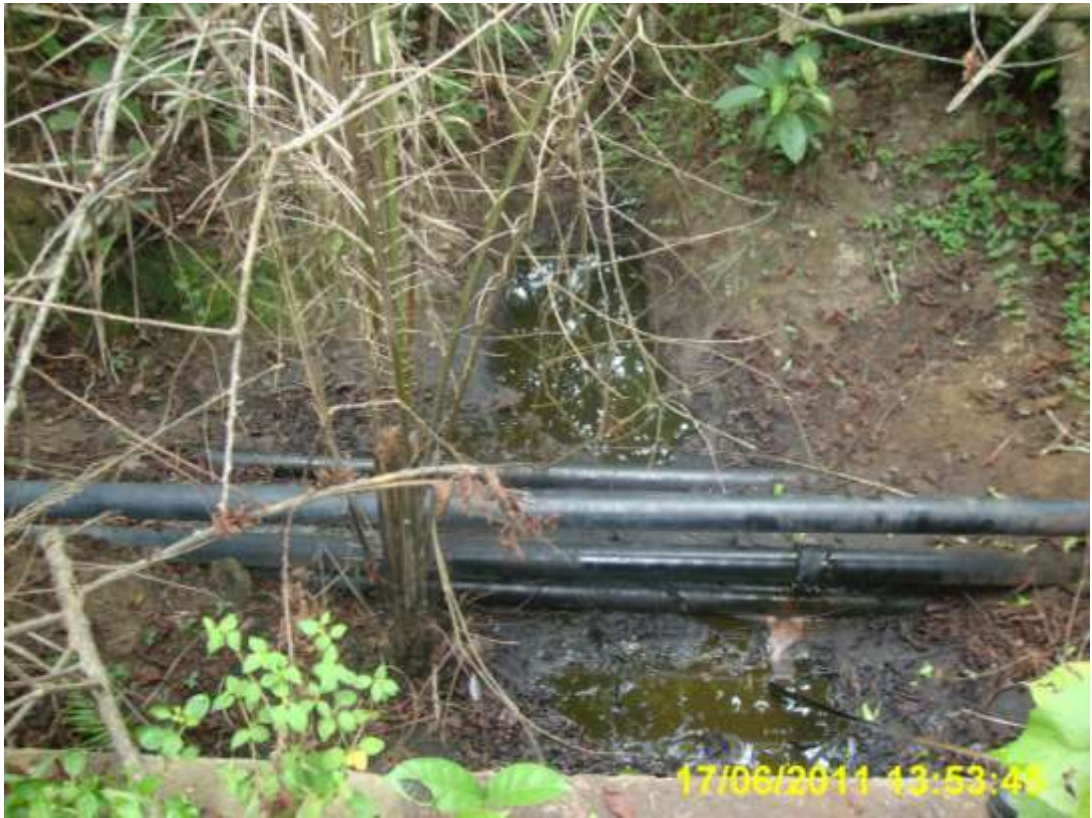
Overview: Part of the spill impact on Imo River Well 55S flowline at Igiriukwu. Picture taken during Joint Investigation of 17th June, 2011

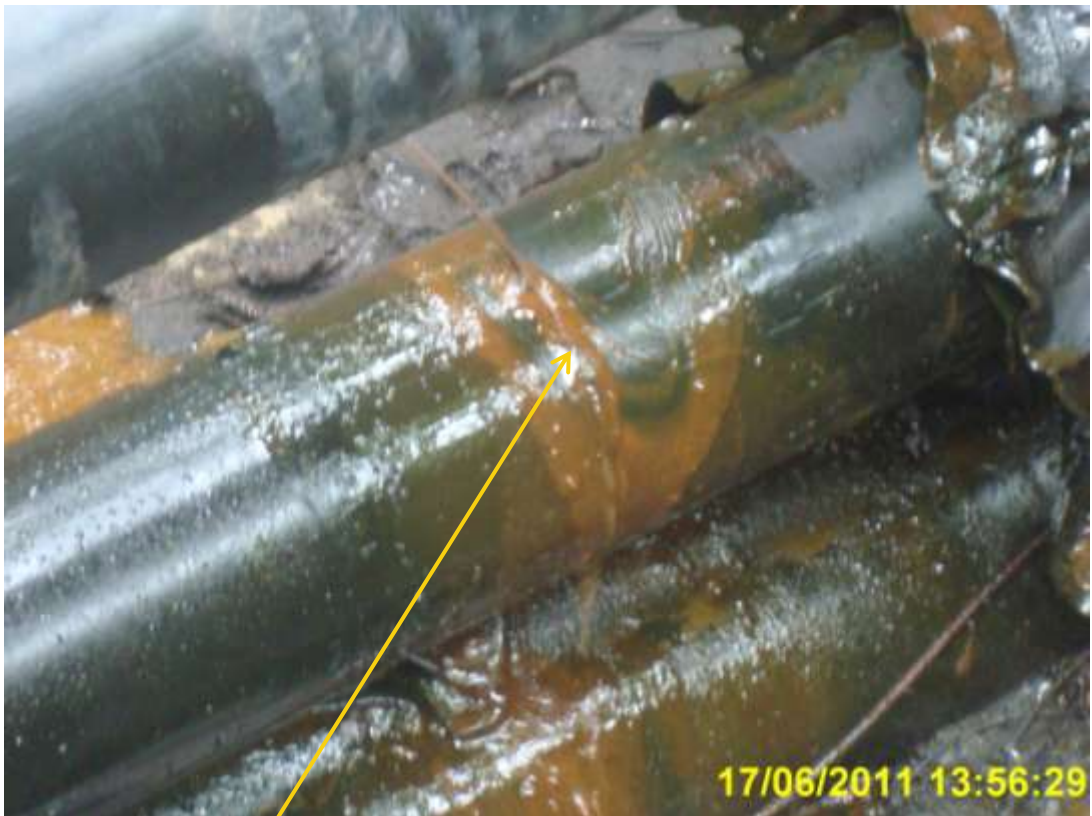
Close-up: Hacksaw cut on Imo River Well 55S flowline at Igiriukwu. Picture taken during Joint Investigation of 17th June, 2011
