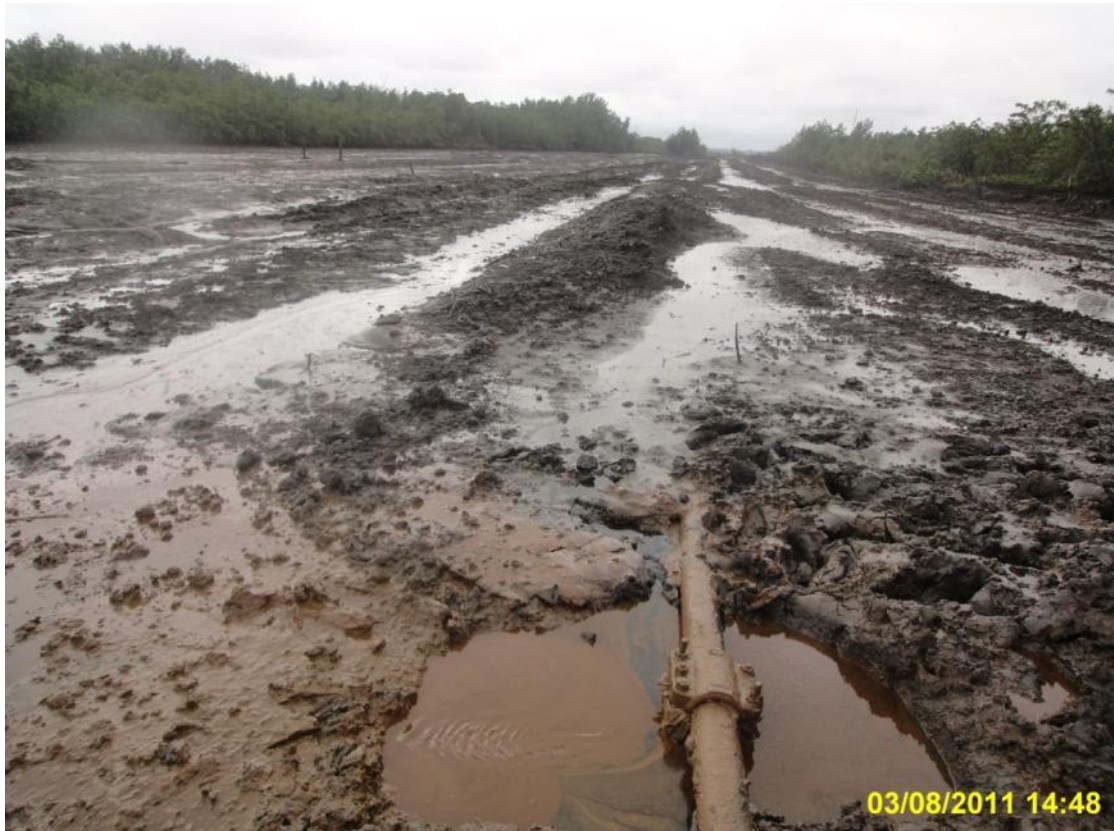
Overview: Part of spill impact on Cawthorne Channel Well 21L flowline at Mbiama.
Picture taken during Joint Investigation of 3rd August, 2011

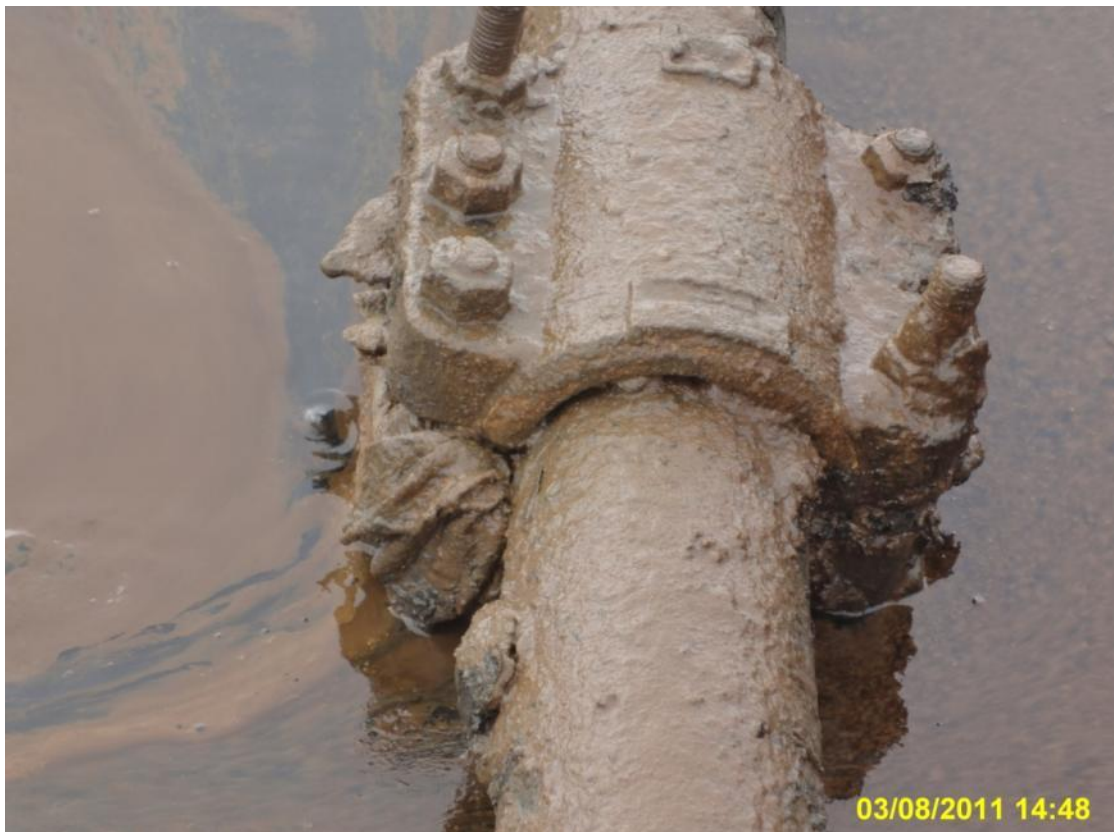
Close-up: Failed clamp on Cawthorne Channel Well 21L flowline at Mbiama. Picture
taken during Joint Investigation of 3rd August, 2011
