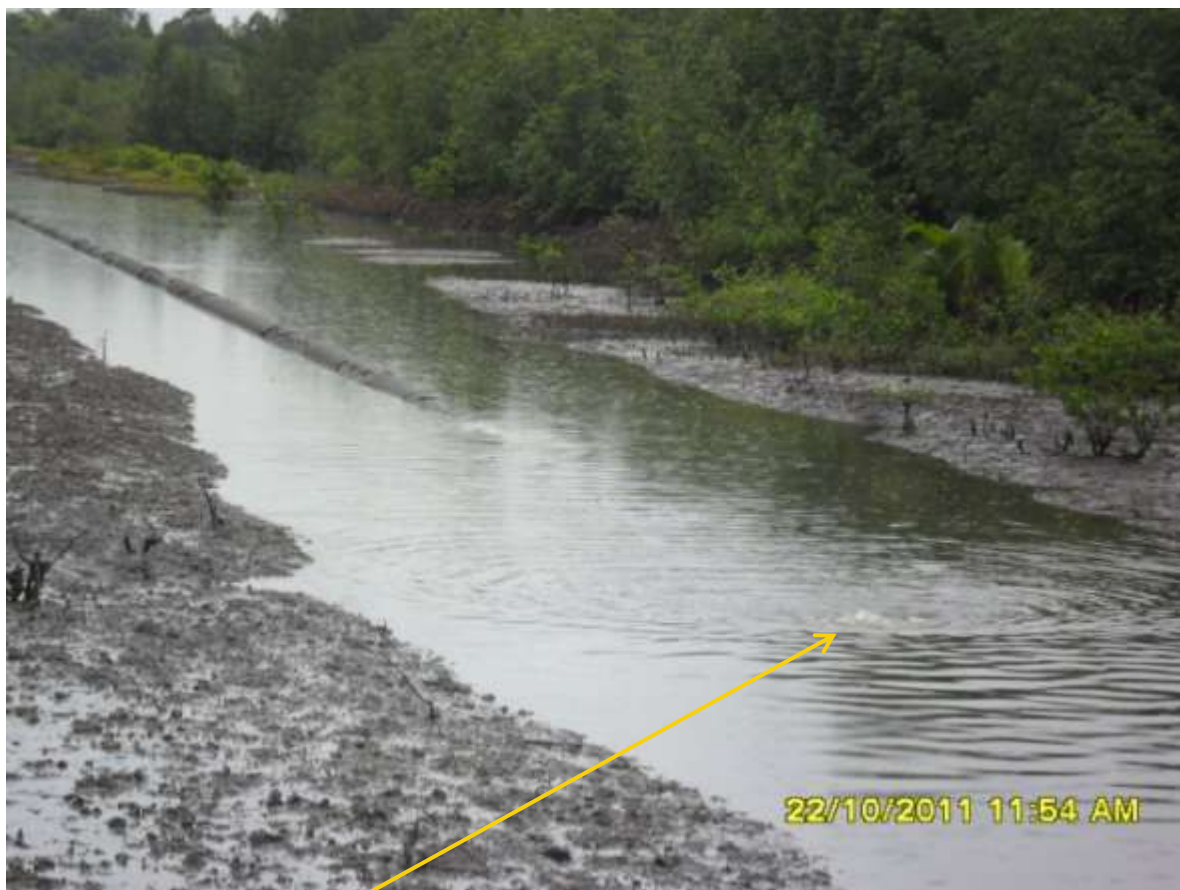
Overview: Bubbling observed on 20" Buguma-Alakiri pipeline right of way at Bakana. Picture was taken during Joint Investigation of 22nd October, 2011.

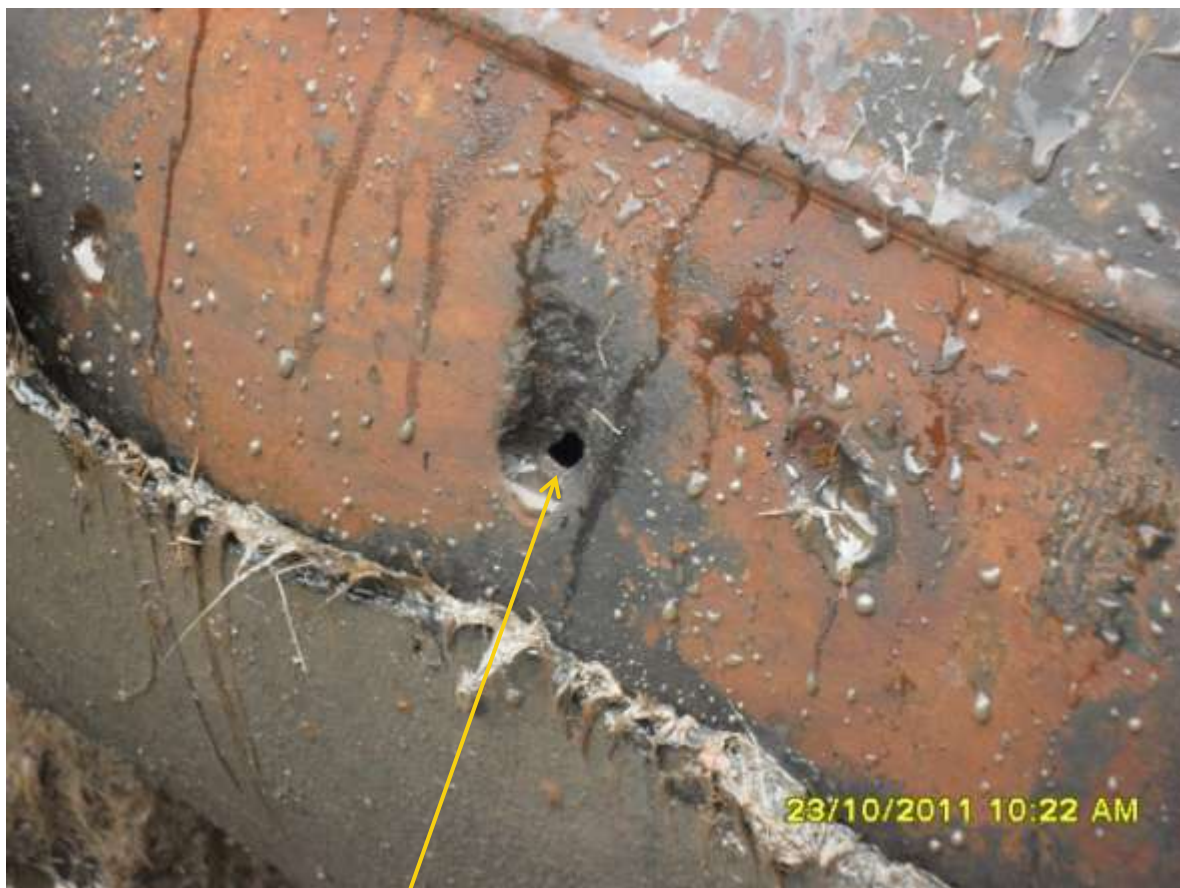
Close-up: Drilled hole on 20" Buguma-Alakiri pipeline at Bakana. Picture was taken during Joint Investigation of 23rd October, 2011.

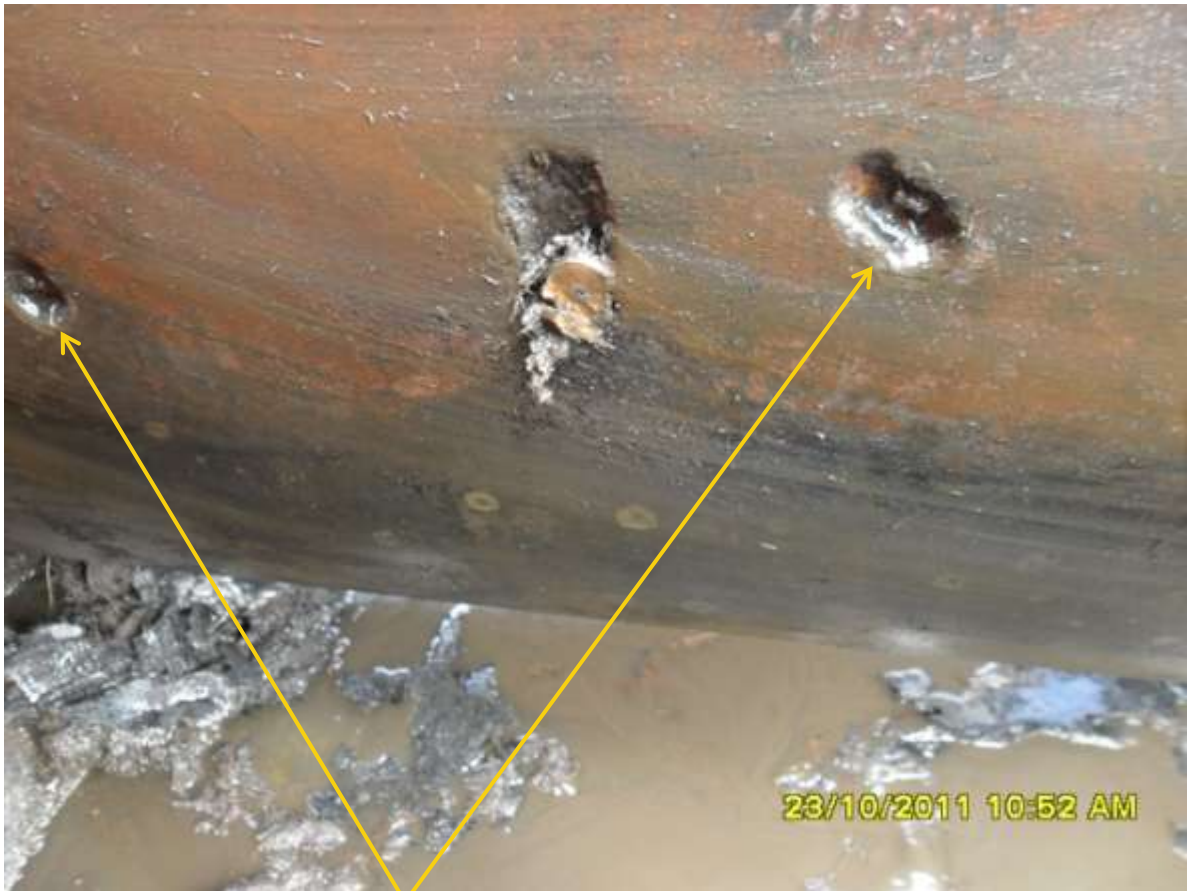
Close-up: Unsuccessful drill attempts can be seen after plugging the Drilled hole on 20" Buguma-Alakiri pipeline at Bakana.
