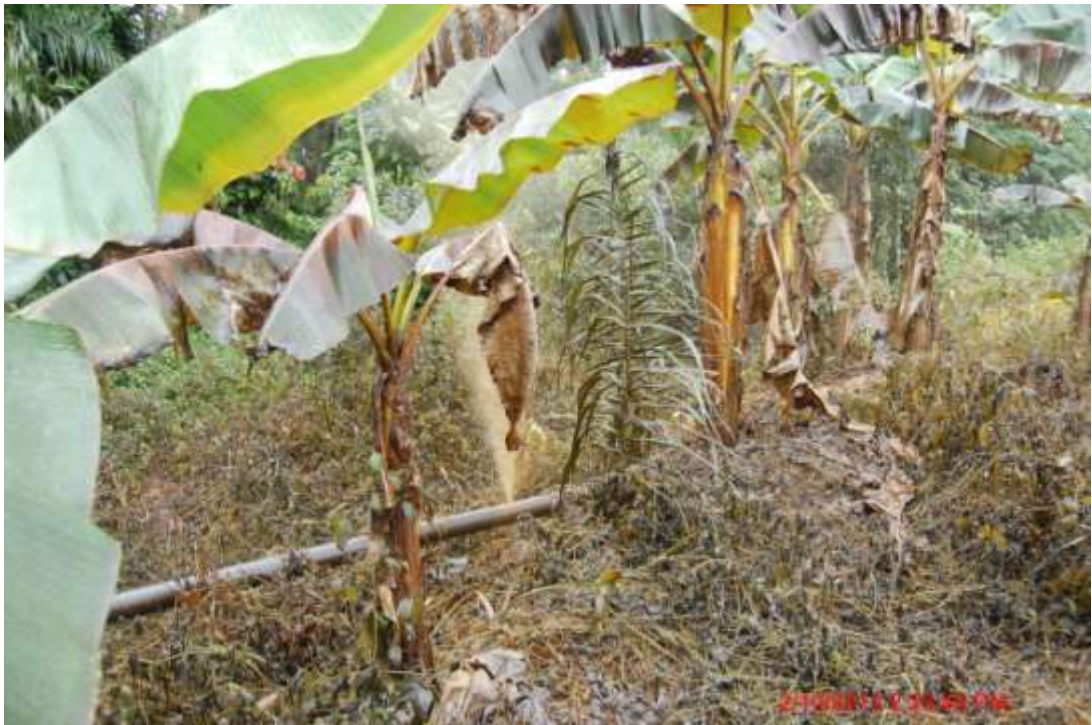
Overview: Part of spill impact on 4" Adibawa North East Well10S flowline at Edagberi/Betterland. Picture was taken during Joint Investigation of 2<sup>nd</sup> October 2013.

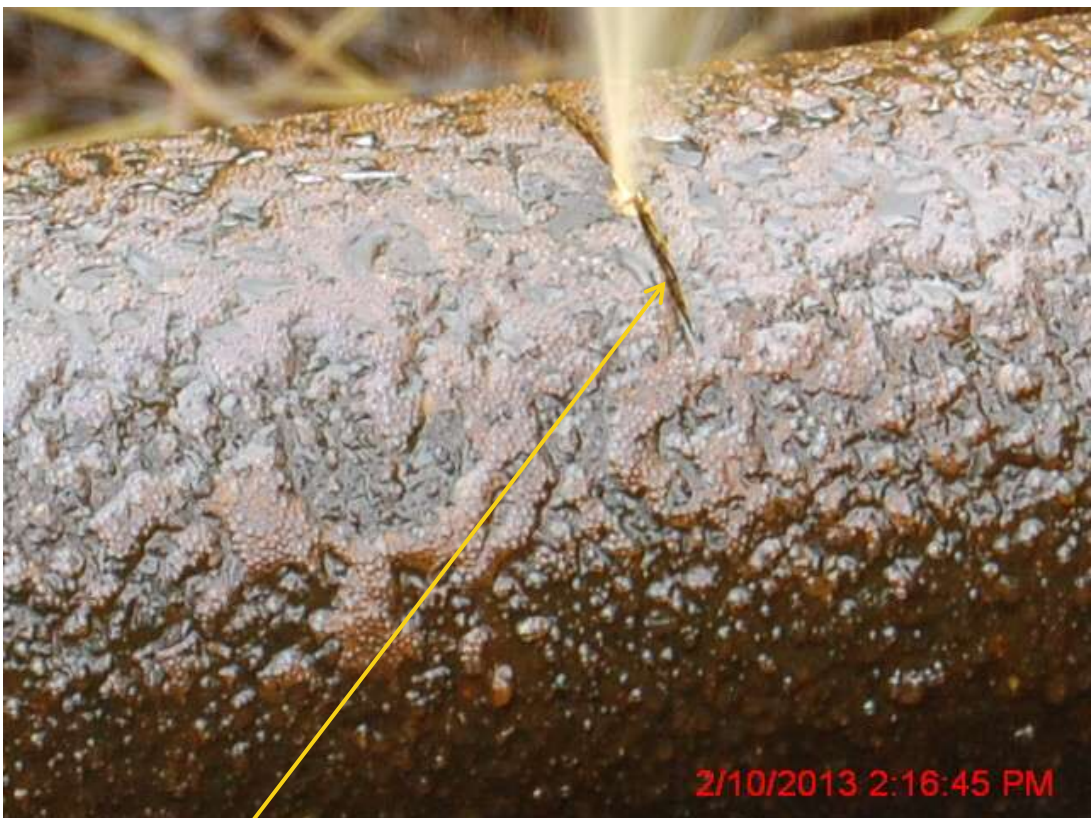
Close up: Hacksaw cut on 4" Adibawa North East Well10S flowline at Edagberi/Betterland. Picture was taken during Joint Investigation of 2<sup>nd</sup> October 2013.

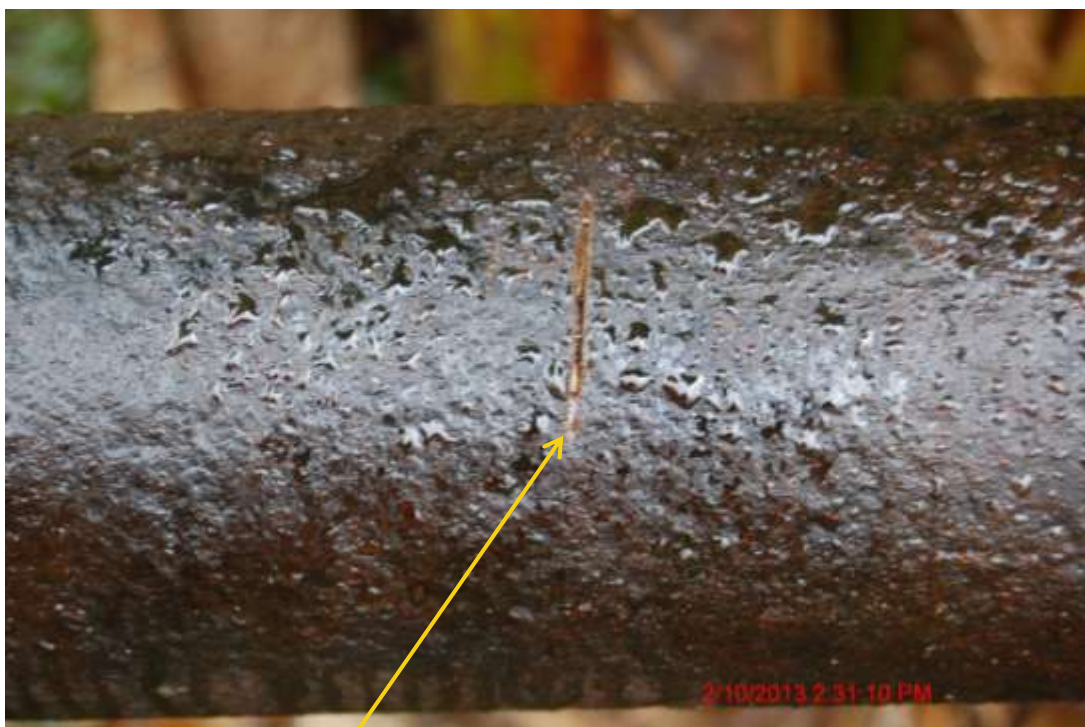
Close up: Hacksaw cut on 4" Adibawa North East Well10S flowline at Edagberi/Betterland. Picture was taken during Joint Investigation of 2<sup>nd</sup> October 2013.
