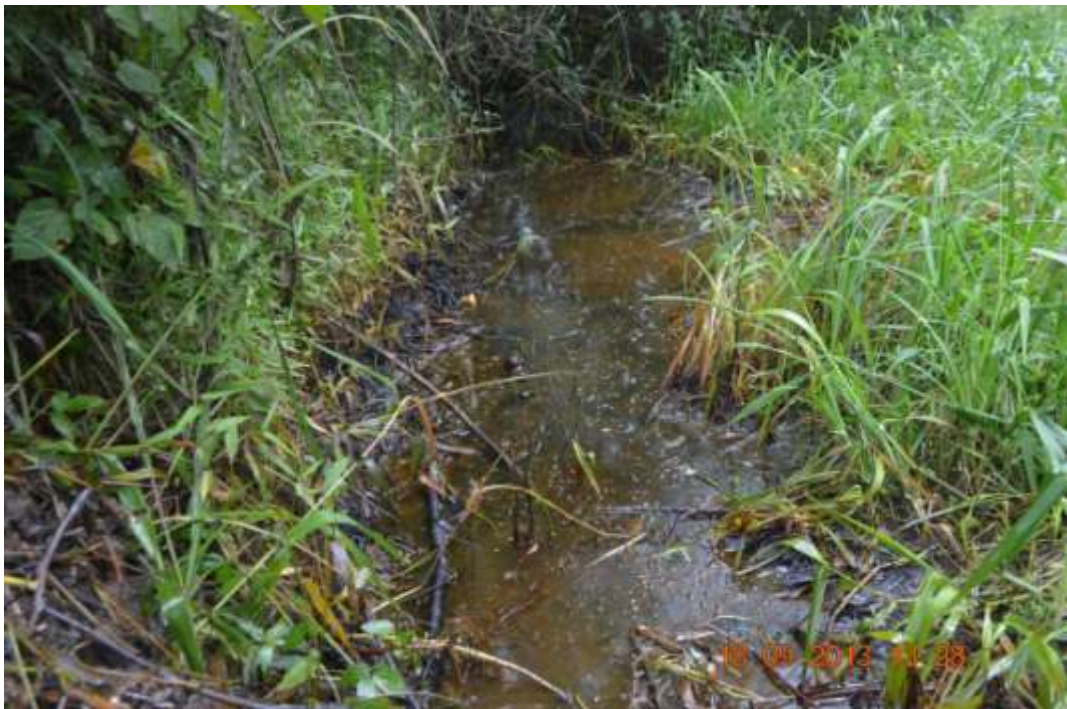
Overview: Part of spill impact on 4" Adibawa North East Well11L flowline right of way at Biseni. Picture was taken during Joint Investigation of 18th September 2013.

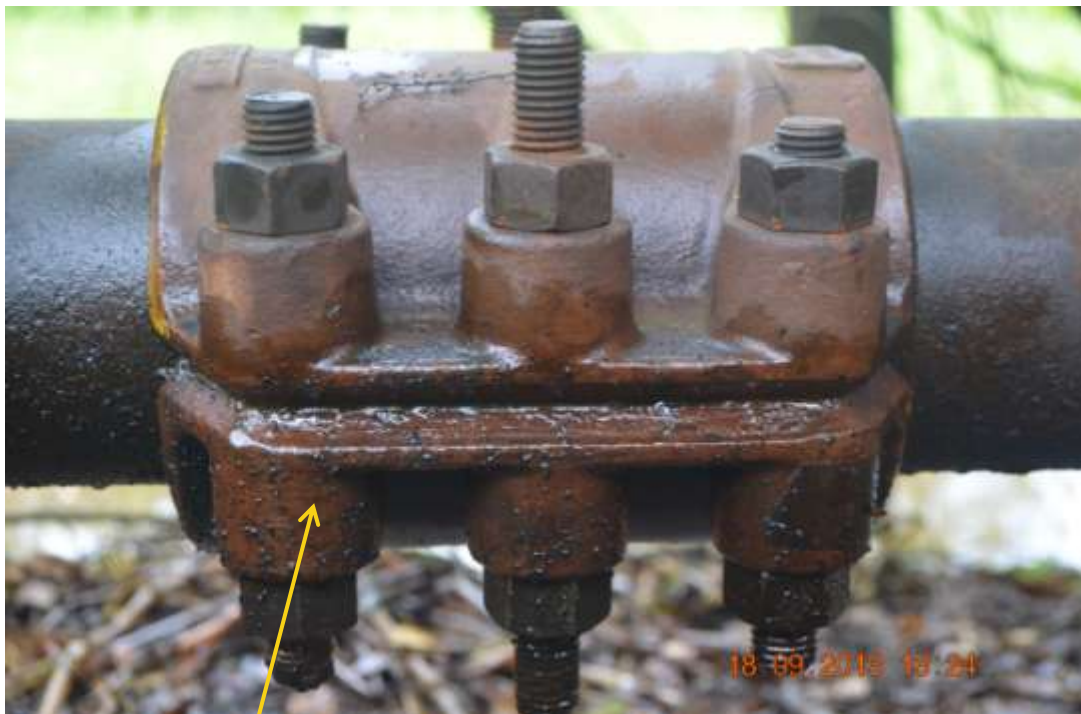
Close up: Tampered clamp on 4" Adibawa North East Well11L flowline at Biseni. Picture was taken during Joint Investigation of 18th September 2013.
