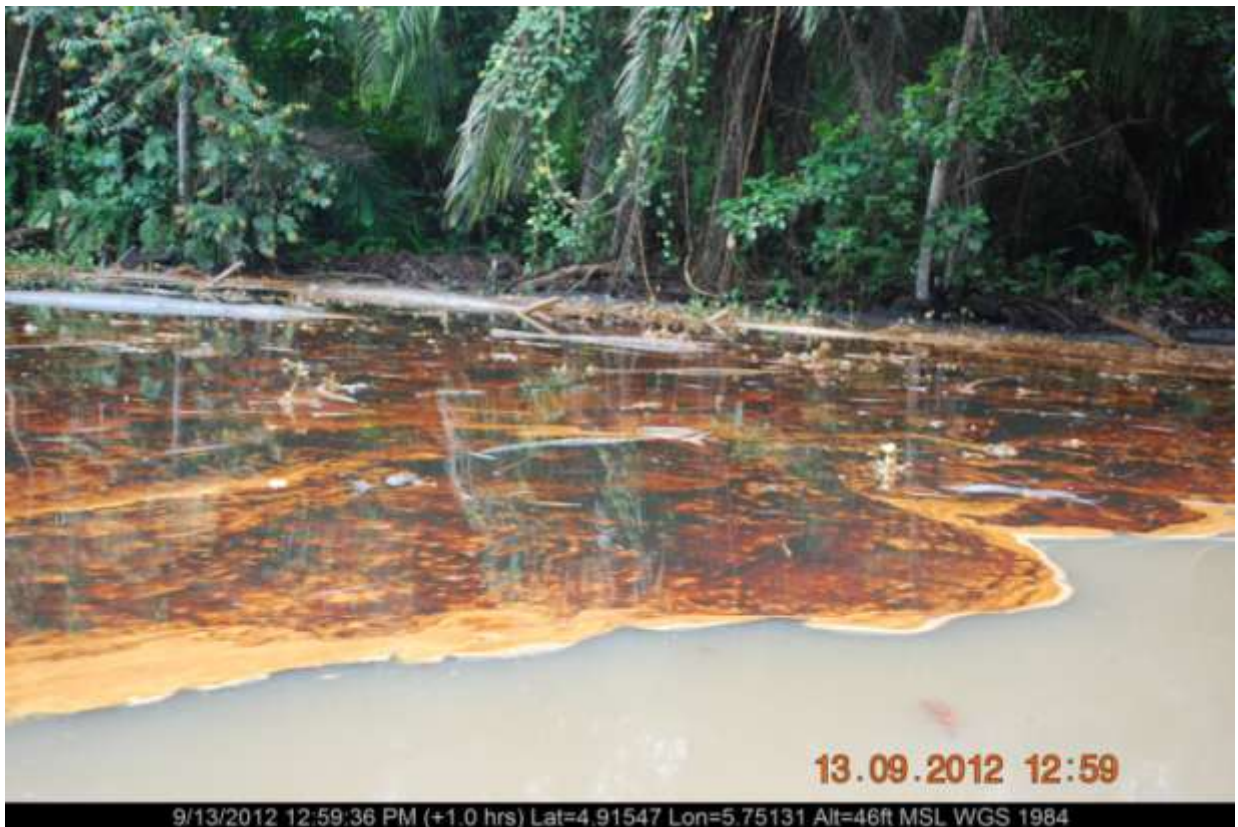
Overview: Part of spill impact on Opukushi Well 25 at Agbediamma. Picture was taken during Joint Investigation of 13<sup>th</sup> Sept. 2012.

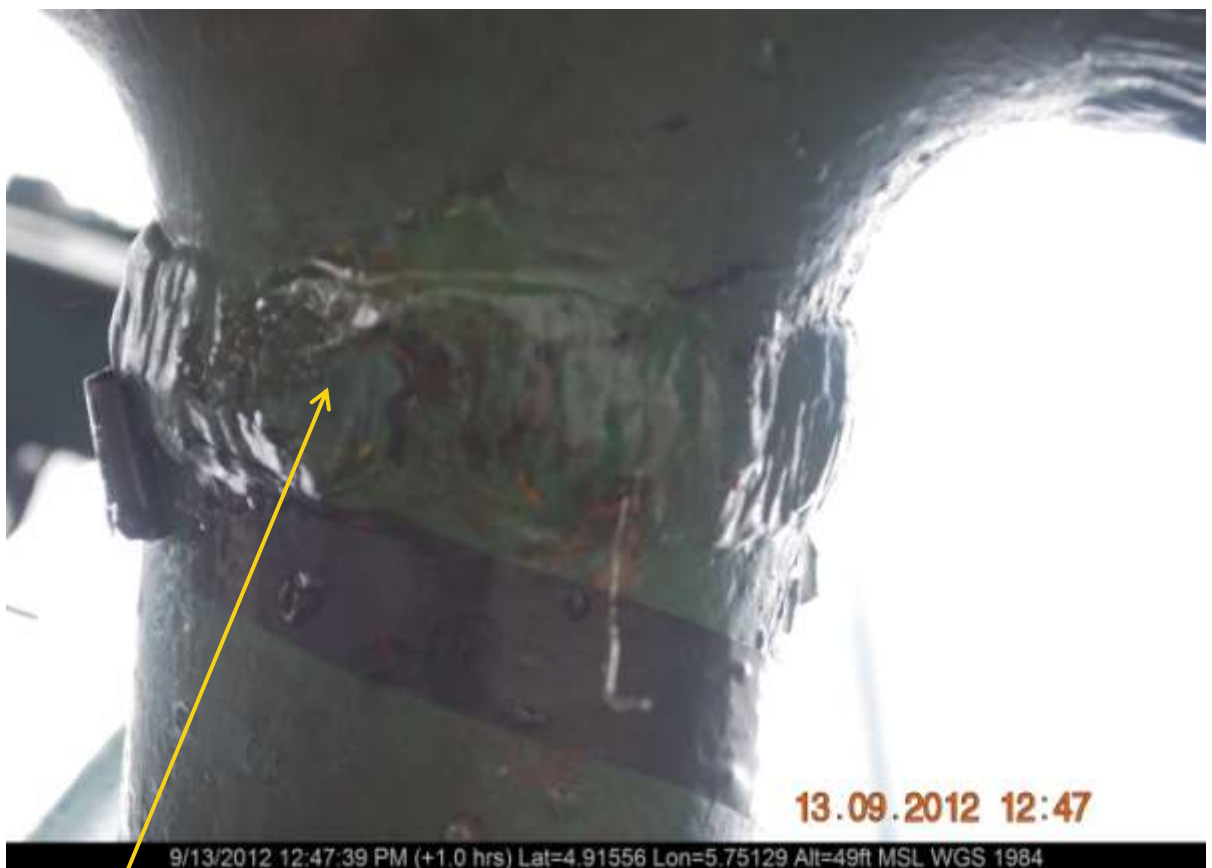
Close-up: Internal corrosion on Opukushi Well 25 at Agbediamma. Picture was taken during Joint Investigation of 13<sup>th</sup> Sept. 2012
