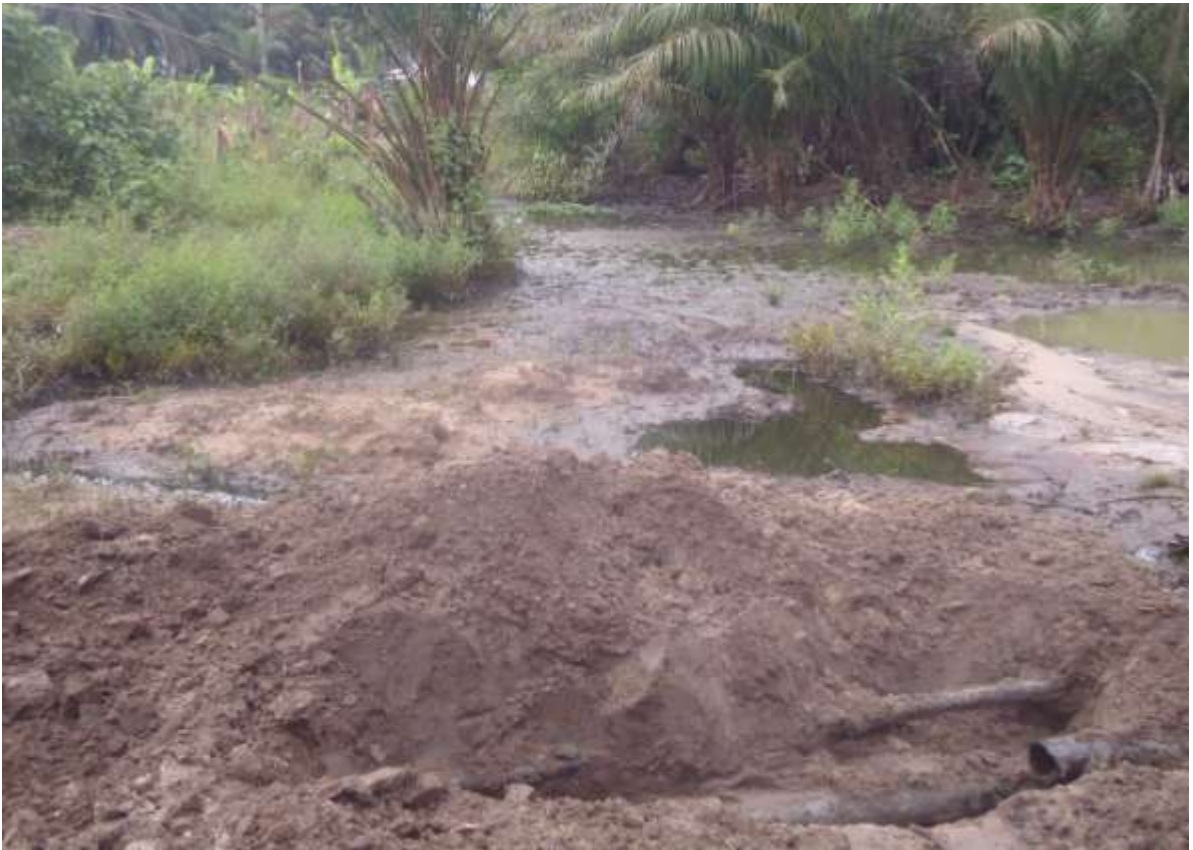
Overview: Part of spill impact on Well 56S flow line right of way (RoW) at Etitioha. Picture was taken during Joint Investigation of 26th August 2012.

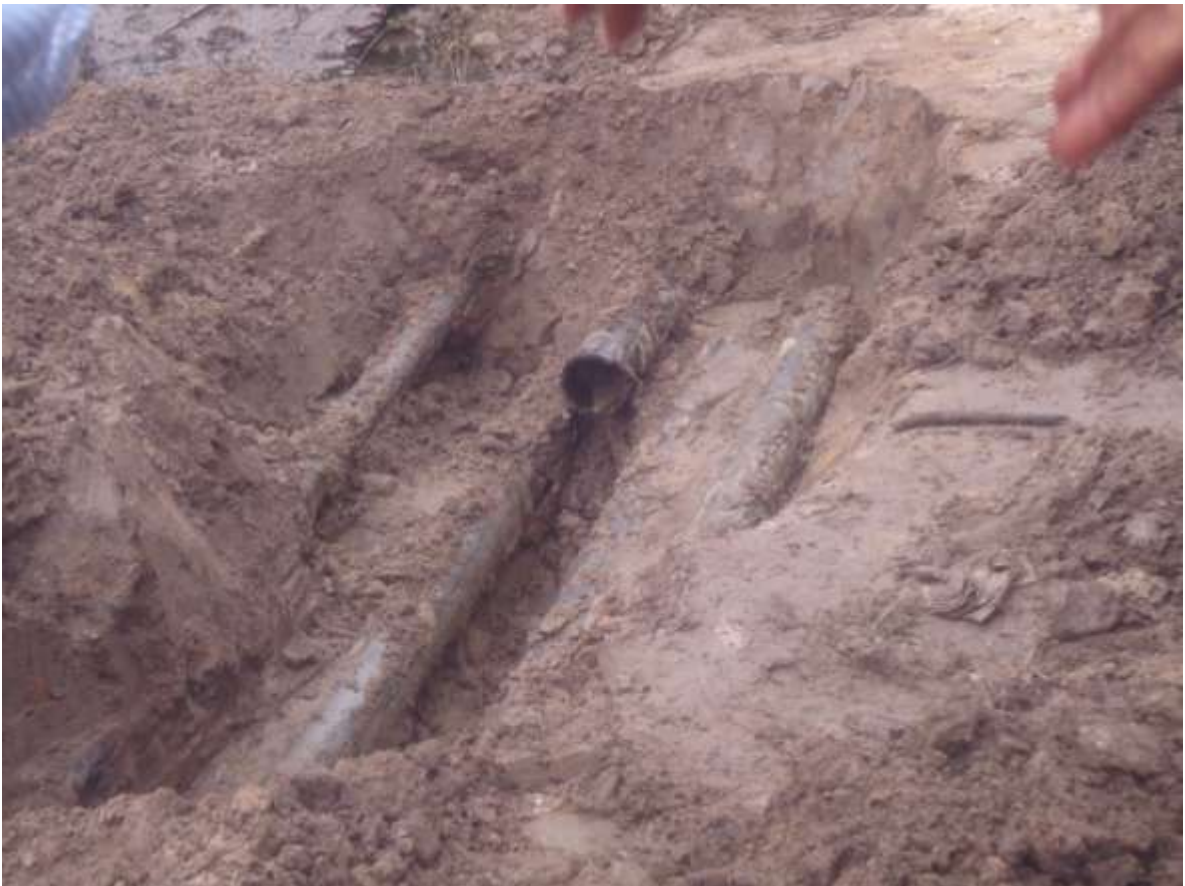
Close-up: Missing flowline on Well 56S flow line right of way (RoW) at Etitioha. Picture was taken during Joint Investigation of 26th August 2012.
