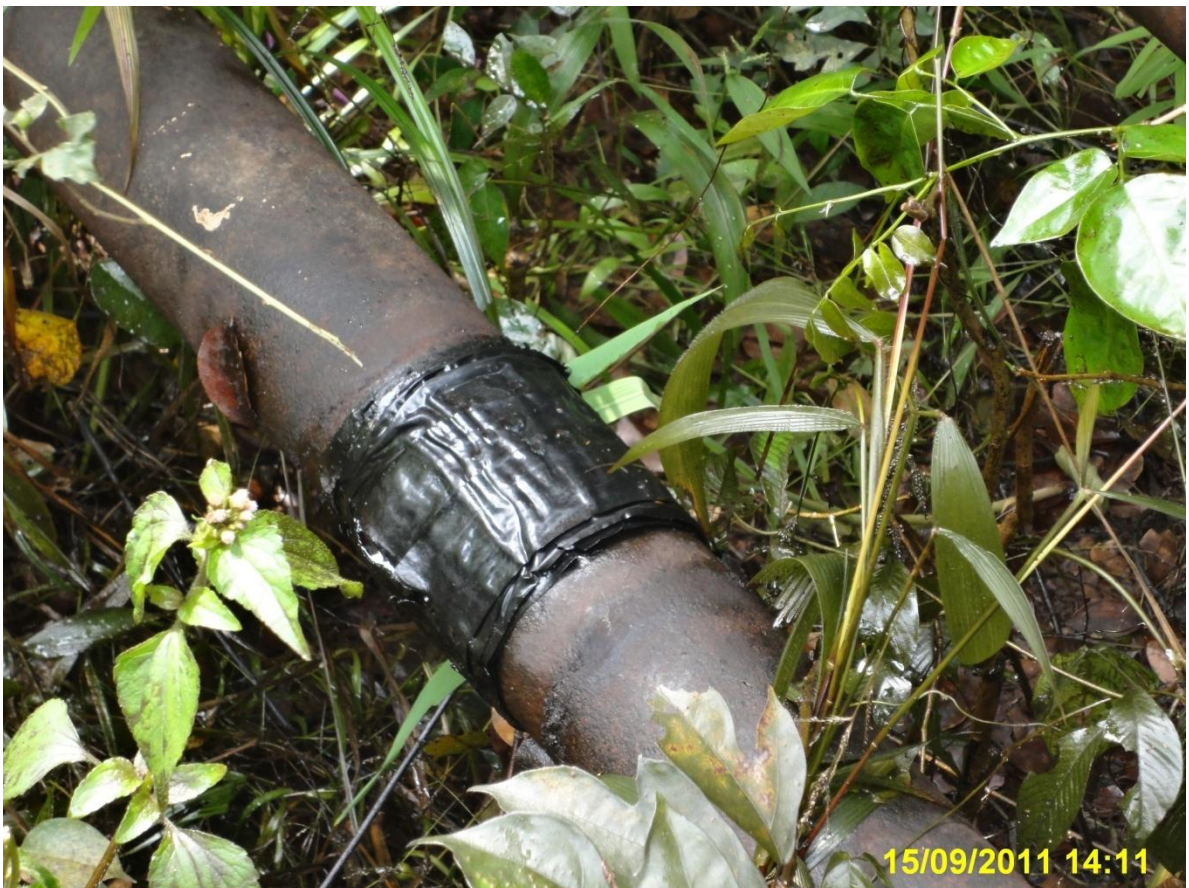
Close-up: Spill point on Adibawa Well 10S flowline at Edagberi. Picture was taken during Joint Investigation of 15th September, 2011.

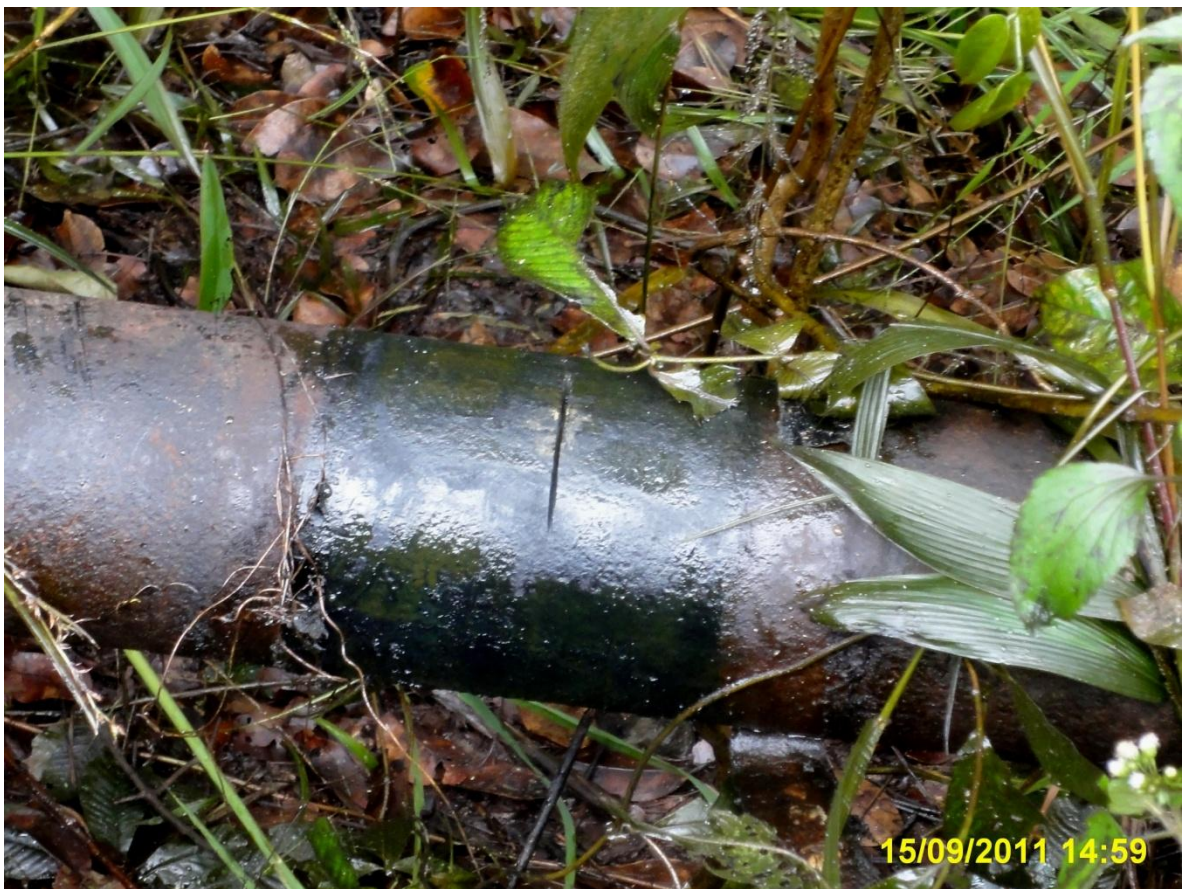
Overview: Initial hacksaw cut previously clamped on Adibawa Well 10S flowline at Edagberi.
Picture was taken during Joint Investigation of 15th September, 2011.
