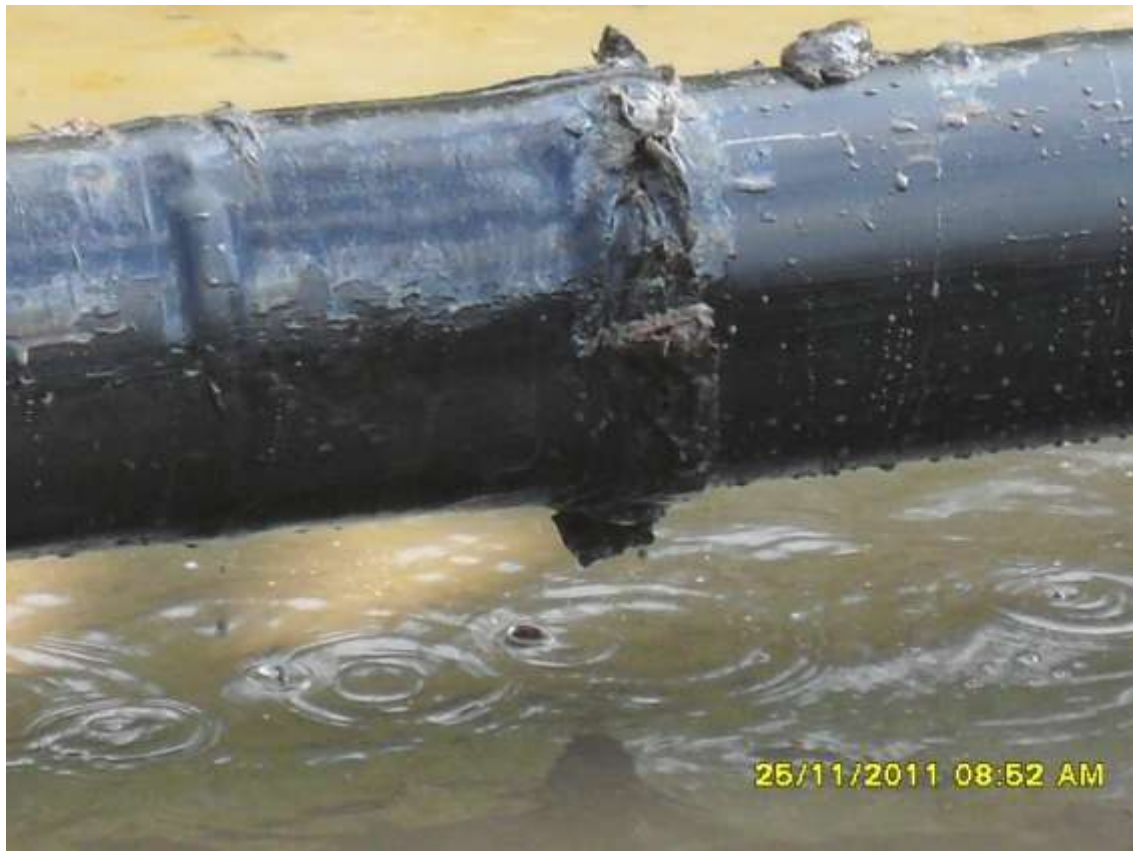
Close-up: Spill due to pinhole and slight tear close to previous weld on Kanbo Well 5L flowline at Egbemo Angalabiri. Picture taken during Joint Investigation of 25<sup>th</sup> November 2011.
