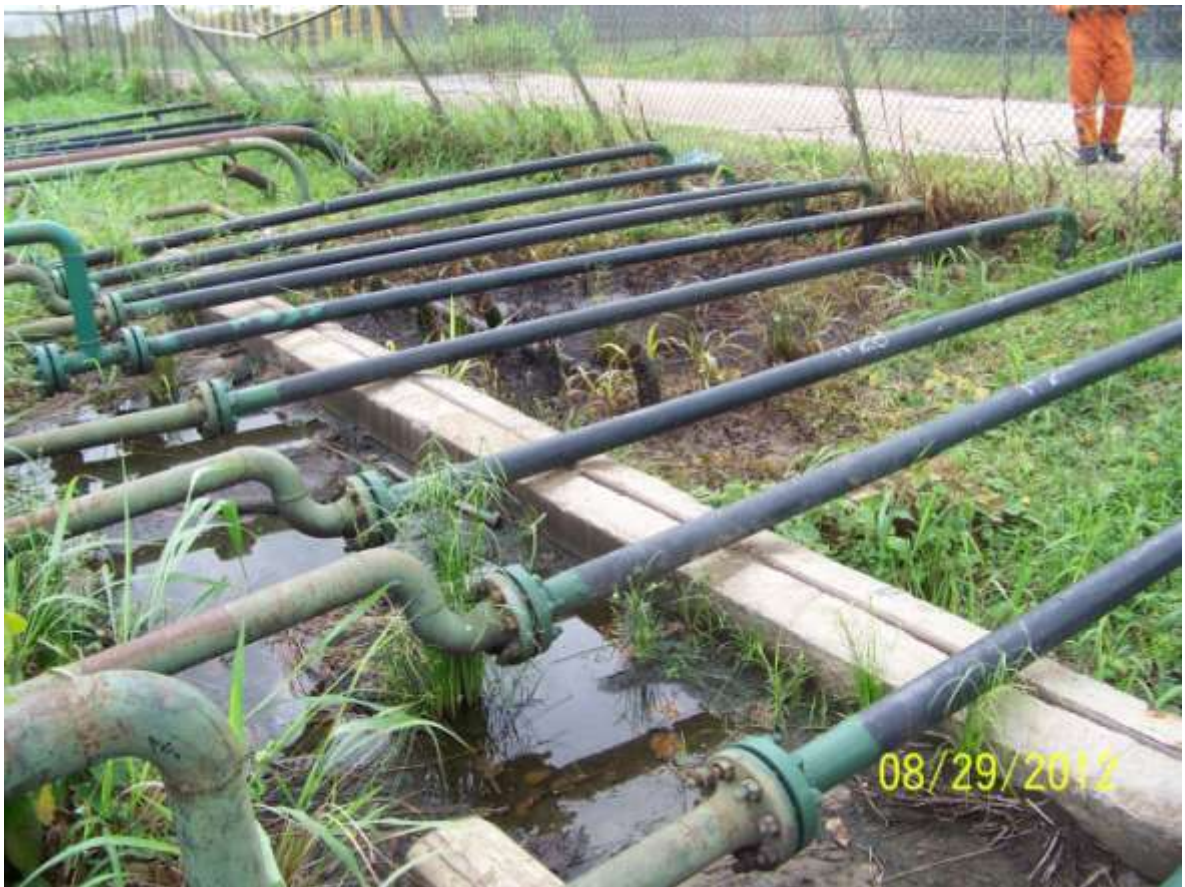
Overview: Part of spill impact on Obigbo Flowline Gathering Manifold route at Umuwalia. Picture was taken during Joint Investigation of 29th August 2012.

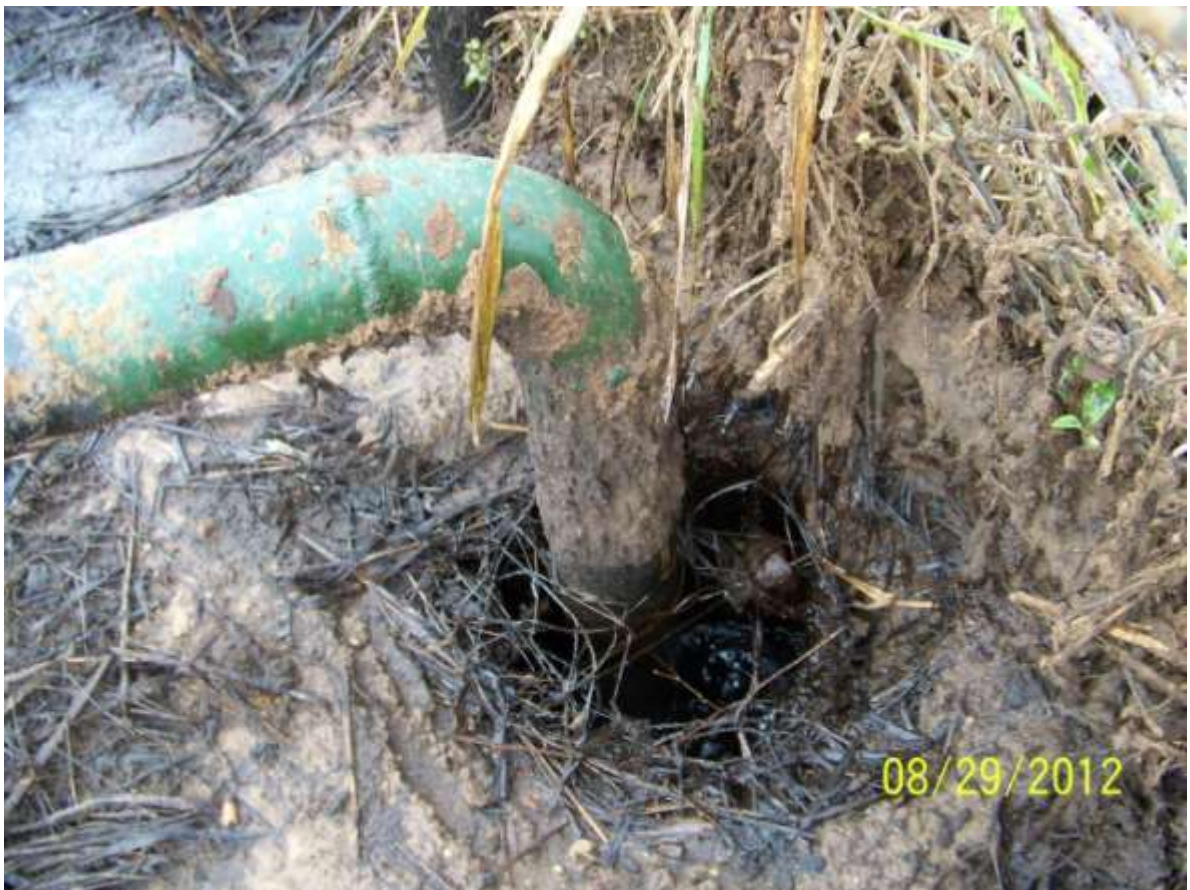
Close-up: Corrosion on Obigbo well 33S flowline at Obigbo Flowline Gathering Manifold at Umuwalia. Picture was taken during Joint Investigation of 29th August 2012.
