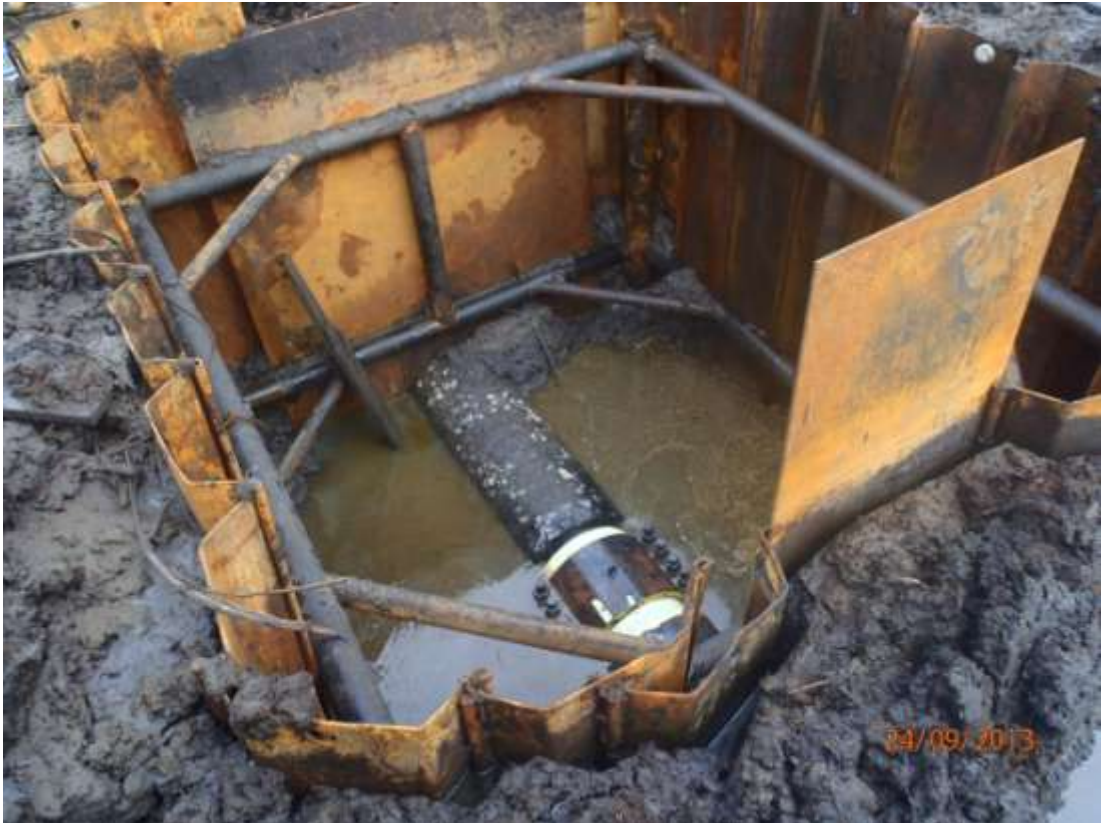
Overview: Spill point within cofferdam on 30" Nembe Creek pipeline right of way at Krakama. Picture was taken during Joint Investigation of 24<sup>th</sup> September 2013.

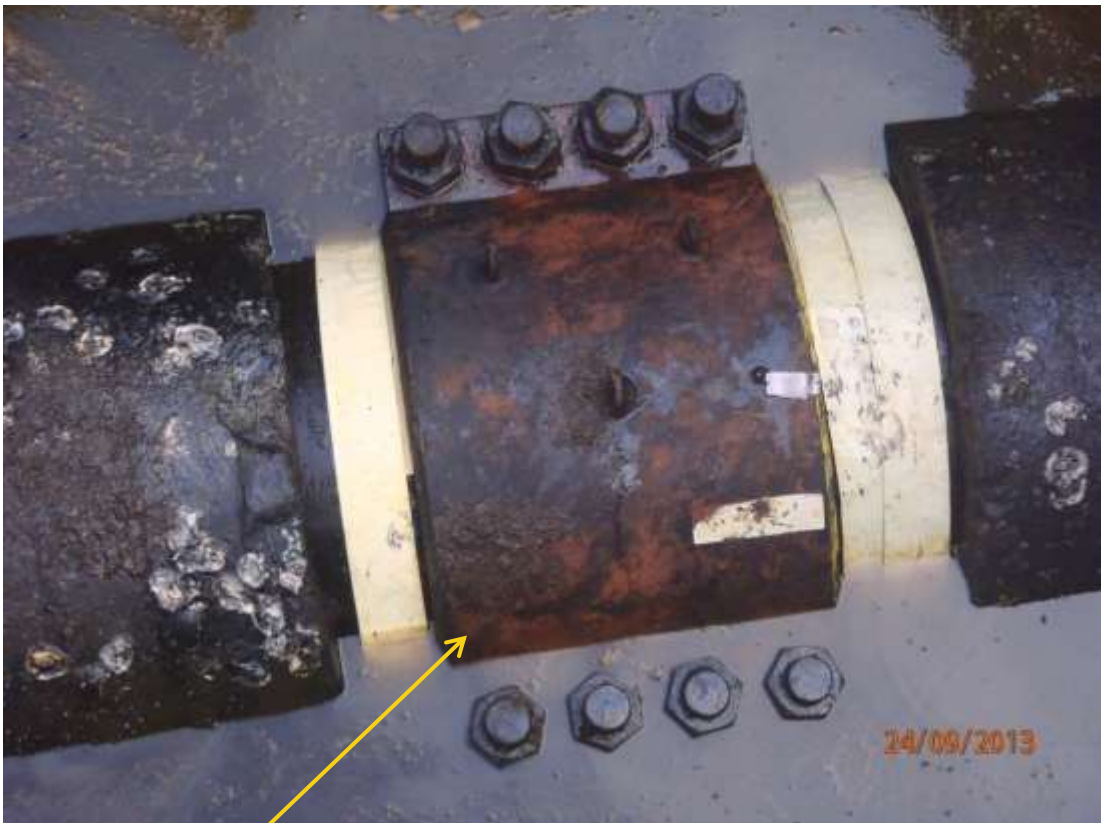
Close up: Failed clamp on 30" Nembe Creek pipeline at Krakama. Picture was taken during Joint Investigation of 24<sup>th</sup> September 2013.
