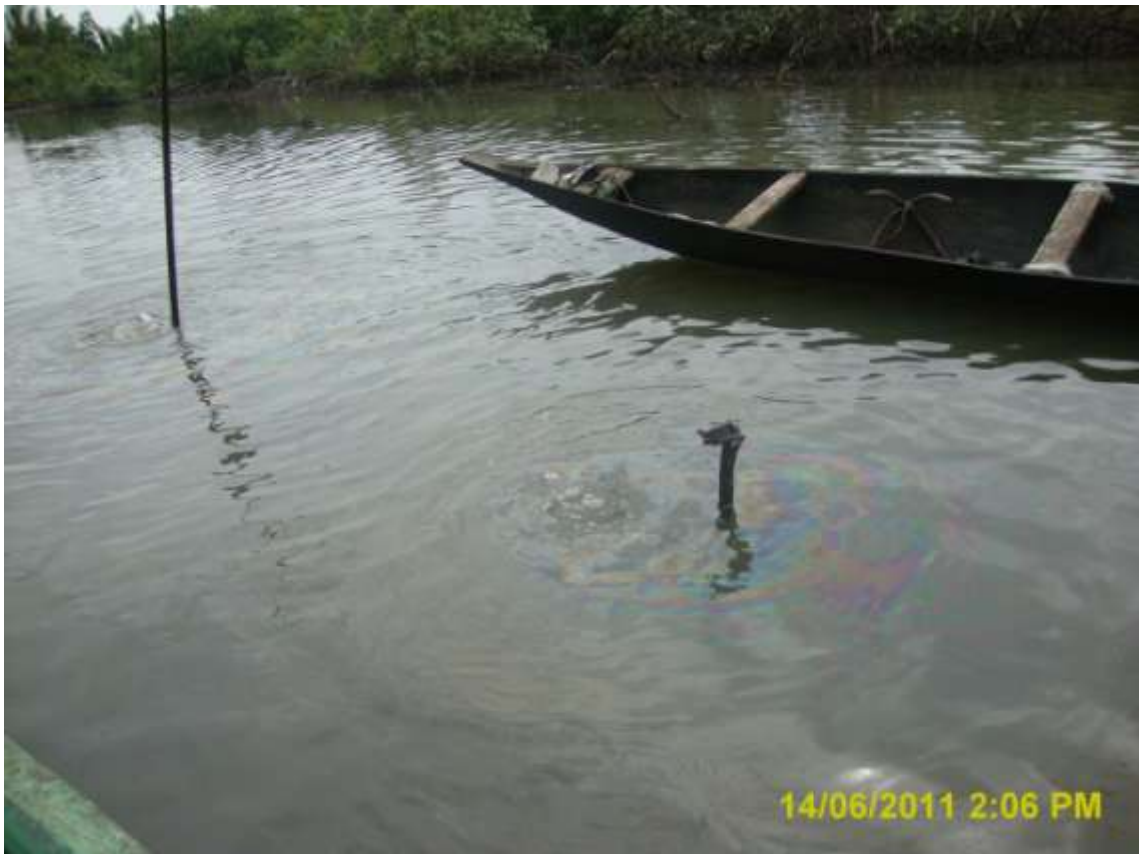
Overview: Bubbles with slight oil sheen along Bonny-Oloma Well 12S flowline Right of Way at Oloma with passing fisherman's canoe in the background.
