Overview: Yokri Well 114S flowline at Yokri/Sokebolou being raised for inspection.
Picture taken during Joint Investigation of 15th August, 2011

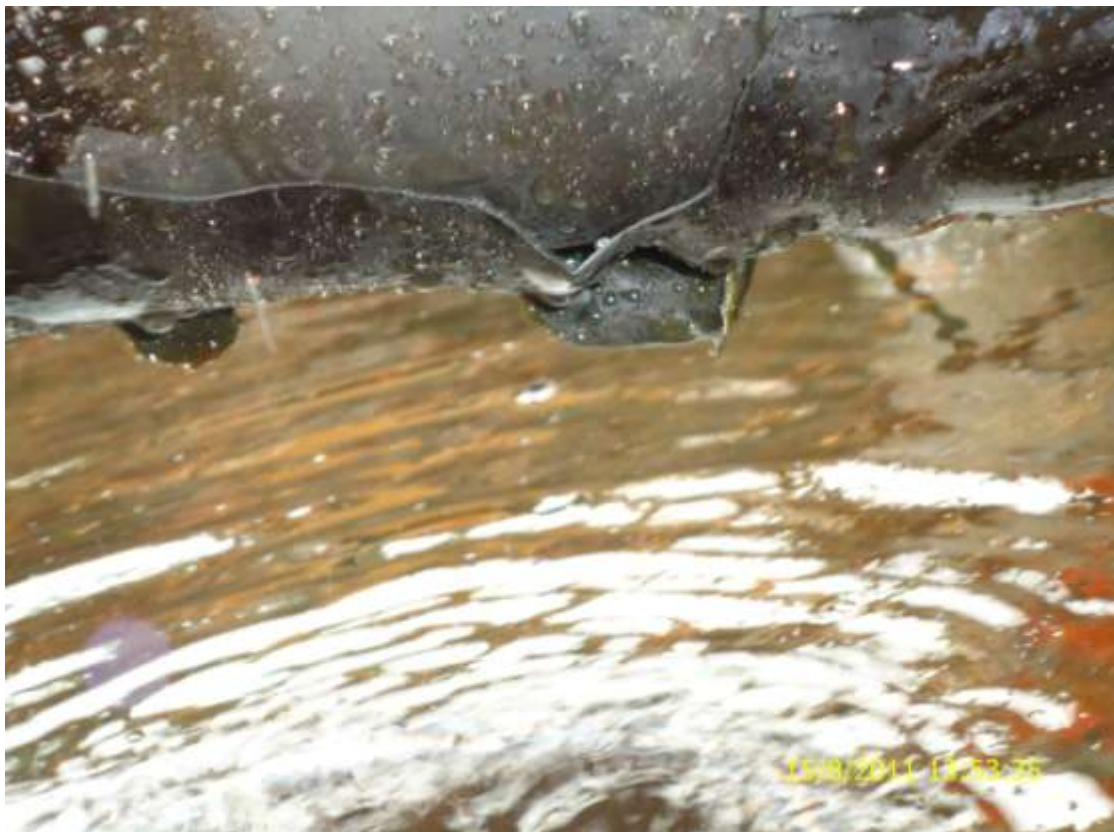
Close-up: Spill due to corrosion on Yokri Well 114S flowline at Yokri/Sokebolou.
Picture taken during Joint Investigation of 15th August, 2011
