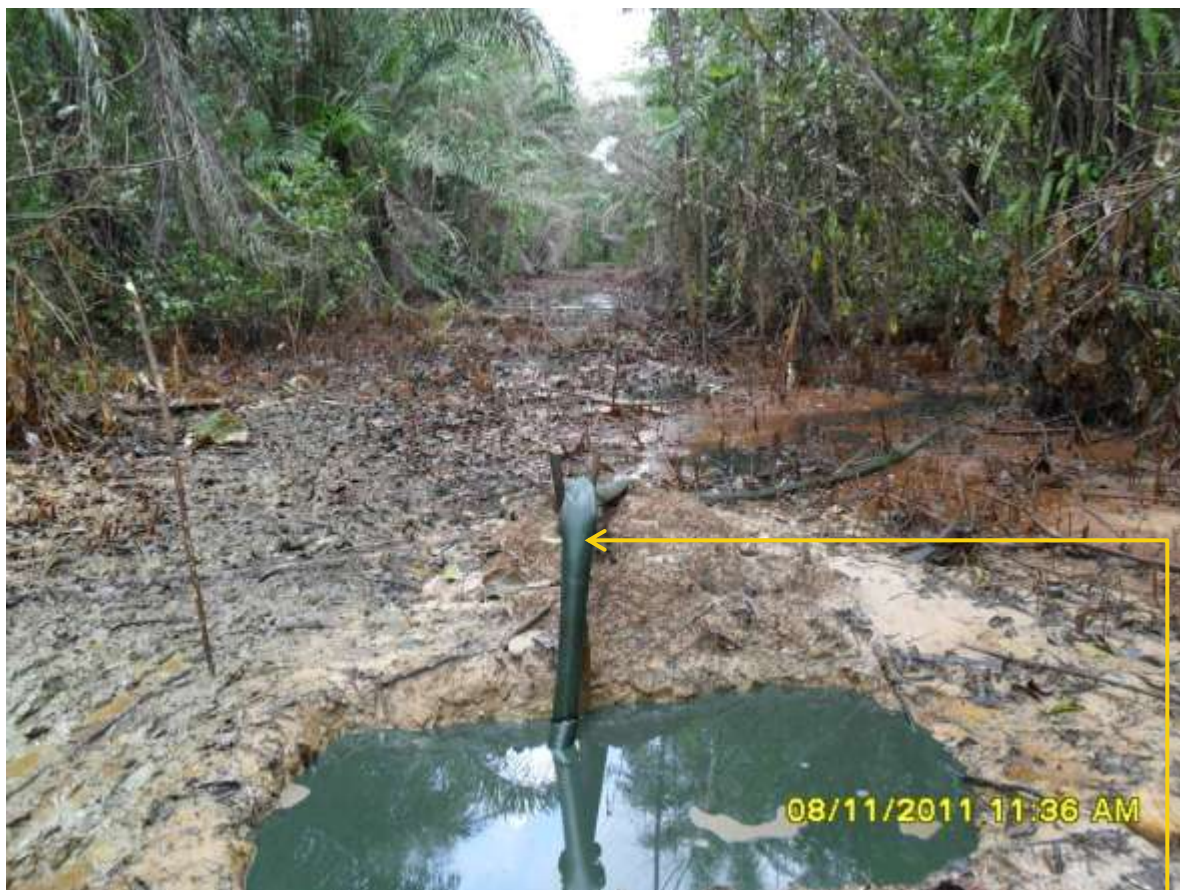
Overview: Part of spill impact on 10" Diebu Creek pipeline at Oporoma right of way. Hose used for bunkering can be seen in the photo.

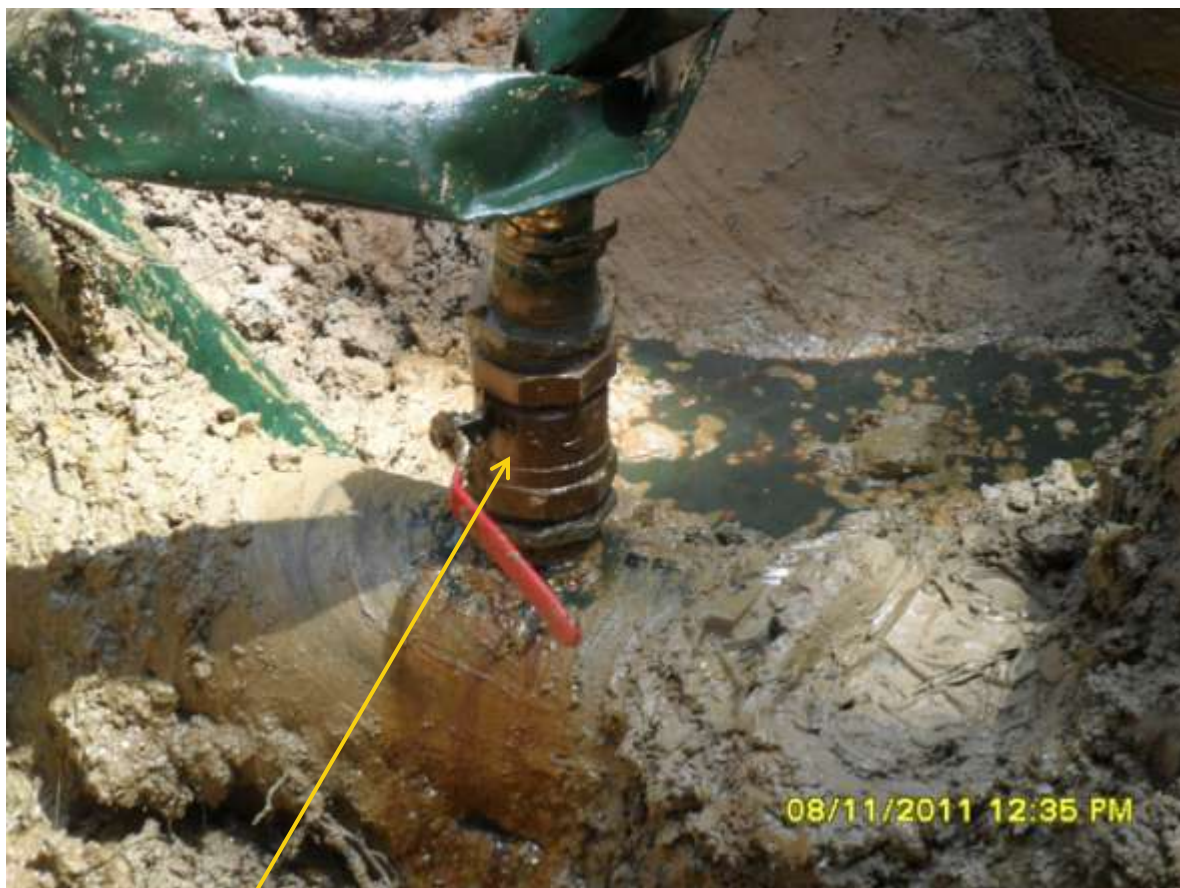
Close-up: One of three Illegal fittings on 10" Diebu Creek pipeline at Oporoma. Picture was taken during Joint Investigation of 8<sup>th</sup> November, 2011.

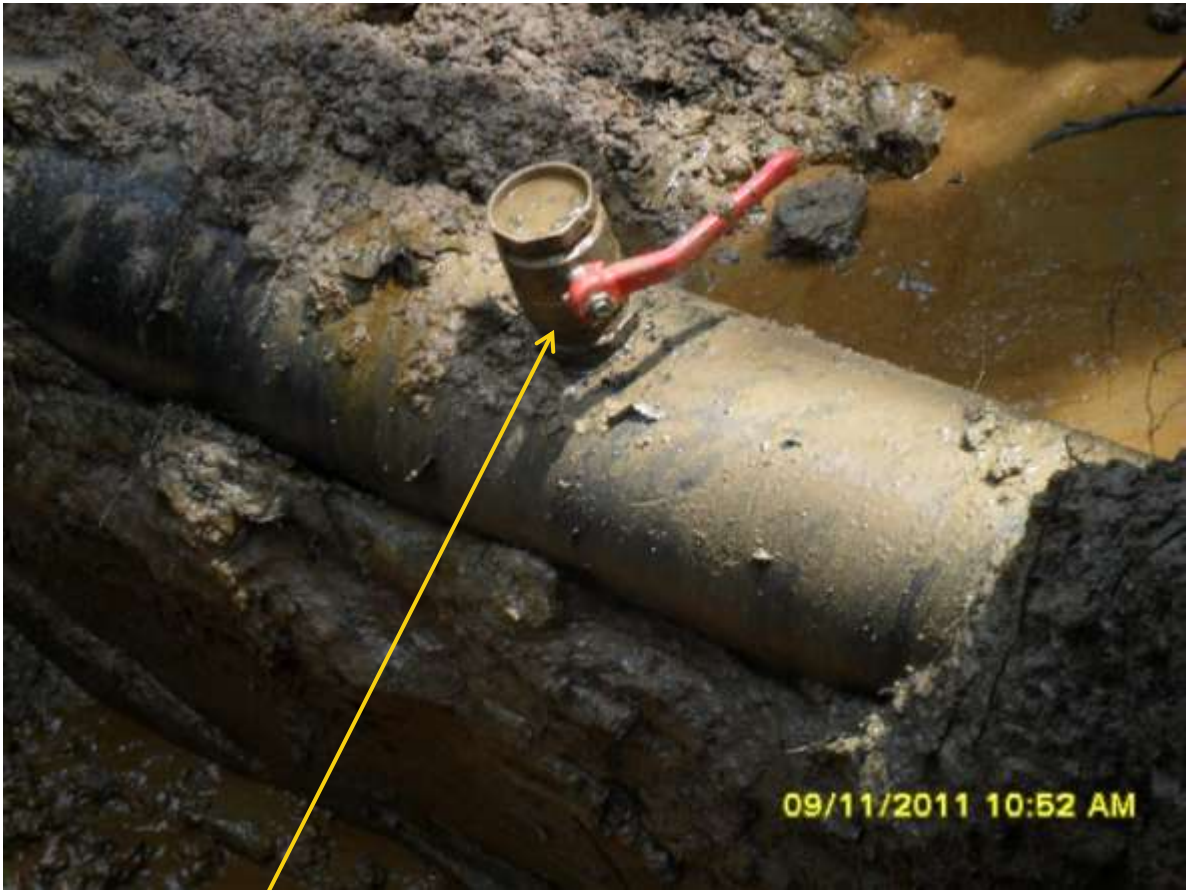
Close-up: One of three illegal fittings on 10" Diebu Creek pipeline at Oporoma. Picture was taken during Joint Investigation of 9<sup>th</sup> November, 2011.
