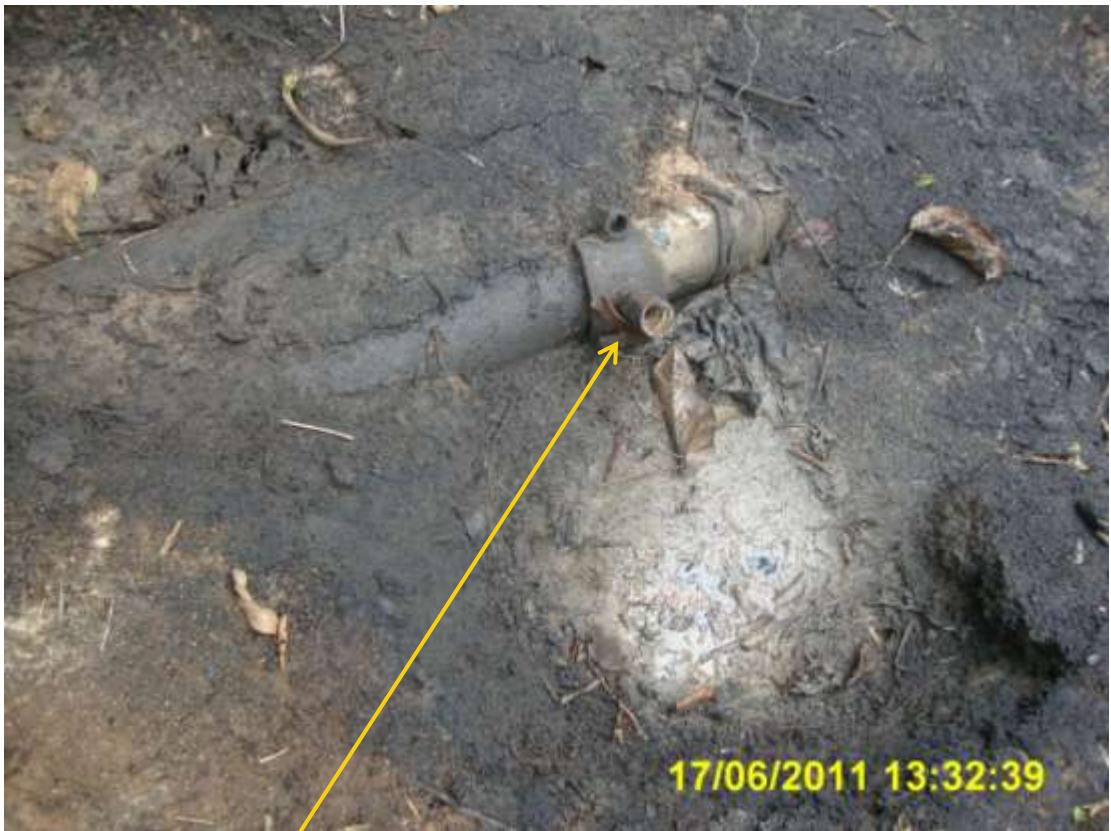
Close-up: Illegally welded fitting on Well56L flowline at Isietitioha. Picture taken during Joint Investigation of 17<sup>th</sup> June, 2011
