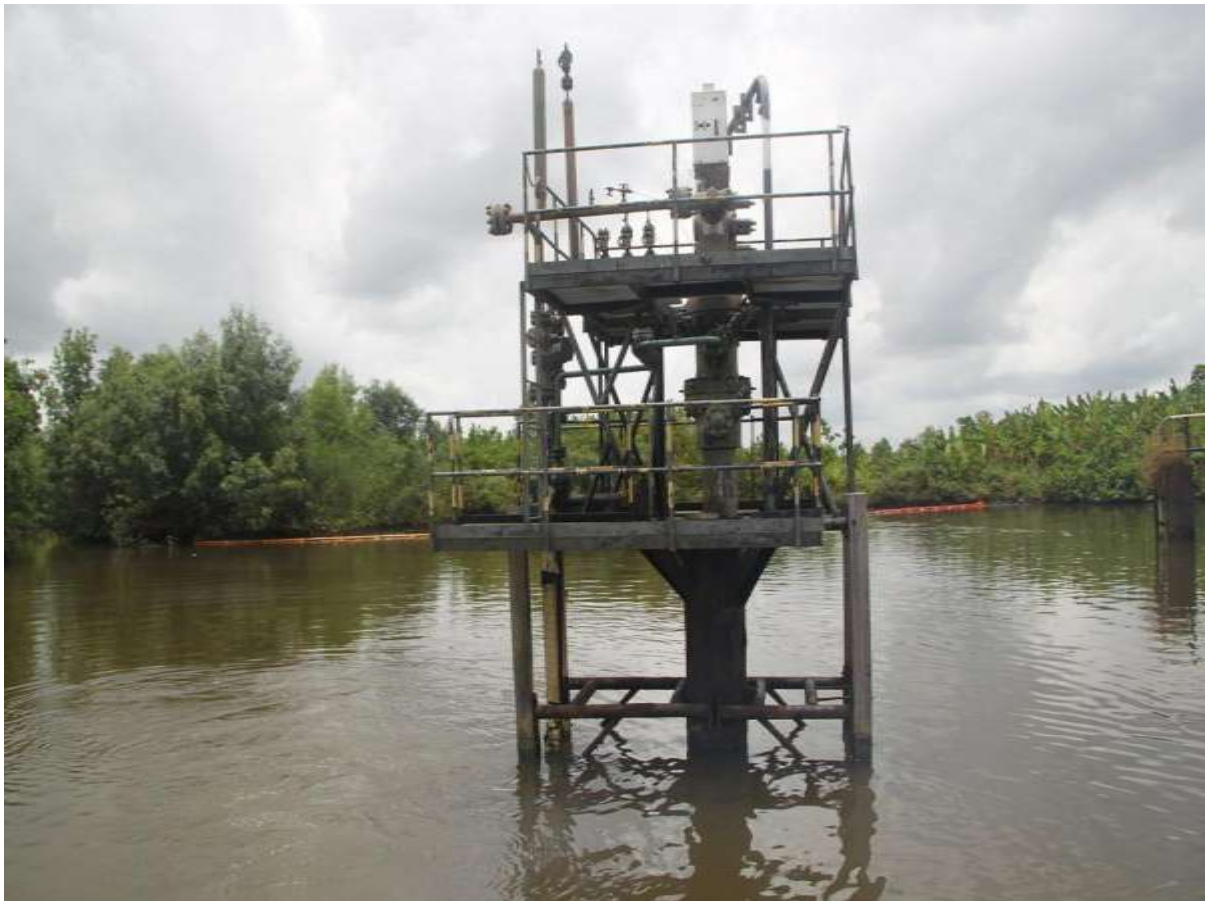
Overview: Extent of the spill incident impact on Otumara W-44S Wellhead riser. Pictures taken during Joint Investigation of 28<sup>th</sup> March, 2011
