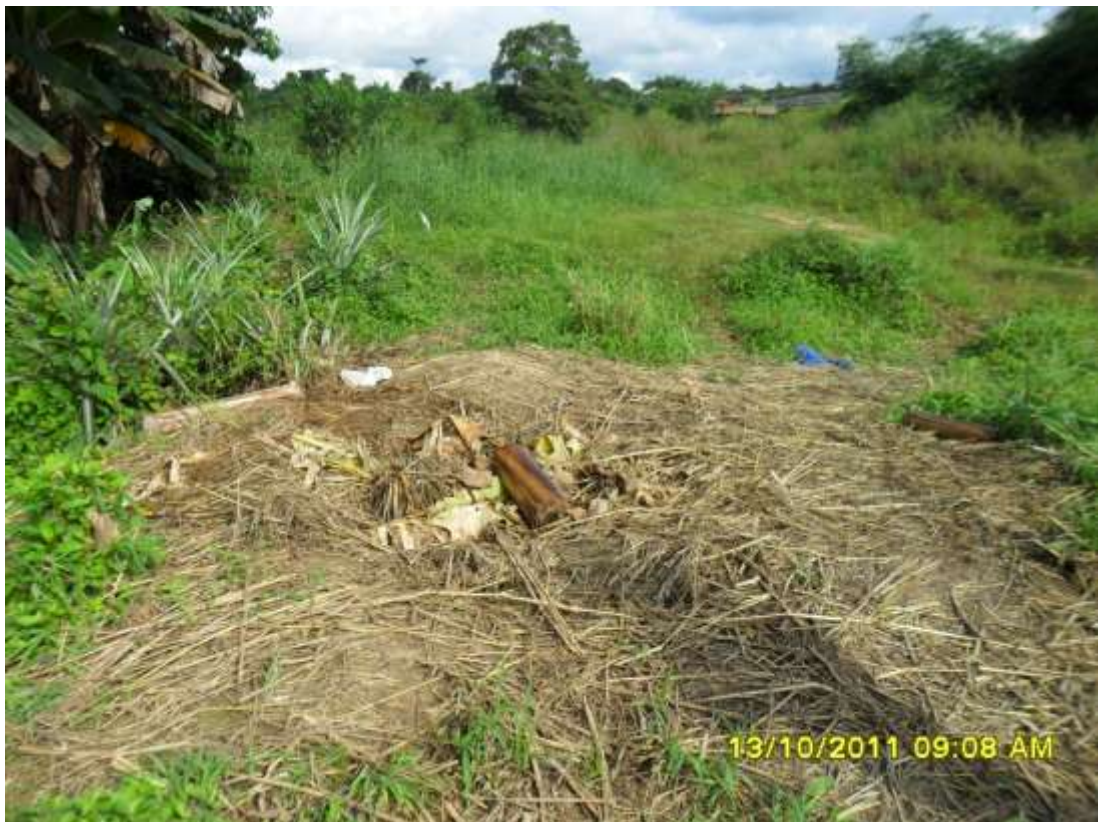
Overview: Location of suspected bunkering point on 12" Egbema-Oguta pipeline right of way at Eziosu. Picture taken during Joint Investigation of 13<sup>th</sup> October, 2011.

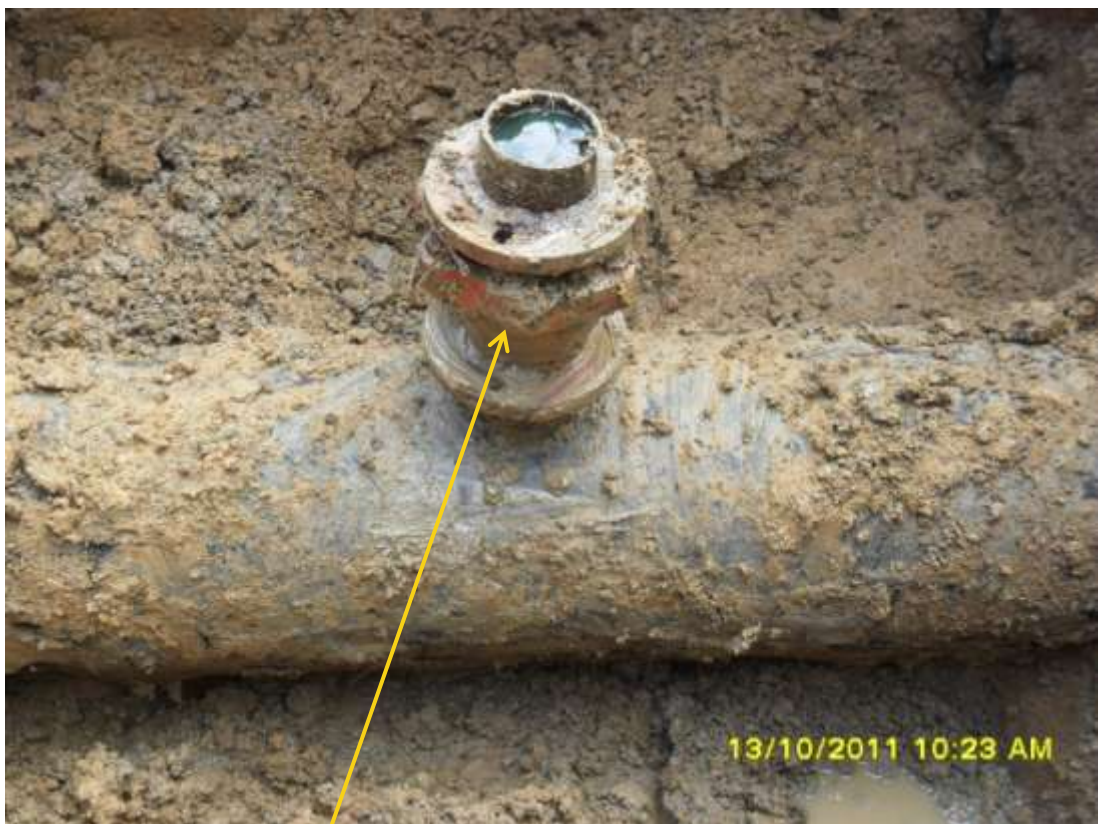
Close-up: Illegal fitting discovered after excavation on 12" Egbema-Oguta pipeline at Eziosu. Picture taken during Joint Investigation of 13<sup>th</sup> October, 2011.
