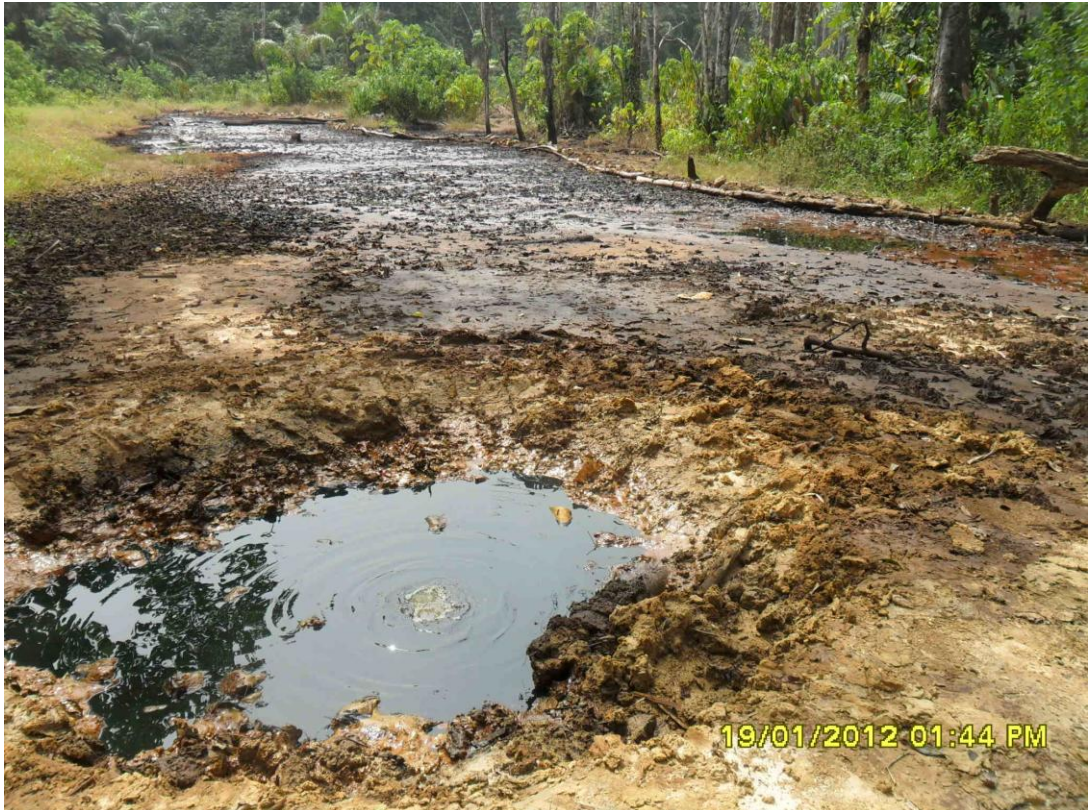
Overview: Part of spill impact on Nun River Well 15S flowline right of way at Onyoma. Picture was taken during Joint Investigation of 19th January 2012.

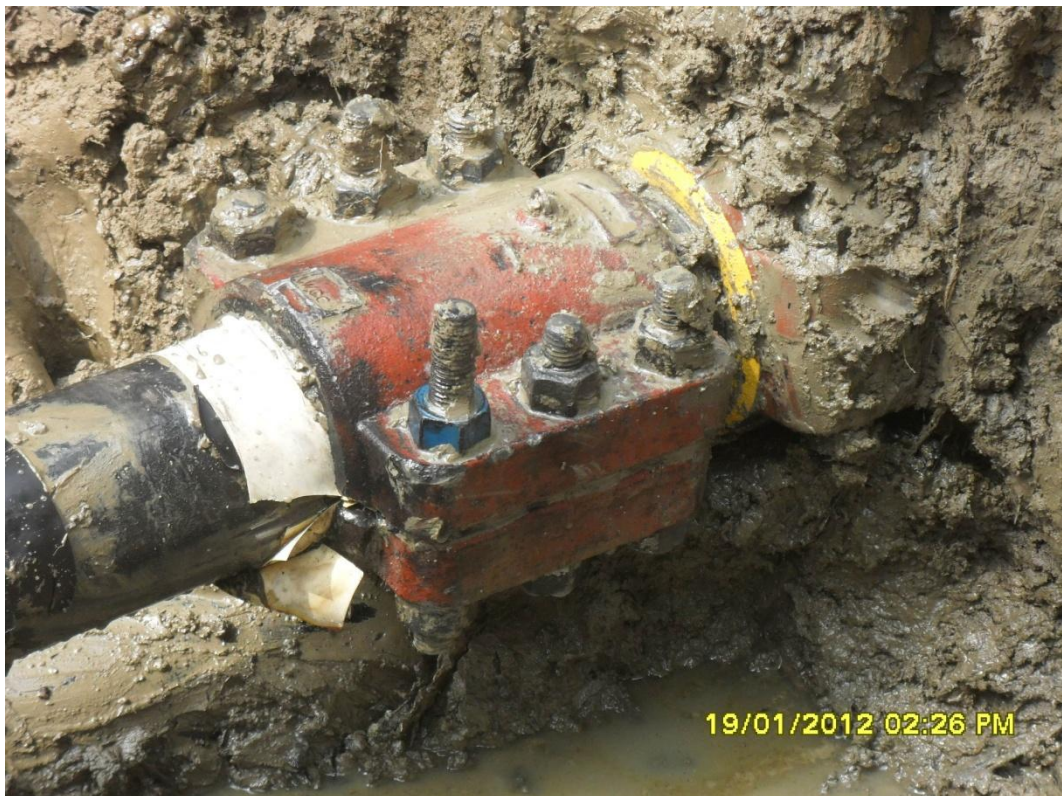
Close-up: Spill due to failed damper on Nun River Well 15S flowline at Onyoma. Picture was taken during Joint Investigation of 19th January 2012.
