Overview: Spill impact on surrounding vegetation on 12" Imo River1 to Oghale pipeline Right of Way at Owaza. Picture taken during Joint Investigation of 15th June, 2011

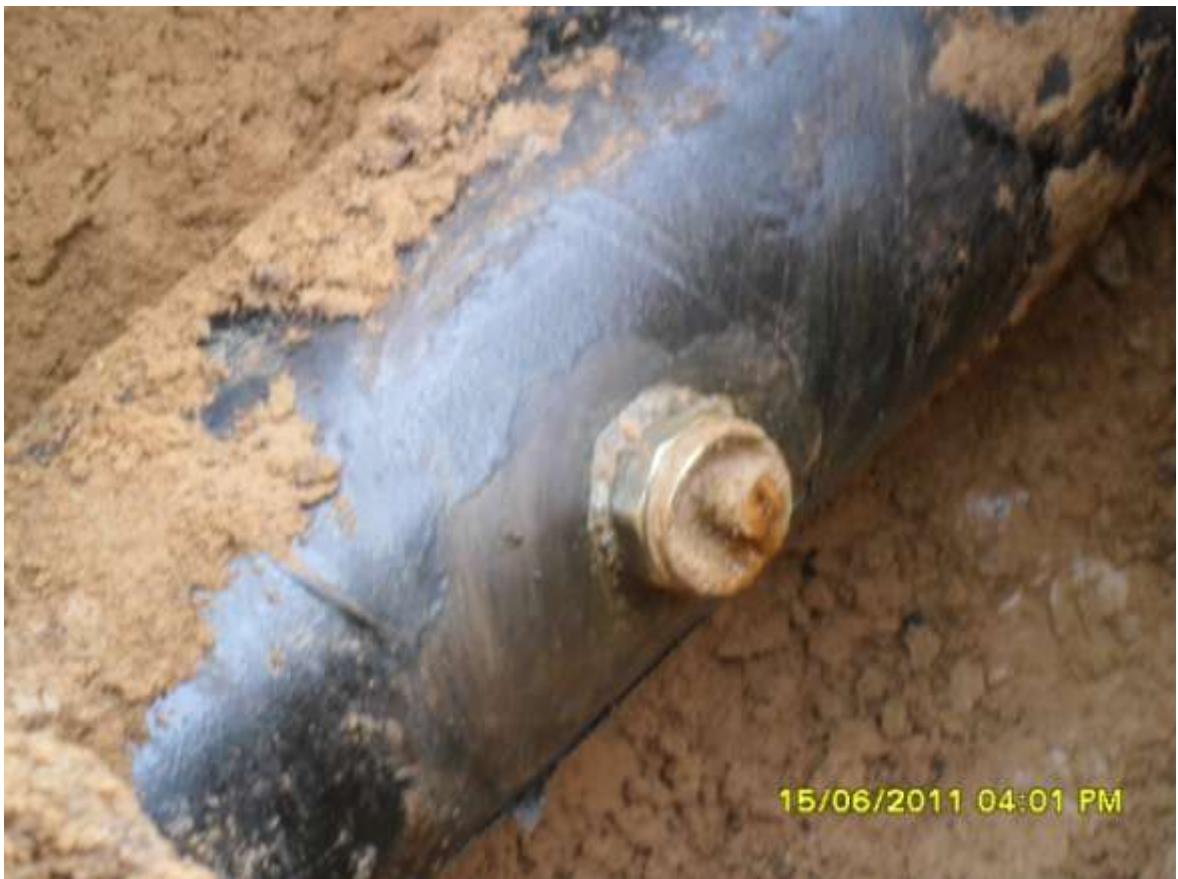
Close-up: Spill due to illegally welded nipple at 2 o'clock position on 12" Imo River1 to Oghale pipeline at Owaza. Picture taken during Joint Investigation of 15th June, 2011
