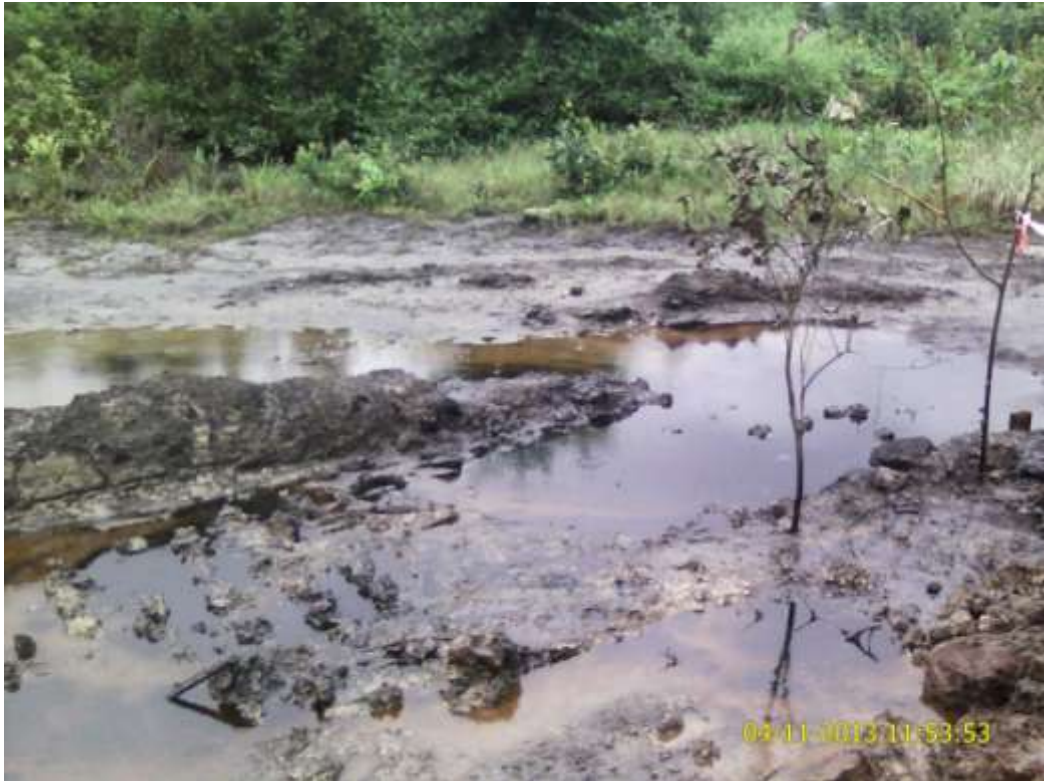
Overview: Part of spill impact on 4" Cawthorne Channel3 Well41S Flowline right of way at Sand-Sand. Picture was taken during Joint Investigation of 4th November 2013.

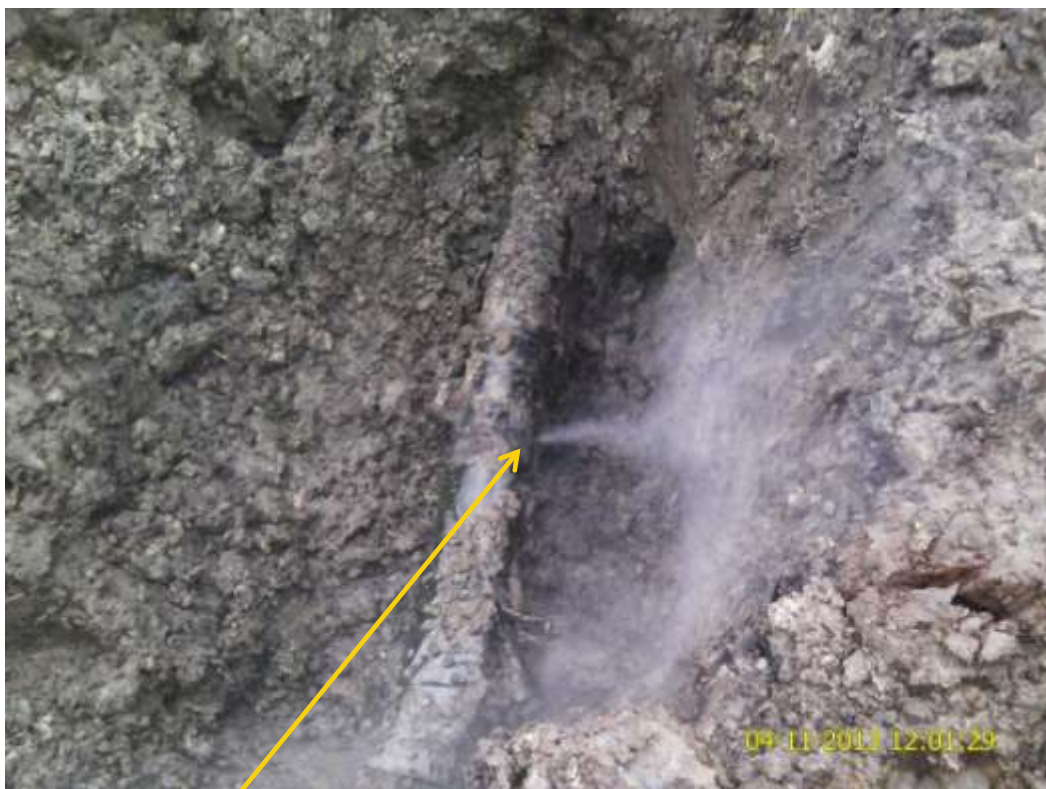
Close-up: Spill due to corrosion on 4" Cawthorne Channel3 Well41S Flowline at Sand-Sand. Picture was taken during Joint Investigation of 4th November 2013.
