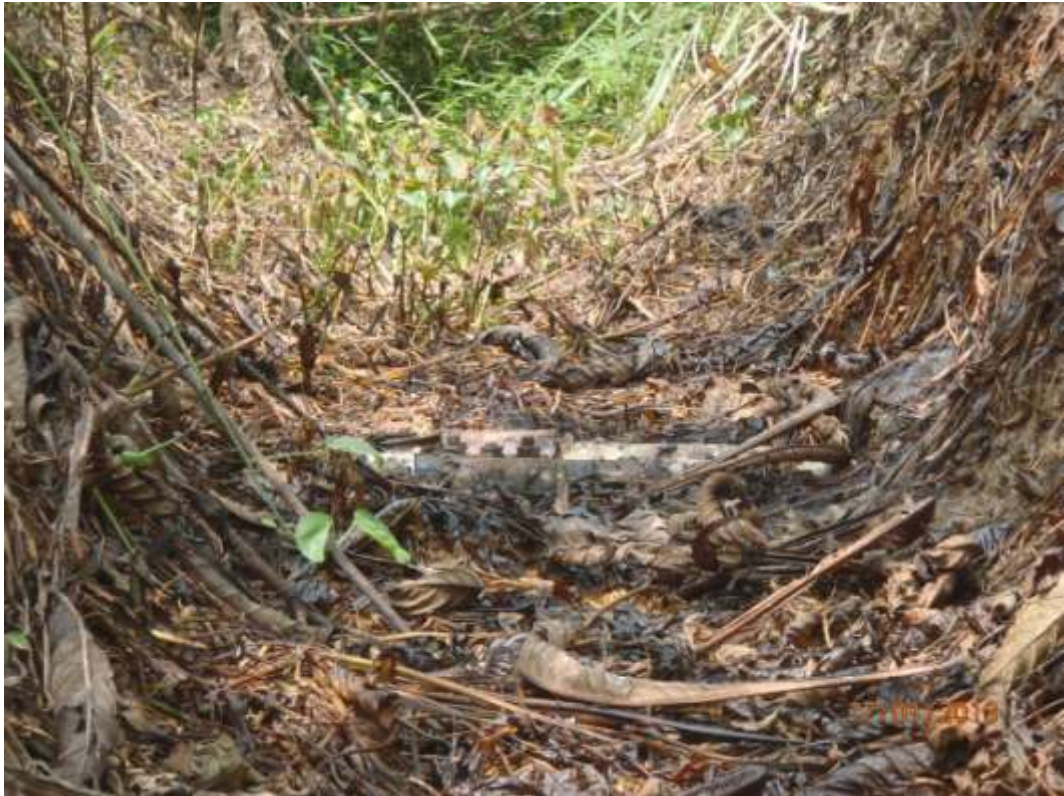
Overview: Part of spill impact on Diebu Creek Well15T flowline right of way at Peremabiri. Picture was taken during Joint Investigation of 17th January 2013.

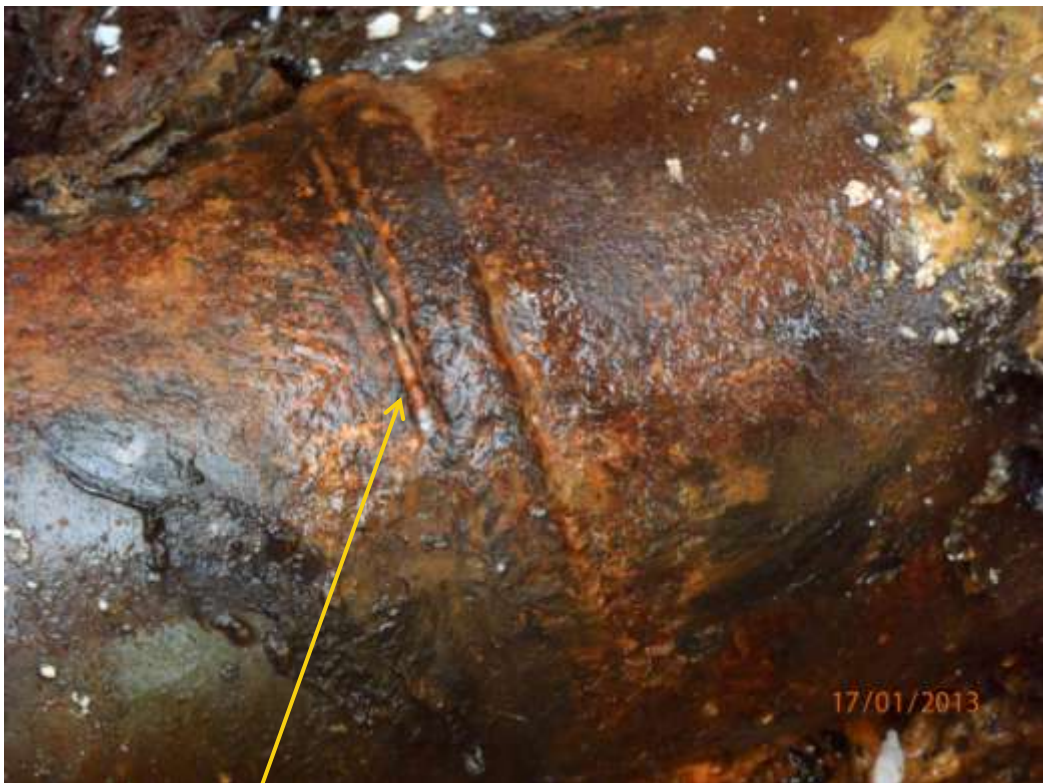
Close up: Hacksaw cut on Diebu Creek Well15T flowline at Peremabiri. Picture was taken during Joint Investigation of 17th January 2013.

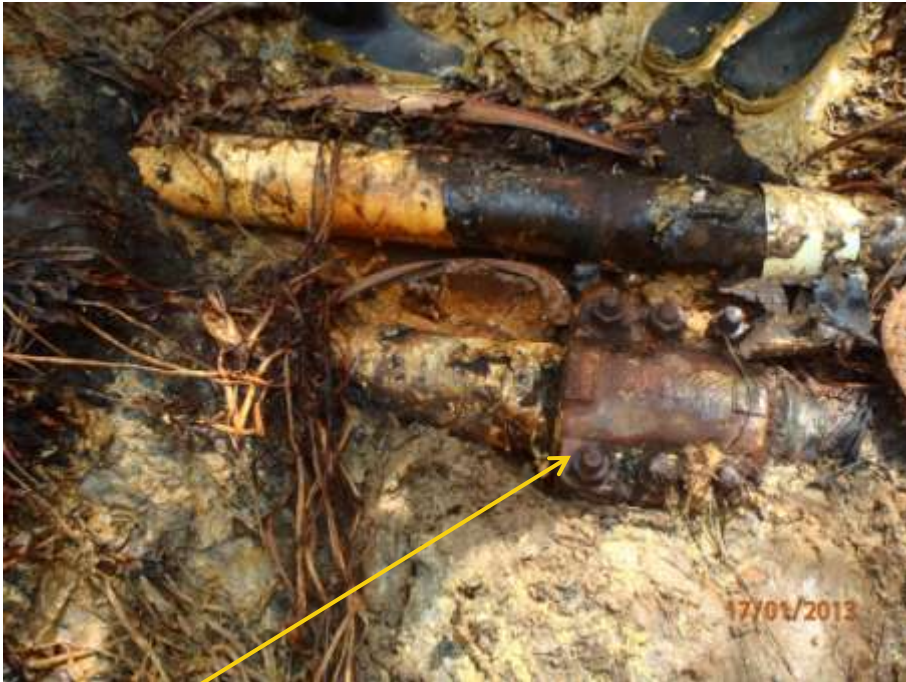
Close up: Loose clamp nut on Diebu Creek Well15T flowline at Peremabiri. Picture was taken during Joint Investigation of 17th January 2013.
