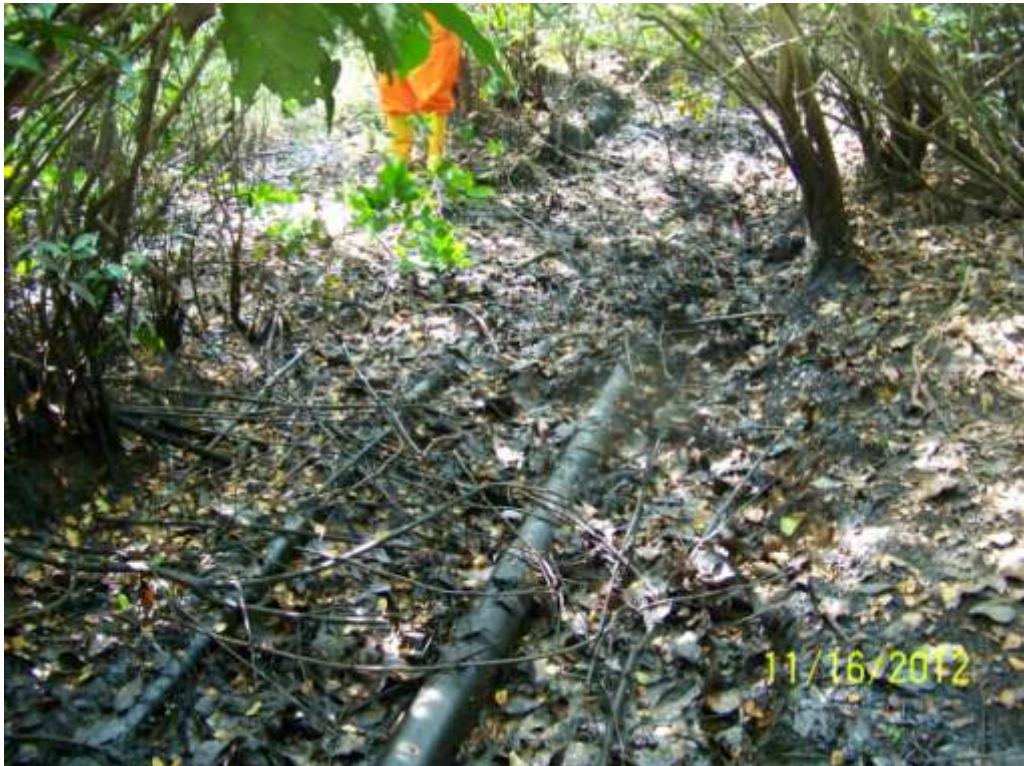
Overview: Part of spill impact on Imo River1 Well25S flowline right of way at Owaza. Picture was taken during Joint Investigation of 16<sup>th</sup> November 2012.

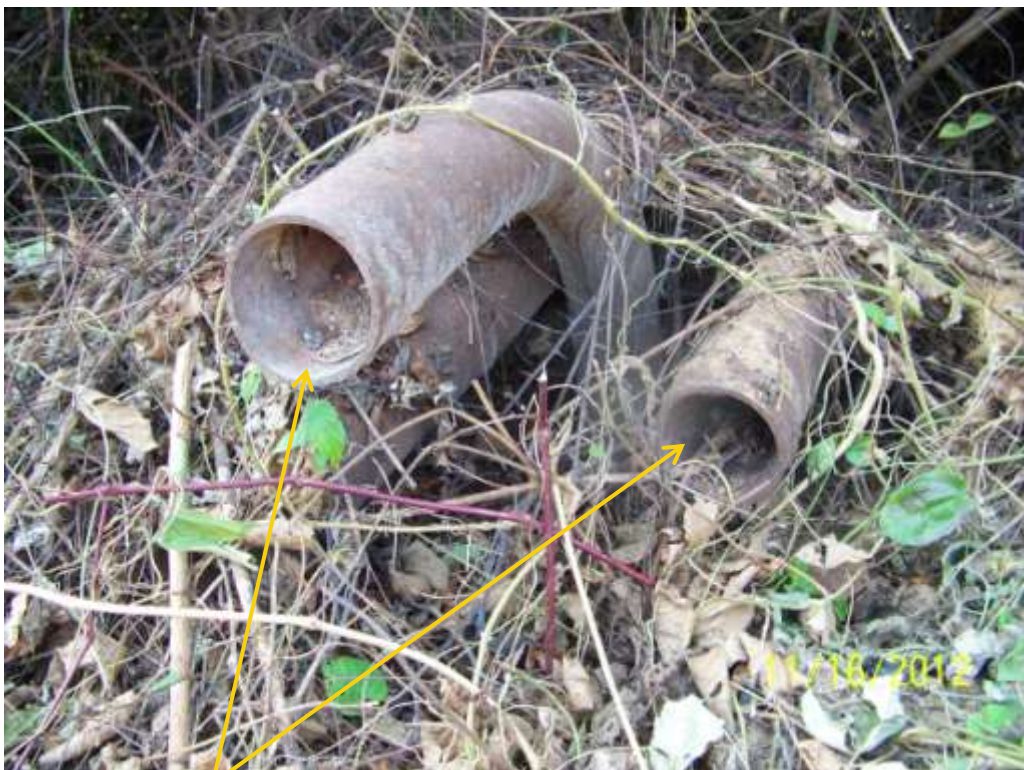
Close up: Cut sections on Imo River1 Well25S flowline at Owaza. Picture was taken during Joint Investigation of 16<sup>th</sup> November 2012.
