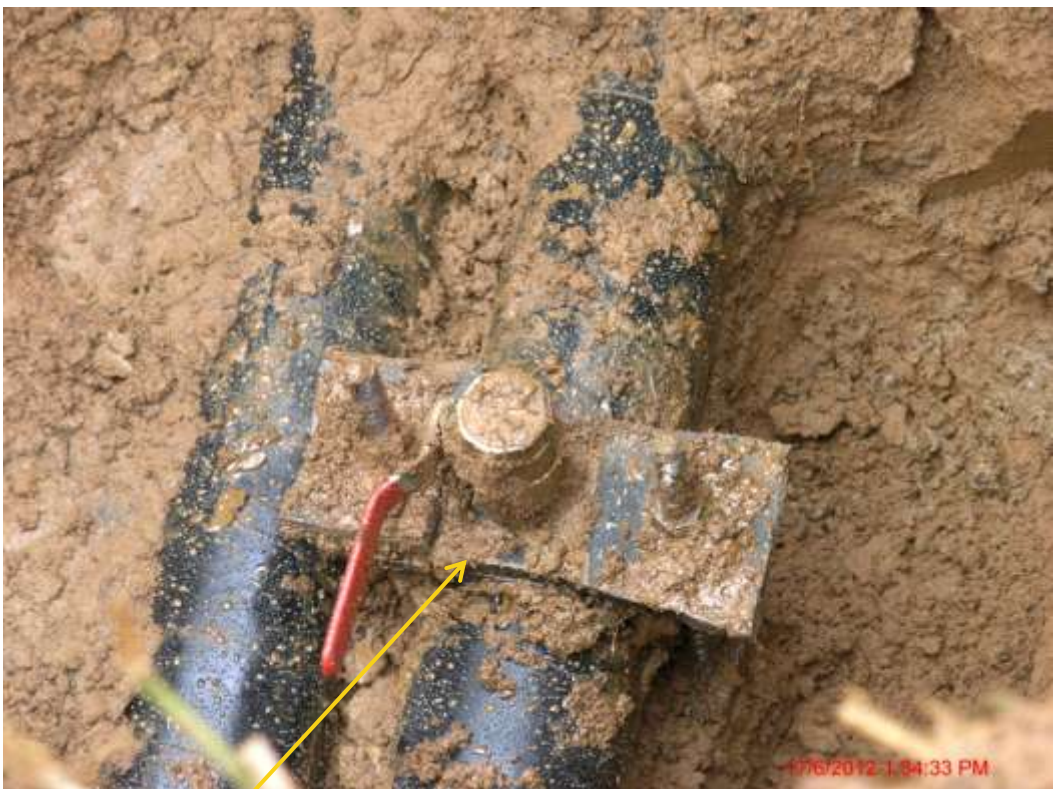
Close up: Illegal fitting on Agbada2 Well69S flowline at Umuokwa. Picture was taken during Joint Investigation of 17<sup>th</sup> June 2012.
