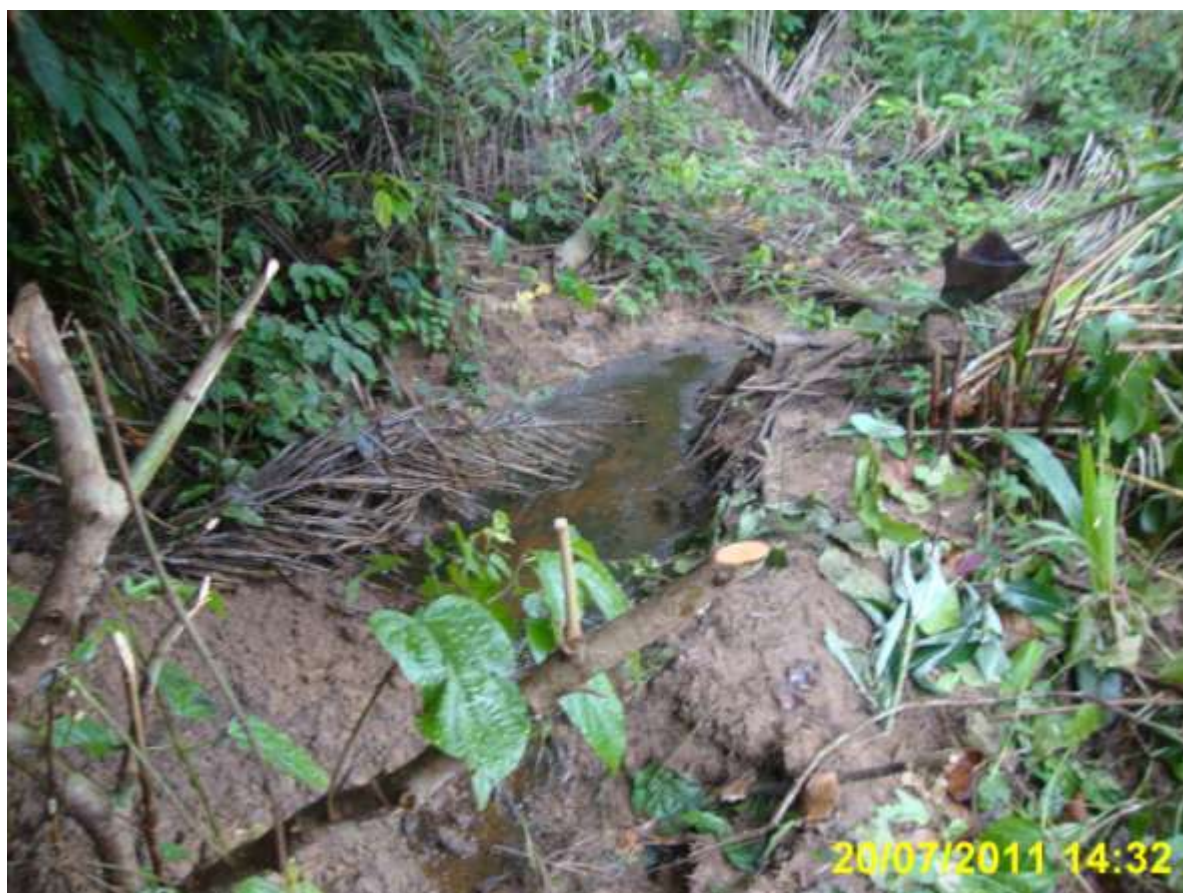
Overview: Part of spill impact on Imo River Well59T flowline at Igiriukwu. Picture taken during Joint Investigation of 20th July, 2011

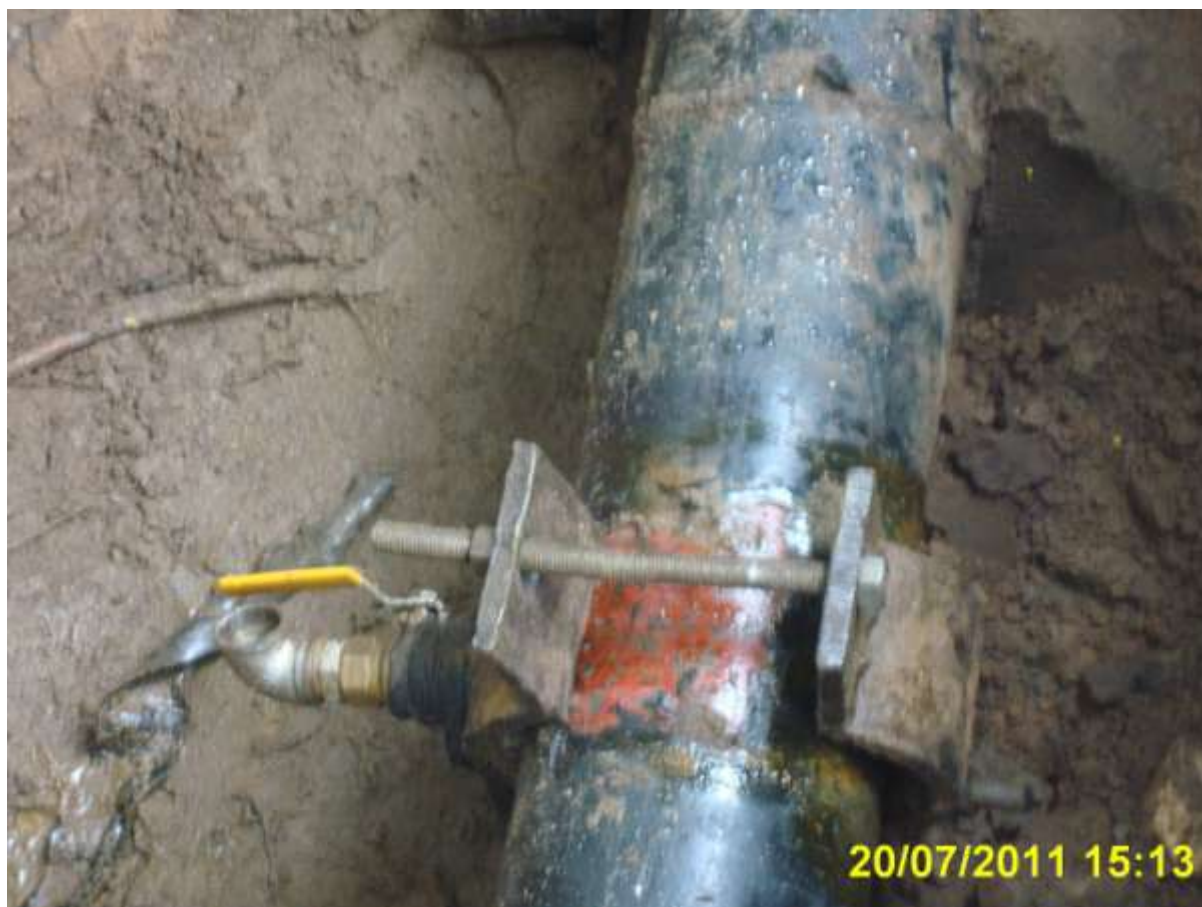
Close-up: Spill due to illegal fitting on Imo River Well59T flowline at Igiriukwu. Picture taken during Joint Investigation of 20th July, 2011
