BELZONA SUPERWRAP II

PURSUANT TO ASME PCC-2 ARTICLE 401 NONMETALLIC COMPOSITE REPAIR SYSTEMS: HIGH-RISK APPLICATIONS

BBH 4640

Asset Details	
Location	GOM
Asset Reference / Identification	MBM-141 Produced Water Hydrocyclone
Asset Type	Pipe
Material / Grade	ASTM A106B
Geometry	Nozzle/Flange
Asset Contents	Produced Water
Surface Cleanliness	SSPC-SP 11
Repair Type	Circumferential Wrap
Repair Recertification Inspection	10 Years

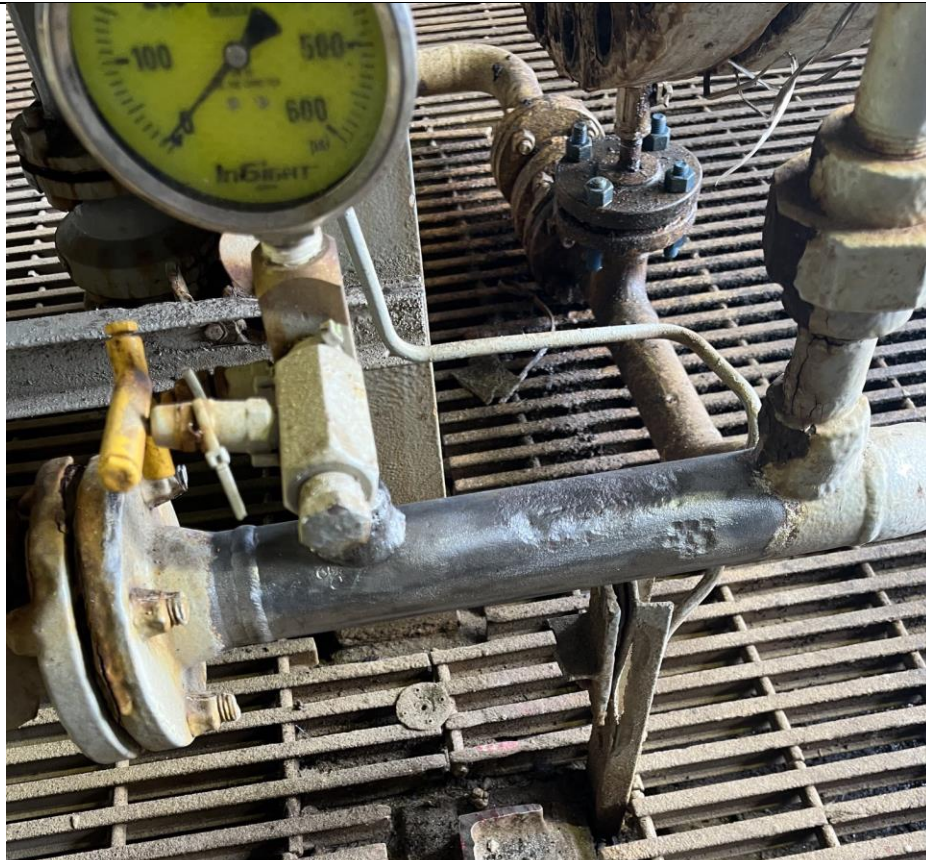
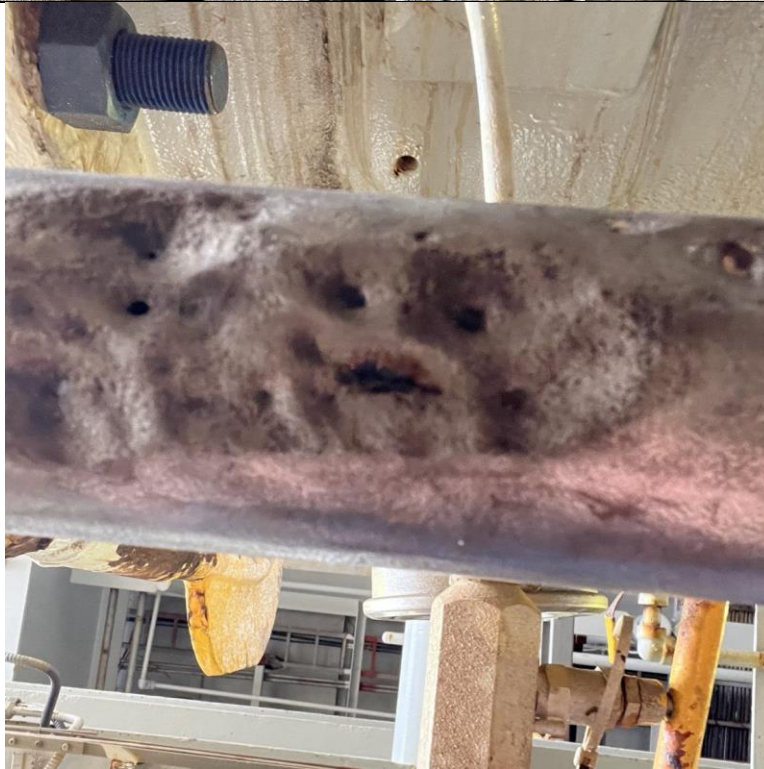
Defective Area Details	
Type of Defect	Type B
Substrate Condition	Substrate Yields
Shape of Most Critical Defect	Circular or Near Circular
Damage Source	Corrosion
Damage Origin	External

Defective Area Data	Value	Units
Longitudinal Length of Critical Defect	0.125	in
Circumferential Length of Critical Defect	0.125	in
Total Length of Defective Area	3.00	in

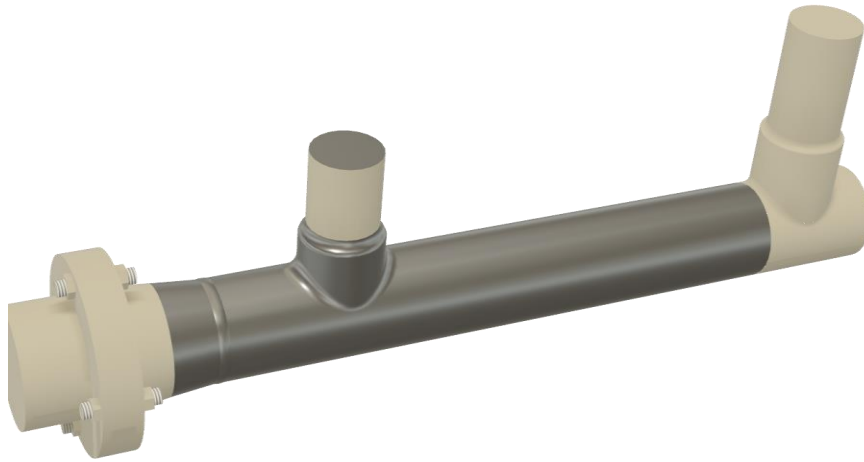
Defective Asset

- Pinhole defect and localized pitting
