883 CYLINDER LINER CHANGE

Purpose

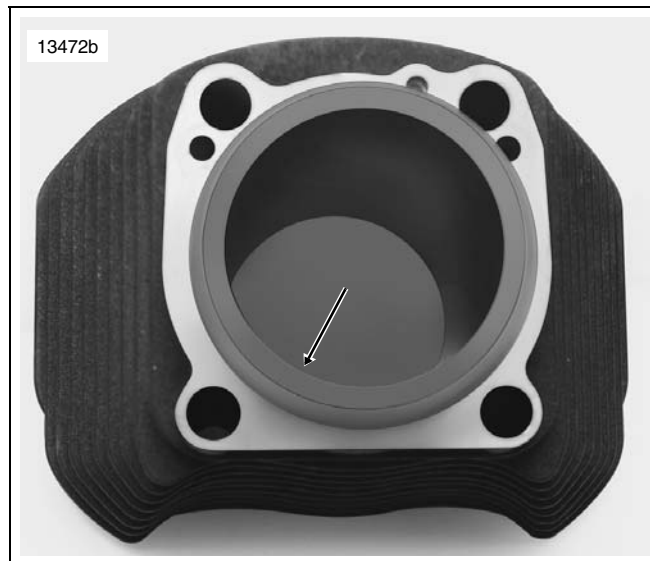
Figure 1. Earlier 883 Cylinder with Steel Cylinder Liner

If a customer chooses to convert an 883cc Sportster to 1200cc displacement by boring existing cylinders, first inspect the 883 cylinders to determine if they allow adequate liner thickness to be bored. See Figure 1. Earlier cylinders have a full steel liner extending from the base. See Figure 2. Later cylinders have an aluminum portion extending from the base with a steel insert.

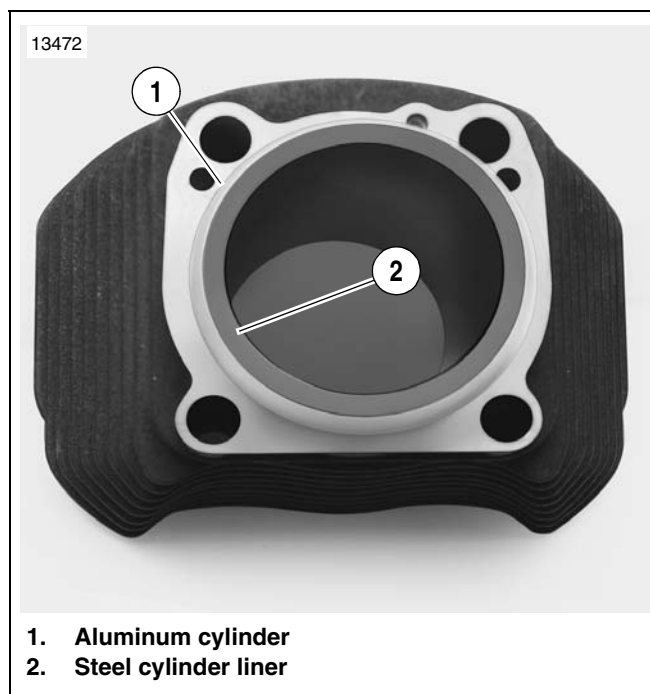
1. Aluminum cylinder
2. Steel cylinder liner

Figure 2. Later 883 Cylinder with Cylinder Liner
