COASTAL EROSION IN SAN DIEGO COUNTY, CALIFORNIA

Gerald G. Kuhn* and Francis P. Shepard**

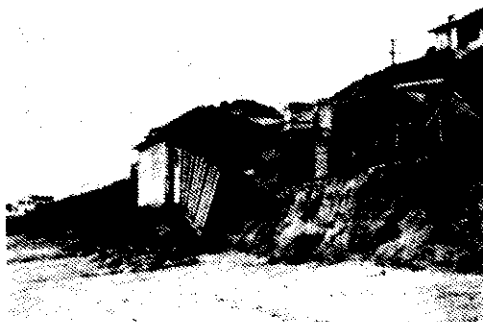
Figure 2. Beach cottage was damaged at Carlsbad during a severe sea storm in 1941. Note: In recent years apartments and homes have been constructed at this site. Photo courtesy of Shore Processes Lab, Scripps Institution of Oceanography; January 5, 1941.

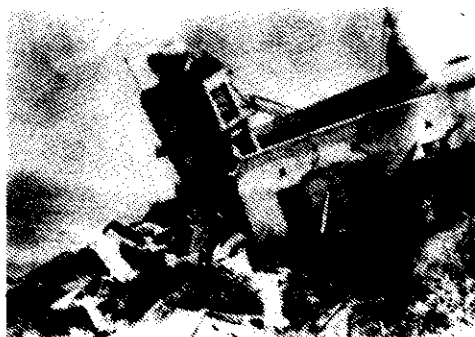
A particularly bad place is in the southern portion of Del Mar where trains have been derailed on various occasions and even fallen over the cliffs. During an extremely stormy period in the winter of 1940-41, the tracks were undermined and a freight train went off the cliff on New Year's Eve, 1940; the cause was a series of heavy rains, large waves and unusually high tides (Kuhn and Shepard, 1979a). Beach cottages were damaged or destroyed along the shore (Figure 2) during the storm, and some additional delayed damage took place at Encinitas. In 1938 the Self-Realization Fellowship temple was built at least 30 feet from the sea-bluff edge. Following the storm period of 1941, the bluff had been weakened by a combination of rain-saturated soil and erosion by wave action, and it collapsed. The temple building was destroyed (Figure 3).

Figure 3. Collapse of Self Realization Fellowship temple along bluff at Encinitas following stormy period in the winter of 1940-41. Photo courtesy of Self Realization Fellowship; 1941.

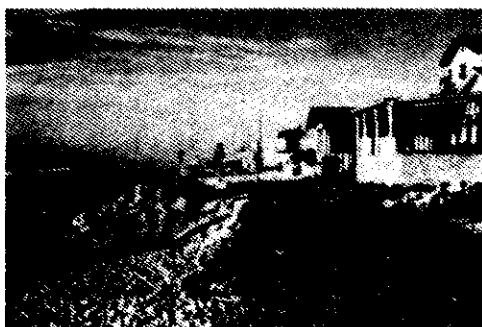
Figure 10. (Before.) 1978 photo of beach cottages located south of Wisconsin Street in Oceanside. Photo courtesy of Sea Grant; January 4, 1978.

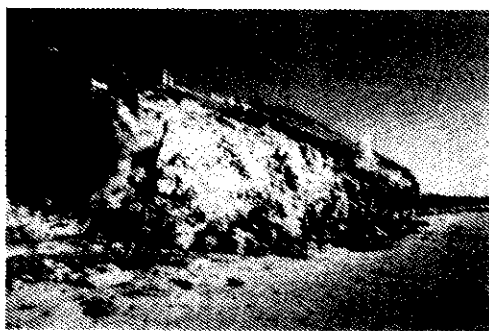
Specific sites which experienced erosion during the drought years prior to 1978 have continued to collapse. Along the cliffs at the Self-Realization Fellowship property in Encinitas a large section of the cliff face separated along parallel joint sets and collapsed on April 26, 1978 (Figures 12 & 13). This recent failure measured 12 to 16 feet landward, 112 feet in width, and a maximum of 40 feet in height. Following the collapse, springs were seen to flow from the cliff face. This is the same site where the cliff collapsed during the 1940's and the temple was lost. Saint and Turner (1980) investigated conditions at this site, including the 1941 and 1978 events, and indicated that the cliffs in this area are subject to collapse as the result of a combination of factors. They stated that "... the large blocks, bounded by weakened joints, fractures and bedding planes move out laterally following a build up of pore pressure under the attack of wave action."

Figure 13. (After.) Same location seen following the cliff collapse of April 26, 1978. Photo courtesy of Sea Grant; May 2, 1978.

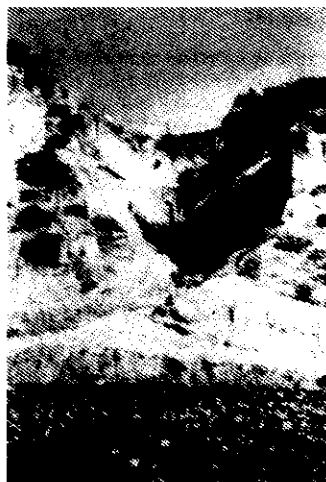
These are but two examples of the man-induced rapid headward erosion during wet years that can occur in canyons located perpendicular to the shoreline. Rapid degradation of the bluffs also occurs wherever fences, stairways, lifeguard towers and storm drain pipes are located along former drainage avenues. Surface water tends to adhere and flow along the underside of such structures, thus eroding the bluff face. At Carlsbad State Park numerous beach stair accesses have been undermined and storm drains collapsed between 1978-1980 (Figures 16 and 17).

Figure 17. (After.) 1979 view at the same location following the collapse of storm drain pipe, and severe gullying of bluff face. Photo courtesy of Sea Grant; February 11, 1979.
