## Incident Technical Report: Gear Wear Progression in Starboard Gear Train MG-5025A of Naval Vessel INS Haifa

### Executive Summary

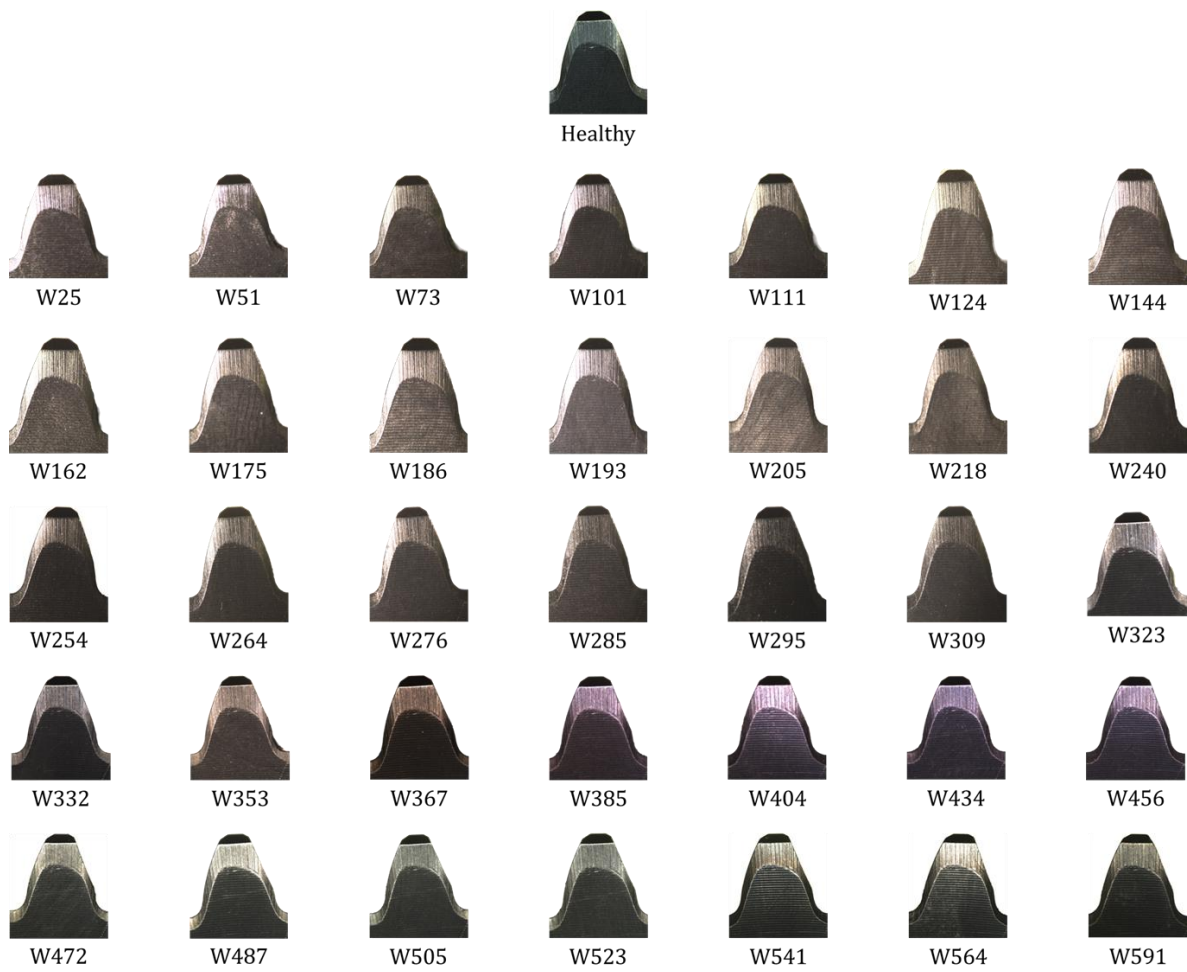
**Imaging:** Following each measurement day, tooth-flank photographs were taken from the driven gear, using a camera integrated with the inspection microscope available in the lab (images archived in the shipyard file and referenced internally to the daily session). Images served as qualitative corroboration of wear evolution (Healthy teeth → micro-wear → macro-wear). They are appeared in Figure 1.

On June 15, the wear process reached its terminal stage and culminated in a failure event directly attributable to the progression of severe wear. Microscope inspection on this date revealed catastrophic surface damage: large sections of the tooth flanks were no longer intact, with deep gouges, fragmented edges, and visible fracture of material layers. Several

teeth displayed clear spalling and breakaway of previously worn regions, indicating that the accumulated damage had exceeded the load-bearing capacity of the contact surfaces.

The first signs of wear appeared on April 9, initially detected through tooth profile images. A small deviation from the healthy baseline was visible on the flanks of several teeth, although the signals remained largely unchanged at this early stage. Between April 9 and April 23, progressive visual changes were observed: tooth wear was visible in the photographs but did not yet manifest in the vibration data. From April 16 onward, subtle variations emerged in both time domain and spectral domain signals, with small irregularities beginning to disrupt the smooth baseline pattern. These deviations, while still minor, marked the transition toward measurable wear. By April 23, RMS values rose above the baseline, confirming the onset of detectable wear in both the visual and signal-based assessments.

Figure 1: Face view of the drive gear tooth at all health status

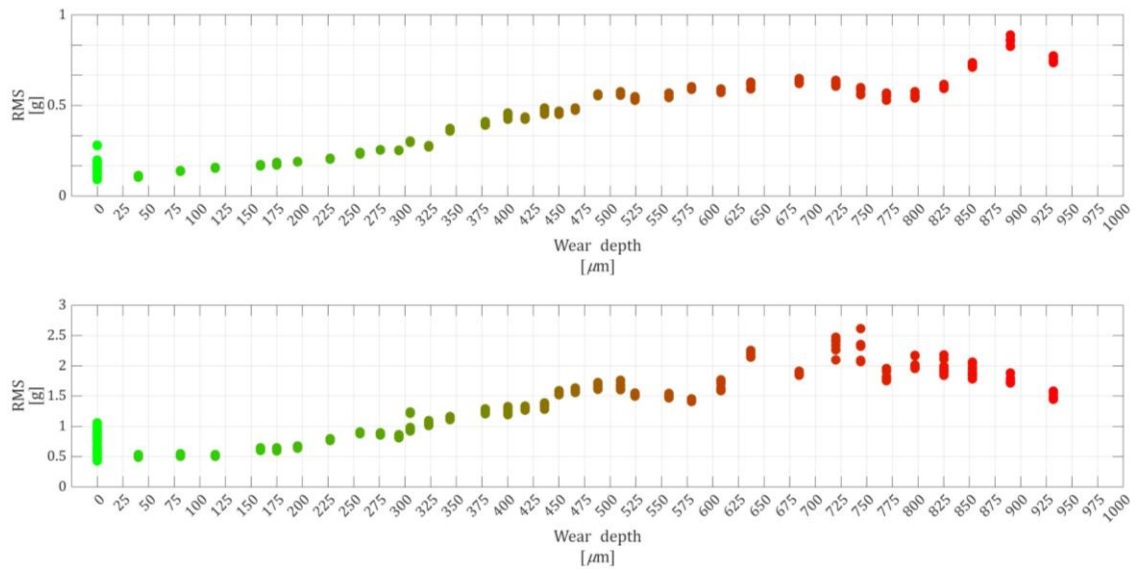
deviations in their patterns. A more distinct change appeared by W13, when the RMS values rose above the baseline. This established that the earliest effective indicator of wear was visual, while the dynamic response lagged behind.

Figure 2: RMS level against wear depth at 15 [RPS] (above) and at 45 [RPS] (below). Healthy records are noted as zero wear depth.

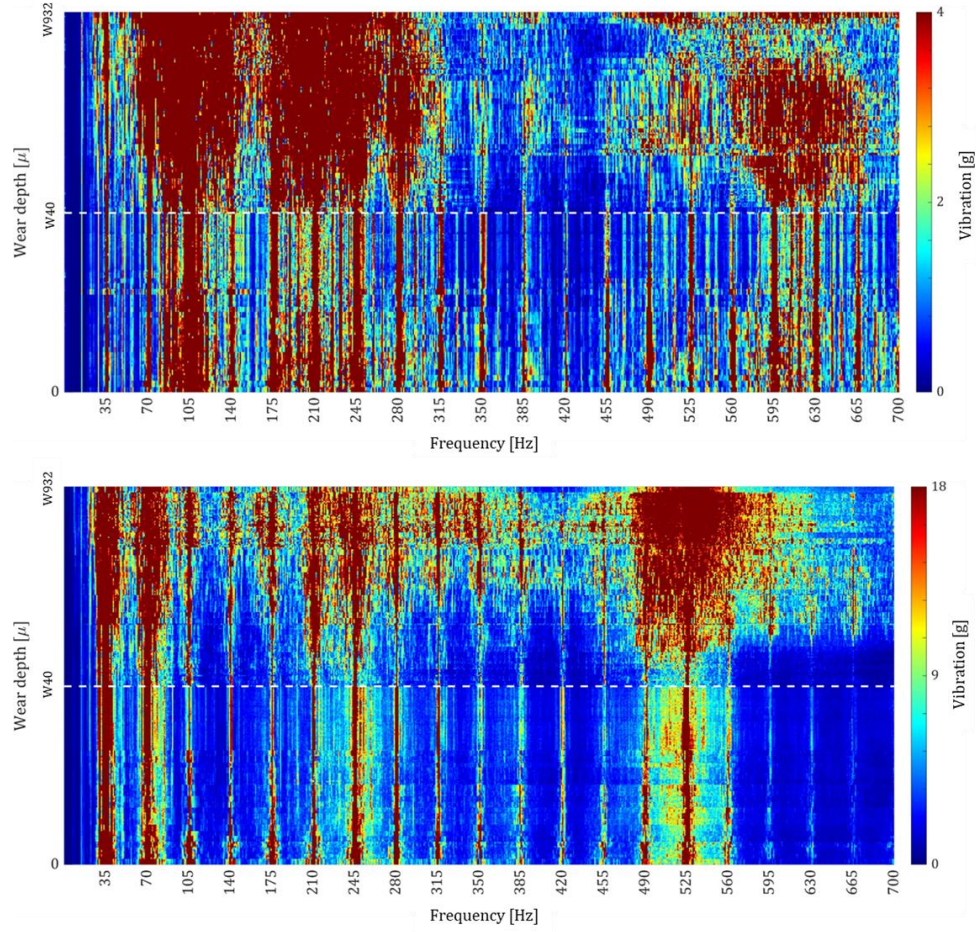
**Figure 3: Fast Fourier Transform (FFT) spectrogram at 15 [RPS] (above) and 45 [RPS] (below). GMF harmonics are labeled on the horizontal axis, and the white dashed line marks the separation between healthy and faulty cases.**

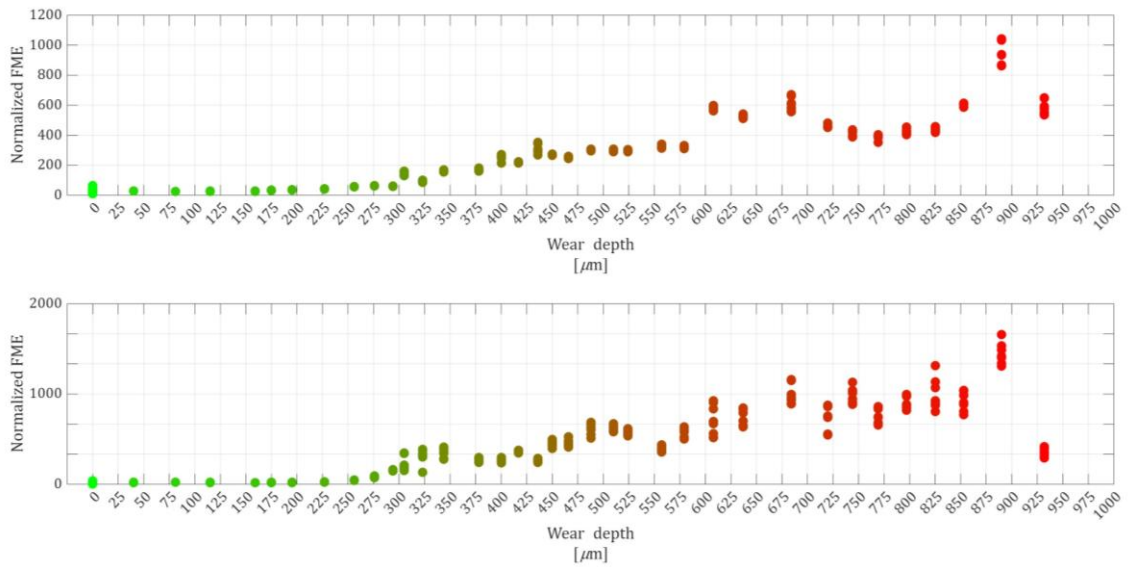
**Figure 4: Normalized FME against wear depth at 15 [RPS] (above) and 45 [RPS] (below).**
