Incident Technical Report: Gear Wear Progression in Starboard Gear Train MG-5025A of Naval Vessel INS Haifa

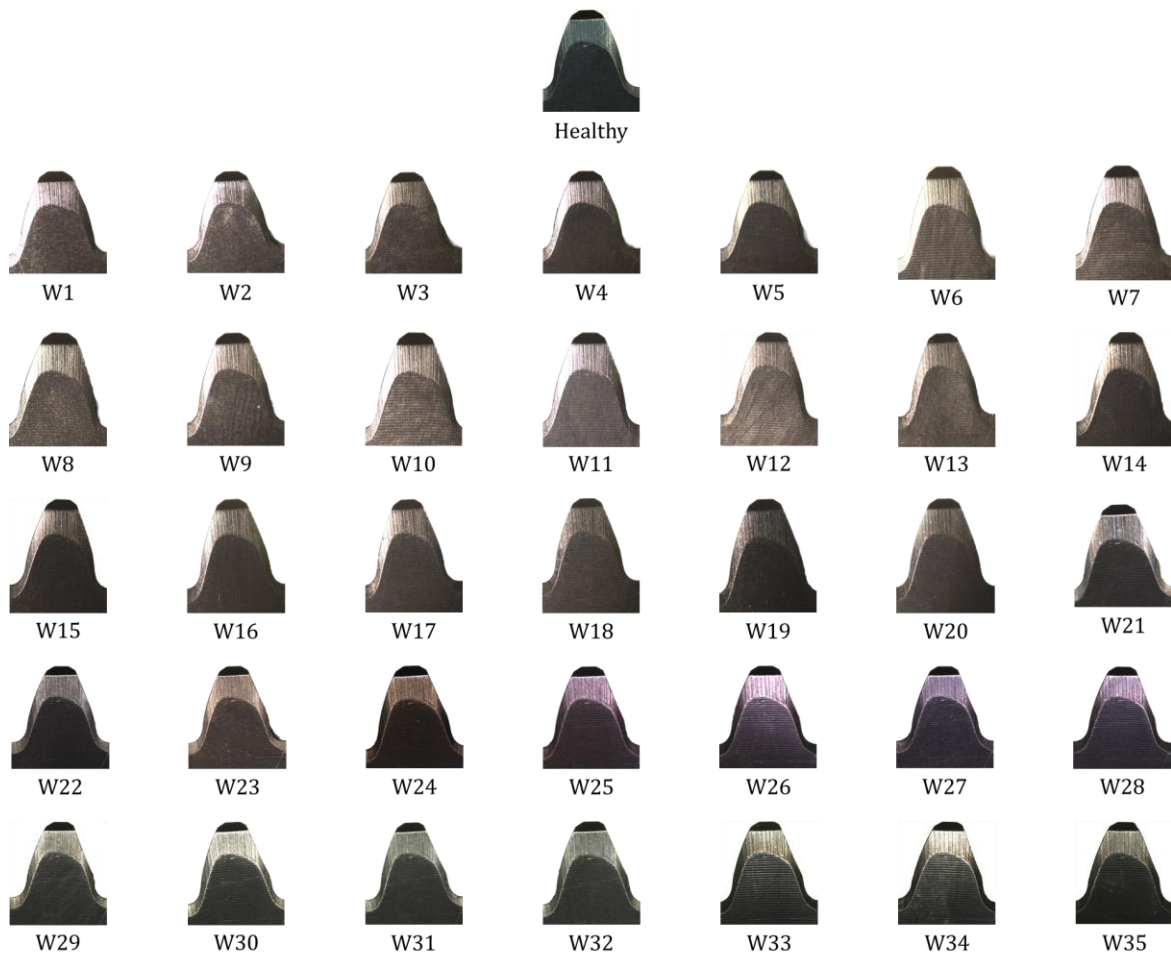
Imaging: Following each measurement day, tooth-flank photographs were taken from the driven gear, using a camera integrated with the inspection microscope available in the lab (images archived in the shipyard file and referenced internally to the daily session). Images served as qualitative corroboration of wear evolution (Healthy teeth → micro-wear → macro-wear). They are appeared in Figure 1.

Figure 1: Face view of the drive gear tooth at all health status.

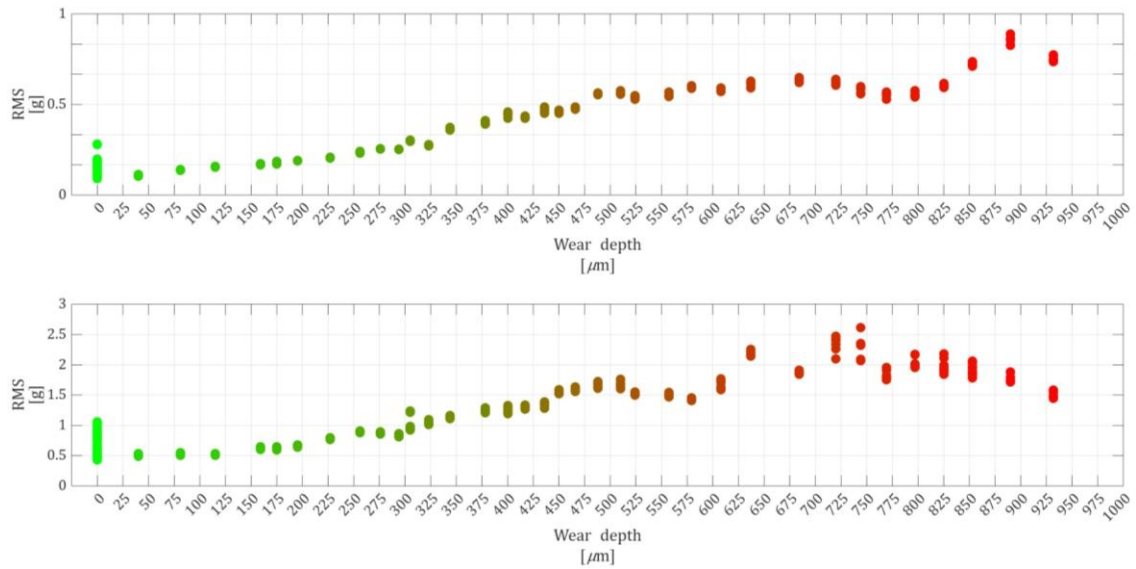
Figure 2: RMS level against wear depth at 15 [RPS] (above) and at 45 [RPS] (below). Healthy records are noted as zero wear depth.

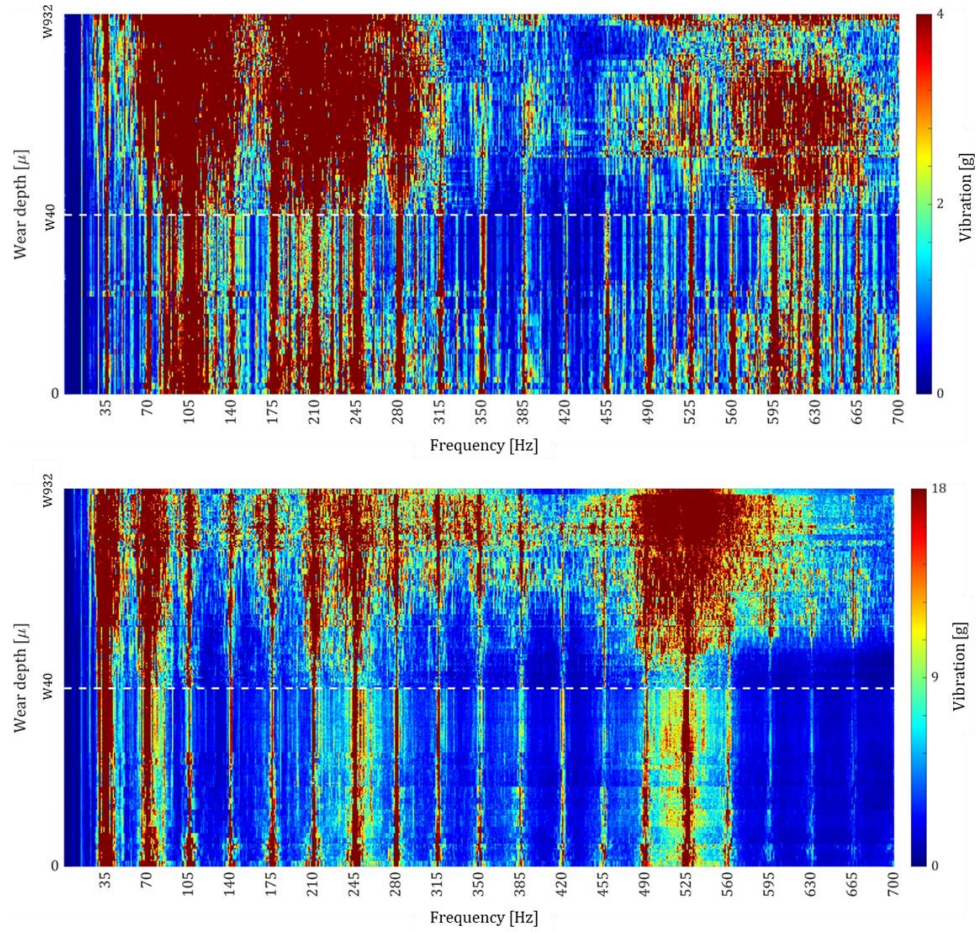
Figure 3: Fast Fourier Transform (FFT) spectrogram at 15 [RPS] (above) and 45 [RPS] (below). The white dashed line marks the separation between healthy and faulty cases.

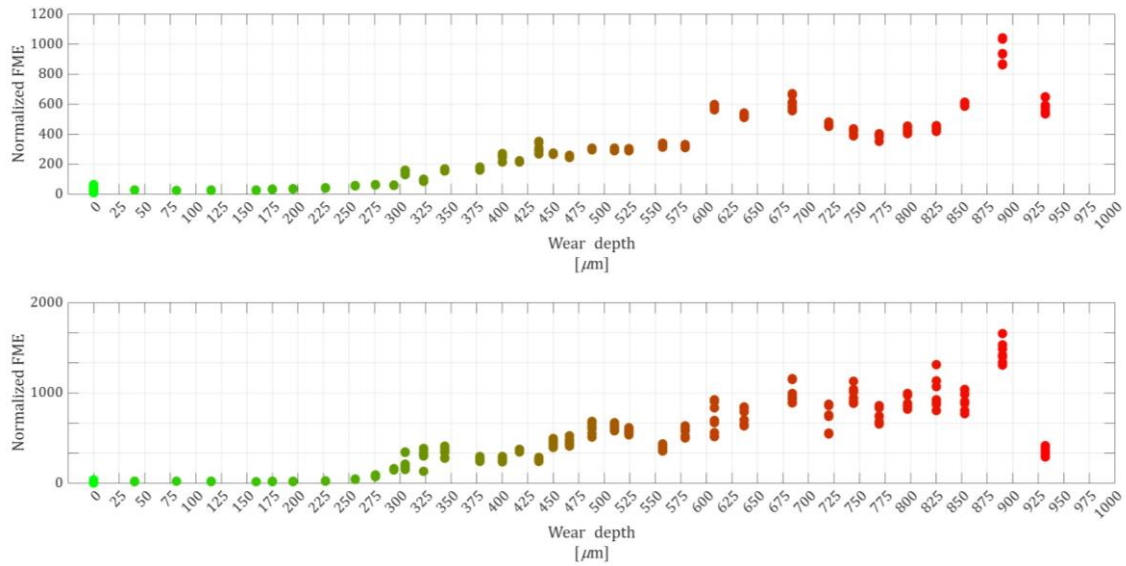
Figure 4: Normalized Frequency Modulation Energy (FME) against wear depth at 15 [RPS] (above) and 45 [RPS] (below).
