Incident Technical Report: Gear Wear Progression in Starboard Gear Train MG-5025A of Naval Vessel INS Haifa

Executive Summary

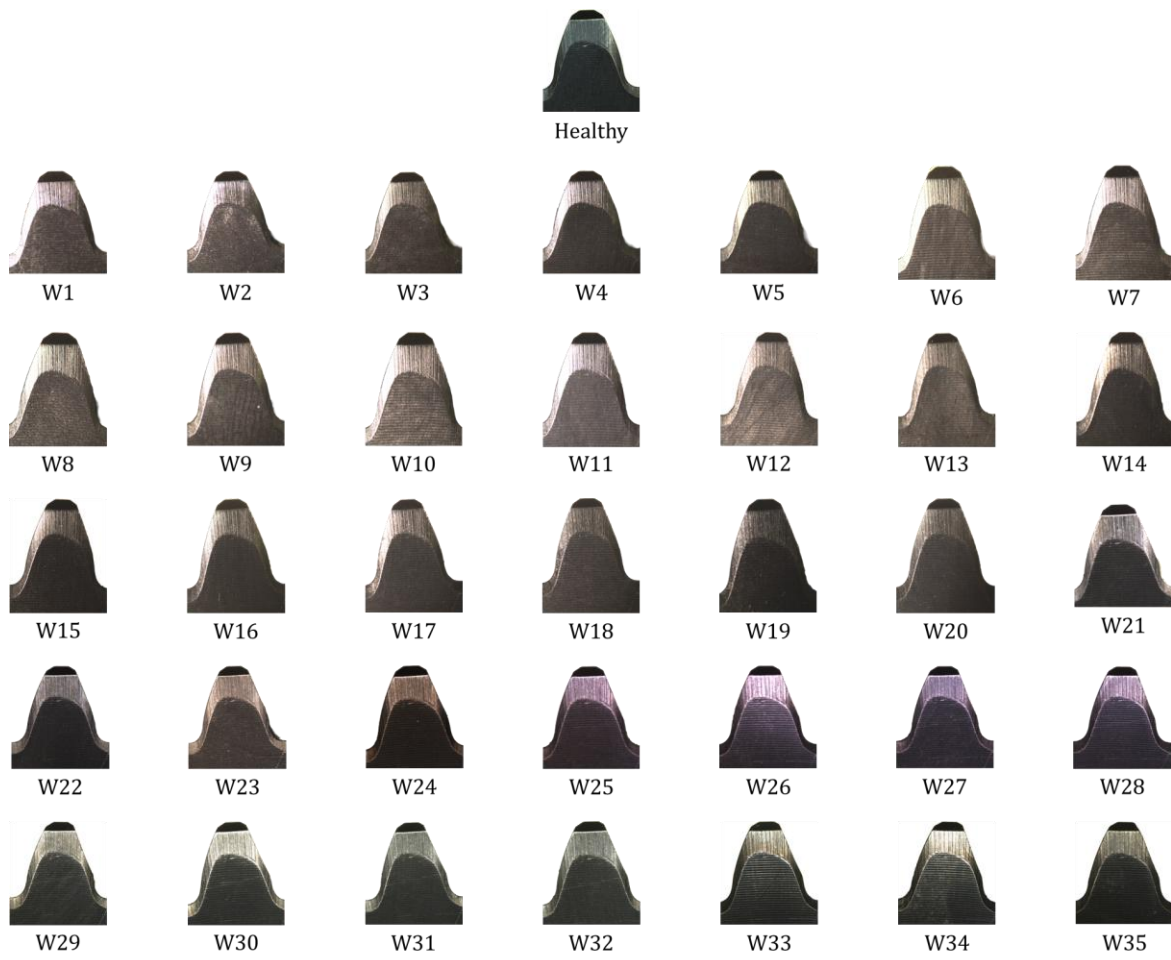
Imaging: Following each measurement day, tooth-flank photographs were taken from the driven gear, using a camera integrated with the inspection microscope available in the lab (images archived in the shipyard file and referenced internally to the daily session). Images served as qualitative corroboration of wear evolution (Healthy teeth → micro-wear → macro-wear). They are appeared in Figure 1.

images from February 13, subtle modifications of the tooth profile were visible: part of the contact area had been removed, showing the first physical evidence of surface alteration. This visual cue prompted a closer inspection of the contemporaneous vibration data.

The transition into severe wear was first documented on May 14, when microscope photographs revealed sharp-edged scars and material loss extending across large sections of the tooth flank. Unlike the smoother polishing or gradual flattening seen during the moderate stage, the worn regions now displayed darker, roughened textures intermixed with bright reflective zones, characteristic of scuffing and surface tearing. Contact scars widened significantly, consuming much of the original flank geometry, with visible depth variations along the wear path. These changes were not confined to isolated teeth: by mid-May, photographs confirmed that multiple consecutive teeth exhibited similar damage, establishing that the wear mechanism had advanced to a system-wide condition.

On June 15, the wear process reached its terminal stage and culminated in a failure event directly attributable to the progression of severe wear. Microscope inspection on this date revealed catastrophic surface damage: large sections of the tooth flanks were no longer intact, with deep gouges, fragmented edges, and visible fracture of material layers. Several

teeth displayed clear spalling and breakaway of previously worn regions, indicating that the accumulated damage had exceeded the load-bearing capacity of the contact surfaces.

Figure 1: Face view of the drive gear tooth at all health status

1. Photographic inspection proved to be the earliest and most sensitive method for detecting the onset of wear.
2. It is recommended to establish a routine photographic monitoring program, using standardized lighting and scale references to ensure comparability between inspection dates.
3. Image-based measurements (e.g., depth, area loss, surface roughness) should be quantified where possible, not just qualitatively assessed.

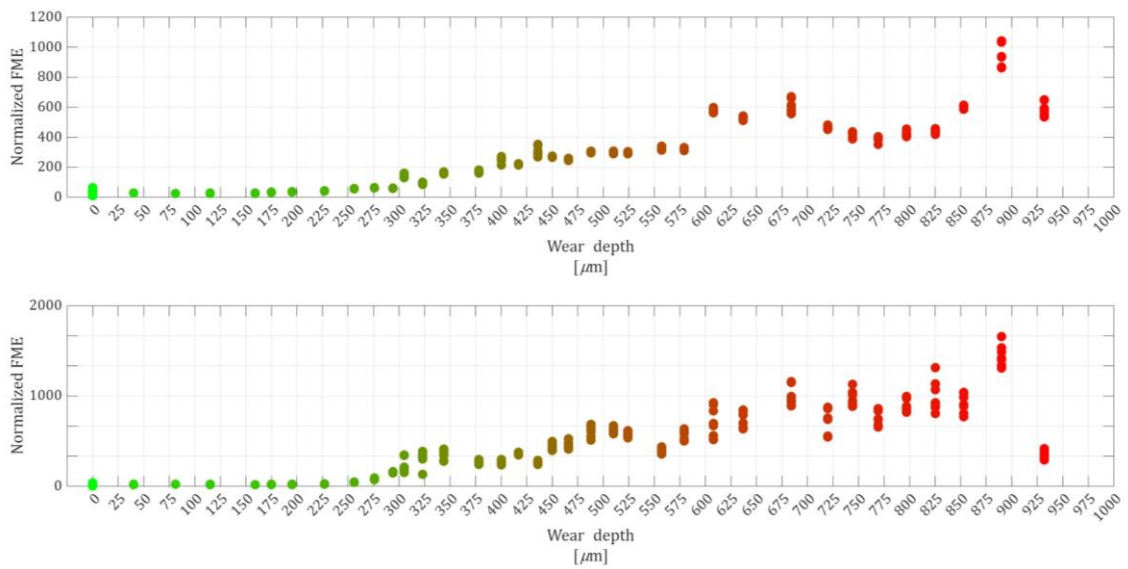
Figure 4: Normalized FME against wear depth at 15 [RPS] (above) and 45 [RPS] (below).
