Incident Technical Report: Gear Wear Progression in Starboard Gear Train MG-5025A of Naval Vessel INS Haifa

Vessel and Transmission: INS Haifa employs a conventional marine propulsion train. The subject gearbox is an MG-5025A naval reduction gear, configured as part of the ship’s main gear transmission. The investigated component is the primary reduction gear pair (driving gear and driven gear).

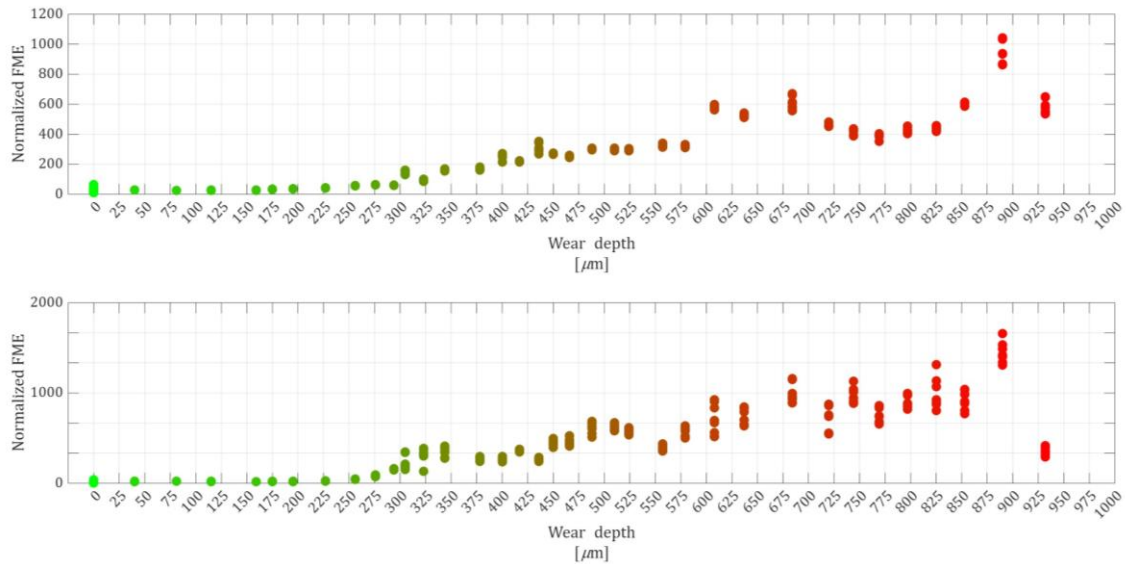
Figure 4: Normalized Frequency Modulation Energy (FME) against wear depth at 15 [RPS] (above) and 15 [RPS] (below).
