Incident Technical Report: Gear Wear Progression in Starboard Gear Train MG-5025A of Naval Vessel INS Haifa

Executive Summary

Vessel and Transmission: INS Haifa employs a conventional marine propulsion train. The subject gearbox is an MG-5025A naval reduction gear, configured as part of the ship’s main gear transmission. The investigated component is the primary reduction gear pair (driving gear and driven gear).

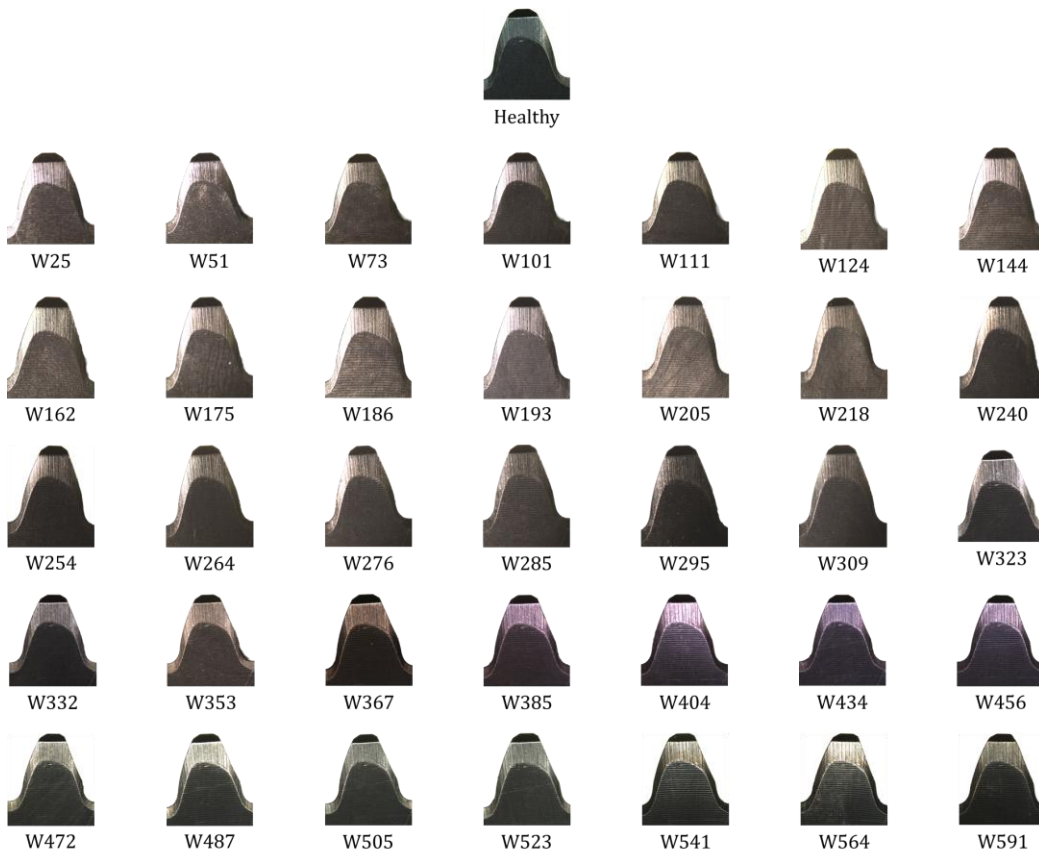
5. Imaging Corroboration. Daily camera-through-microscope photos tracked flank condition from smearing to micro-pitting, then macro-pit formation and finally extended spalling by mid-June; this aligned with the growing noise and impact content in the time records.

6. Likely Mechanism. The evidence supports progressive surface distress on a loaded flank—scuffing → pitting → macropitting/spall—likely accelerated by local film breakdown and debris re-entrainment. Alignment or load-sharing imperfections may have concentrated stress on a sector of the driven gear, enabling rapid pit coalescence once nucleated.
7. Contributing Factors Considered.
8. Lubricant: 2640 semi-synthetic 15W/40 in use; no anomalies were recorded in this investigation, but contamination and film thickness under local sliding are potential accelerants.
9. Operating Profile: Repeated starts/halts and dwell at fixed speeds can amplify contact pattern persistence, accelerating localized damage once initiated.

Figure 1: Face view of a gear tooth at all health status

2. Imaging Routine. After each monitoring day, capture tooth-flank images at identical magnification and lighting, referencing the same tooth indices, to maintain comparable visual evidence of progression.

4. Alignment & Contact Pattern. Perform a contact pattern check at the earliest dock opportunity. Minor contact correction (profile/lead relief) may prevent recurrence on replacement gears.

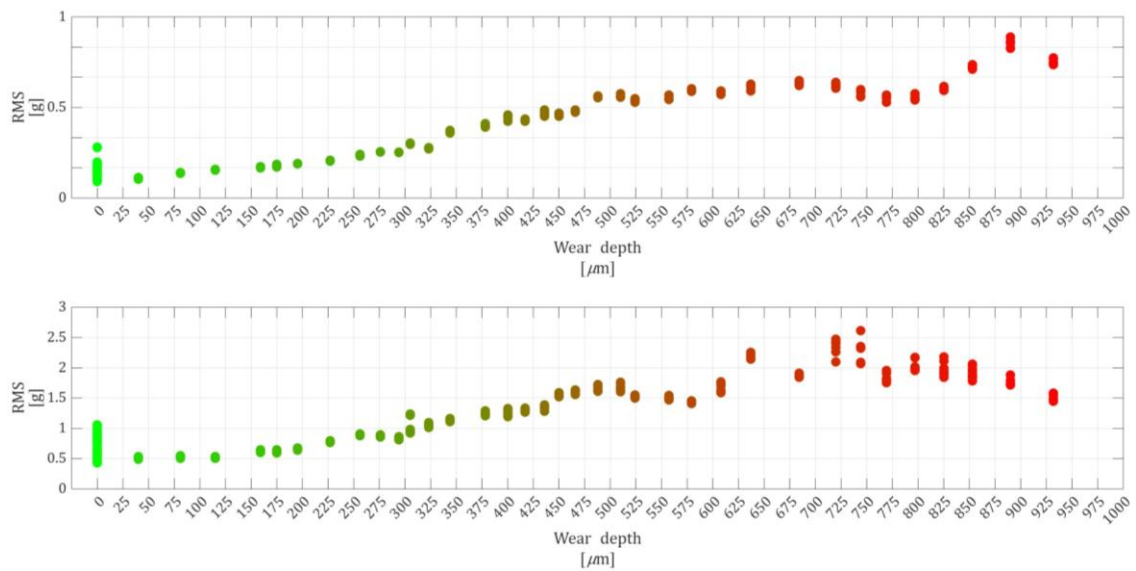
Across April-June, crews consistently reported louder gear noise under steady speed and a gradual rise in overall vibration level. Time-domain RMS, trended upward in step with the Wear Case 1 \rightarrow 35 progression. The final day (15 June) showed a marked jump in amplitude and transient impulsive responses consistent with severe war liberation on a loaded flank, followed by immediate operational withdrawal.

Figure 2: RMS level against wear depth at 15 [RPS] (above) and at 45 [RPS] (below). Healthy records are noted as zero wear depth.

- Metrics: Track RMS, peak, crest factor, and an impulsiveness index per sensor. Alerts when RMS > baseline + 6 dB or crest factor increases by >25% over a 7-day rolling average.

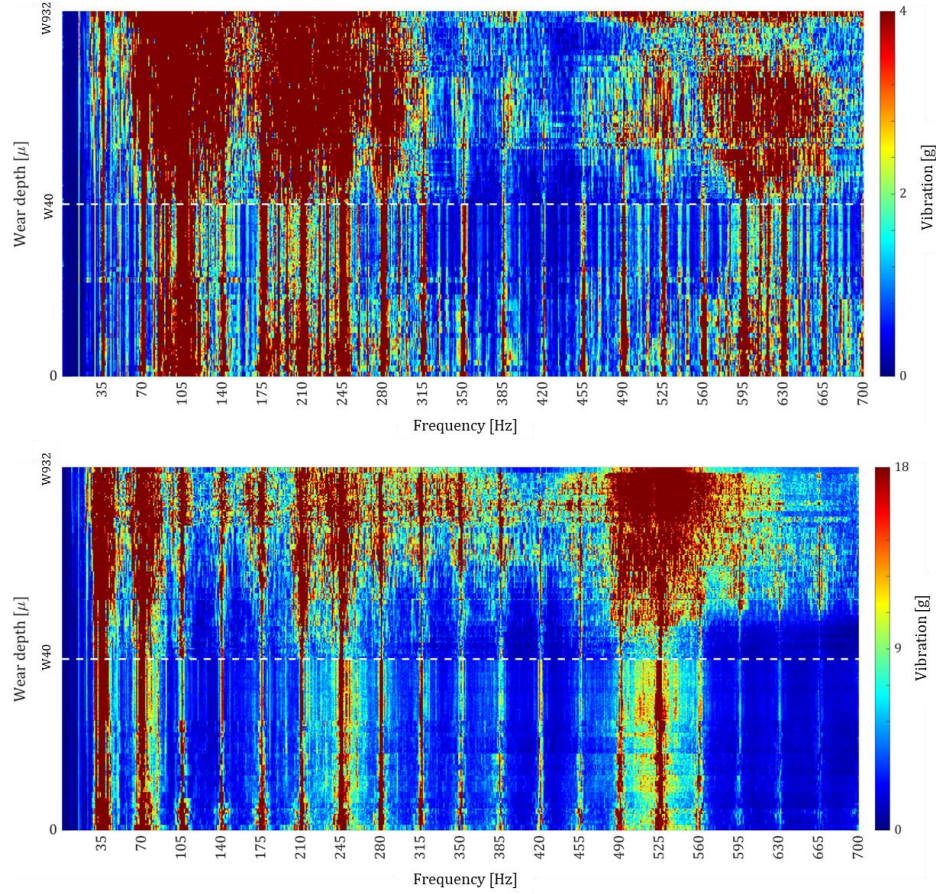
Figure 3: Fast Fourier Transform (FFT) spectrogram at 15 [RPS] (above) and 45 [RPS] (below). GMF harmonics are labeled on the horizontal axis, and the white dashed line marks the separation between healthy and faulty cases.

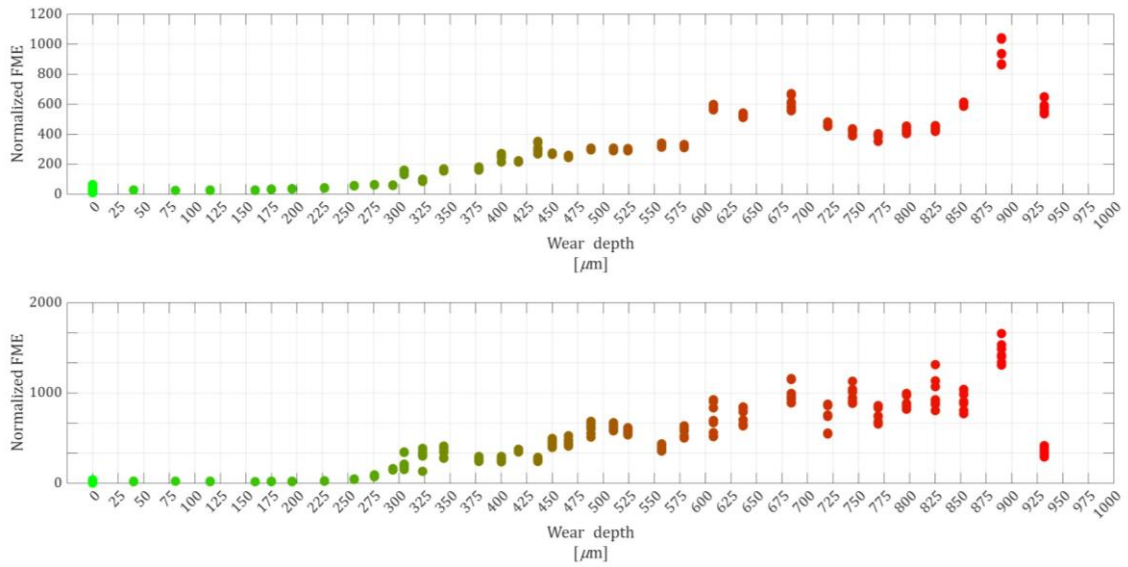
Figure 4: Normalized FME against wear depth at 15 [RPS] (above) and 15 [RPS] (below).
