Incident Technical Report: Gear Wear Progression in Starboard Gear Train MG-5025A of Naval Vessel INS Haifa

Executive Summary

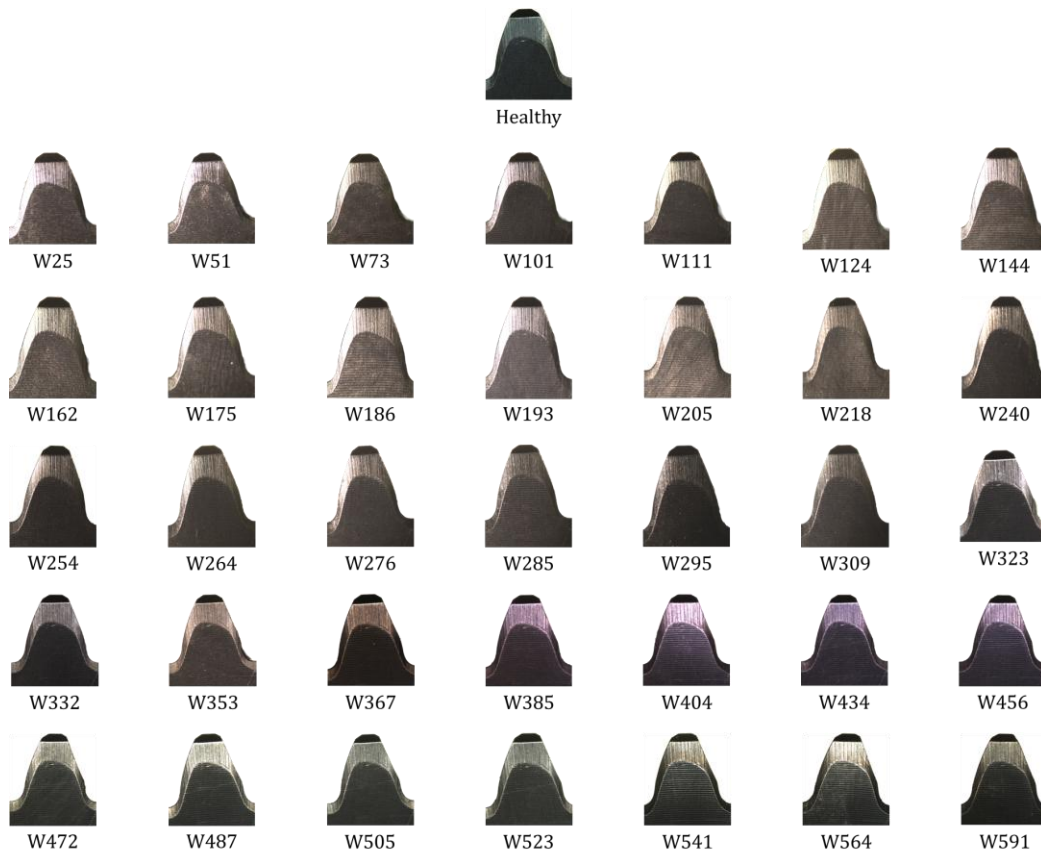
Imaging: Following each measurement day, tooth-flank photographs were taken using a camera integrated with the inspection microscope available in the lab (images archived in the shipyard file and referenced internally to the daily session). Images served as qualitative corroboration of wear evolution (Healthy teeth → micro-wear → macro-wear). They are appeared in Figure 1

images from February 13, subtle modifications of the tooth profile were visible: part of the contact area had been removed, showing the first physical evidence of surface alteration. This visual cue prompted a closer inspection of the contemporaneous vibration data.

The transition into severe wear was first documented on May 14, when microscope photographs revealed sharp-edged scars and material loss extending across large sections of the tooth flank. Unlike the smoother polishing or gradual flattening seen during the moderate stage, the worn regions now displayed darker, roughened textures intermixed with bright reflective zones, characteristic of scuffing and surface tearing. Contact scars widened significantly, consuming much of the original flank geometry, with visible depth variations along the wear path. These changes were not confined to isolated teeth: by mid-May, photographs confirmed that multiple consecutive teeth exhibited similar damage, establishing that the wear mechanism had advanced to a system-wide condition.

On June 15, the wear process reached its terminal stage and culminated in a failure event directly attributable to the progression of severe wear. Microscope inspection on this date revealed catastrophic surface damage: large sections of the tooth flanks were no longer intact, with deep gouges, fragmented edges, and visible fracture of material layers. Several

teeth displayed clear spalling and breakaway of previously worn regions, indicating that the accumulated damage had exceeded the load-bearing capacity of the contact surfaces.

Figure 1: Face view of a gear tooth at all health status

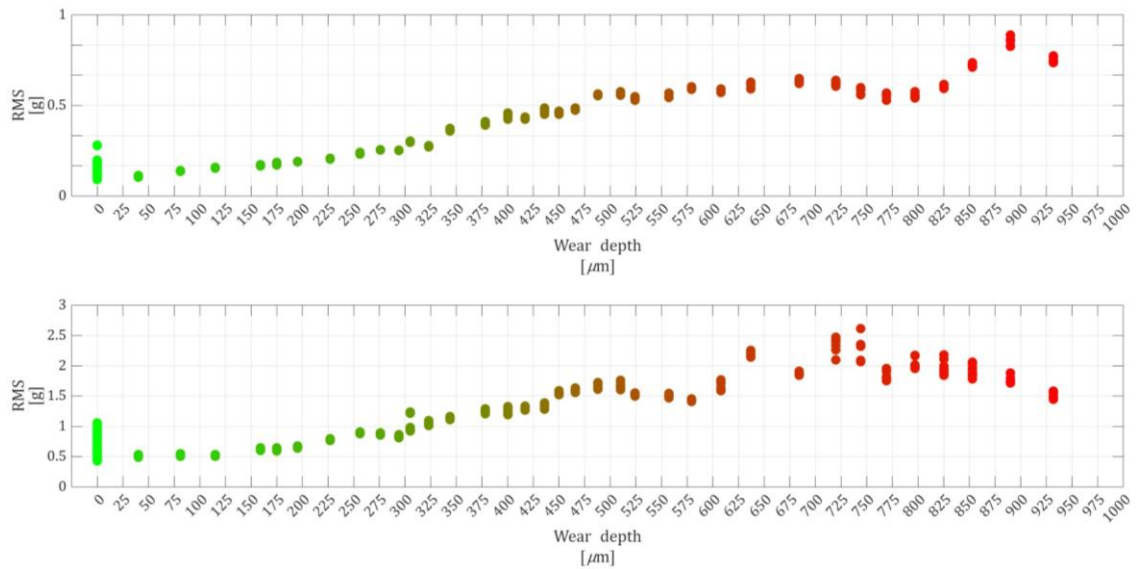
The vibration evidence during this stage paralleled the pronounced visual damage. At 45 RPS, records from May 14 onward showed RMS values elevated by 25–40% above the April 9 baseline, with fluctuations indicating unstable running conditions. Spectral content was markedly altered: sidebands around the mesh frequency became dominant features rather than faint modulations, appearing as dense families with higher amplitudes. The broadband noise floor above 5 kHz rose sharply, pointing to asperity impacts and increased surface roughness.

Figure 2: RMS level against wear depth at 15 [RPS] (above) and at 45 [RPS] (below). Healthy records are noted as zero wear depth.

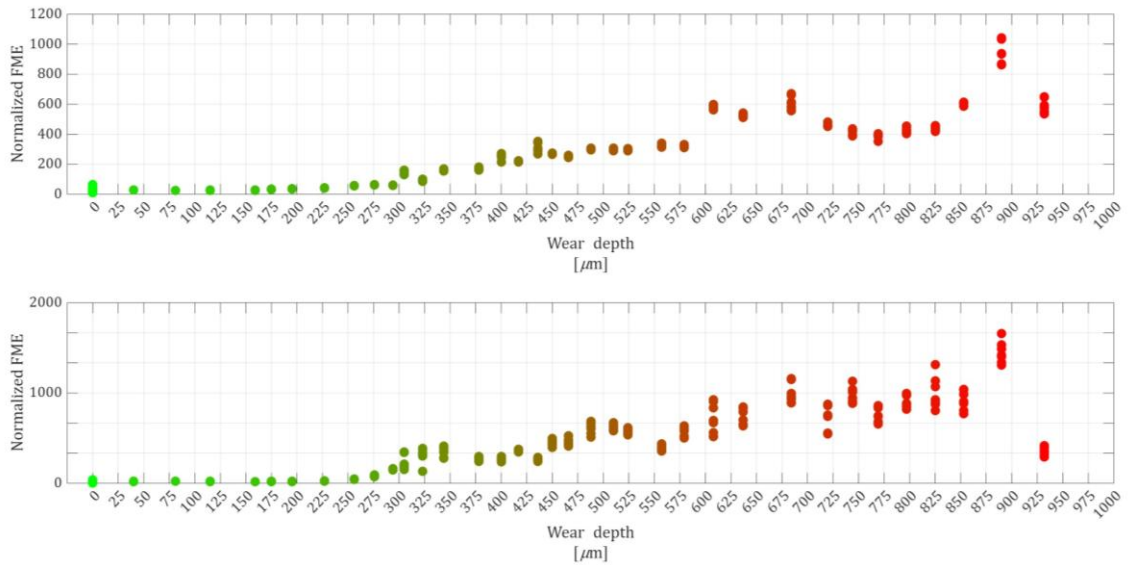
Figure 4: Normalized FME against wear depth at 15 [RPS] (above) and 15 [RPS] (below).
