MCP79410 Hours Alarm Issue

Amond Lin
2024 SEP

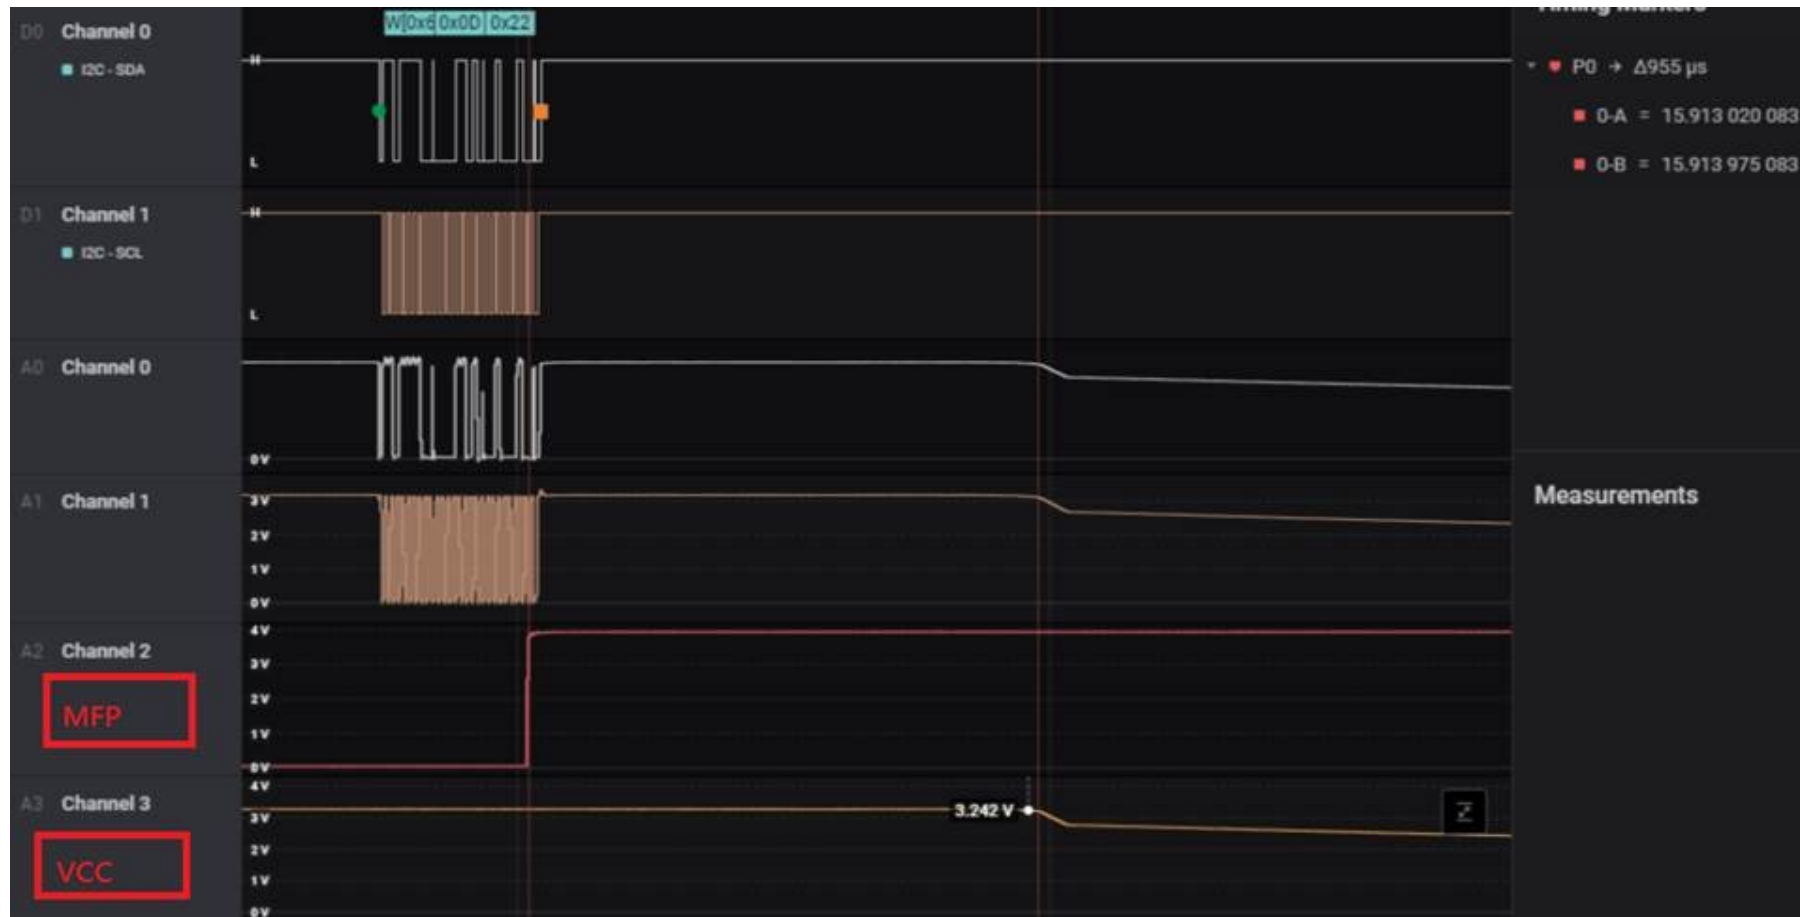
Timing sequence from client (1/3)

- VCC would start falling down after 955ns with MFP pull-high.

- Slide 22, the VDD falling after MFP going high is OK, slide 23 VDD fall rate is fine, not too fast or too slow, exponential decay is typical for many systems. How long until the power is restored and what does the VDD reach just before it is turned on? Does it really reach 0V?

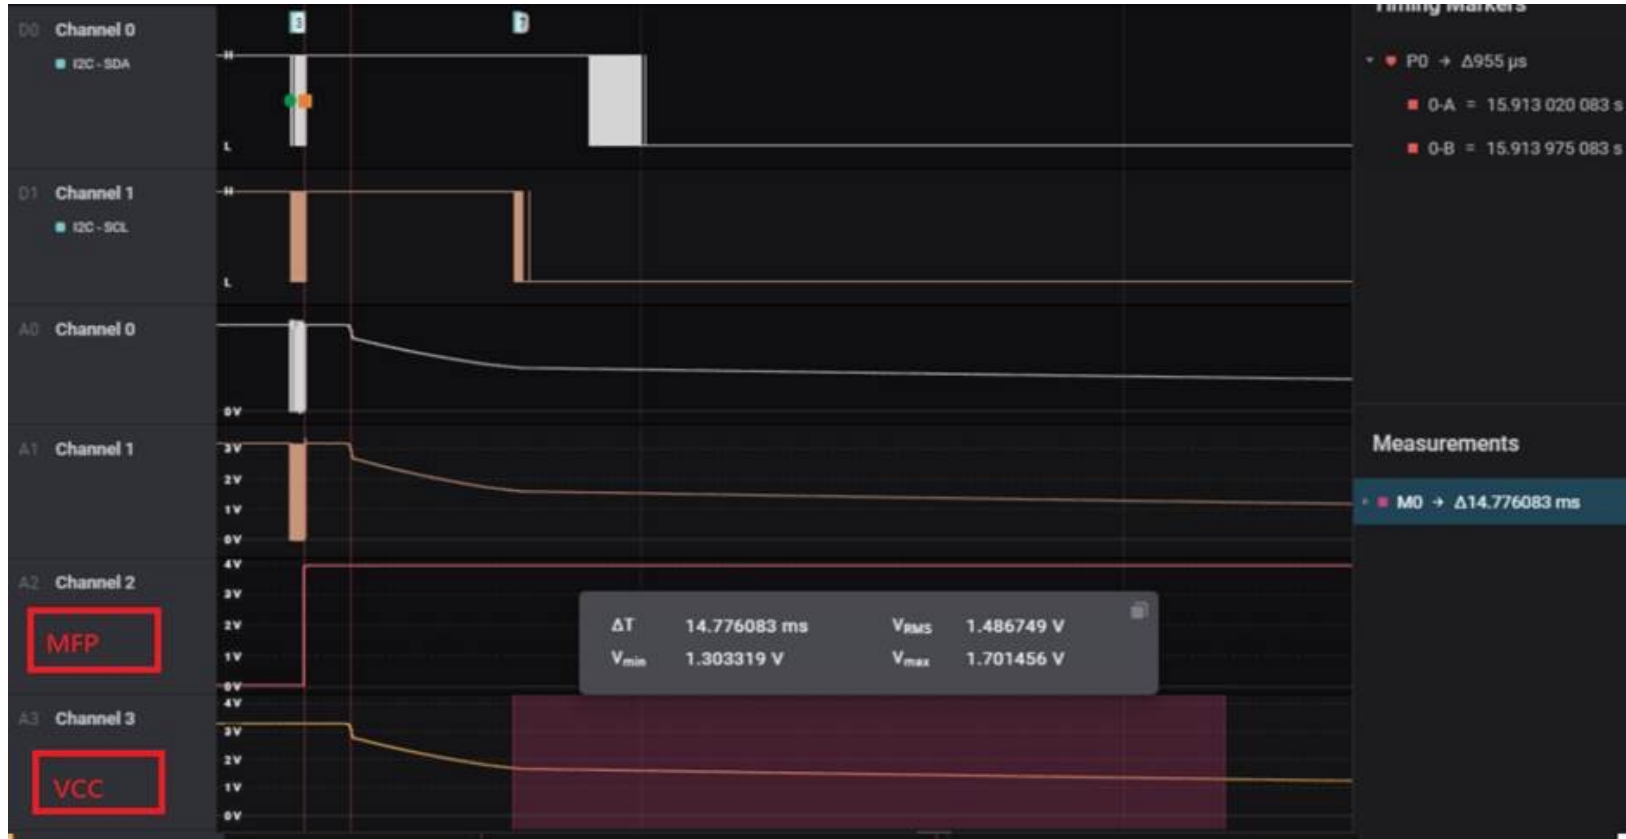
Timing sequence from client (2/3)

- When VCC was powered down (RTC got to sleep), VCC down from 1.7V to 1.3V would take about 14ms to compare with T15 on data sheet.

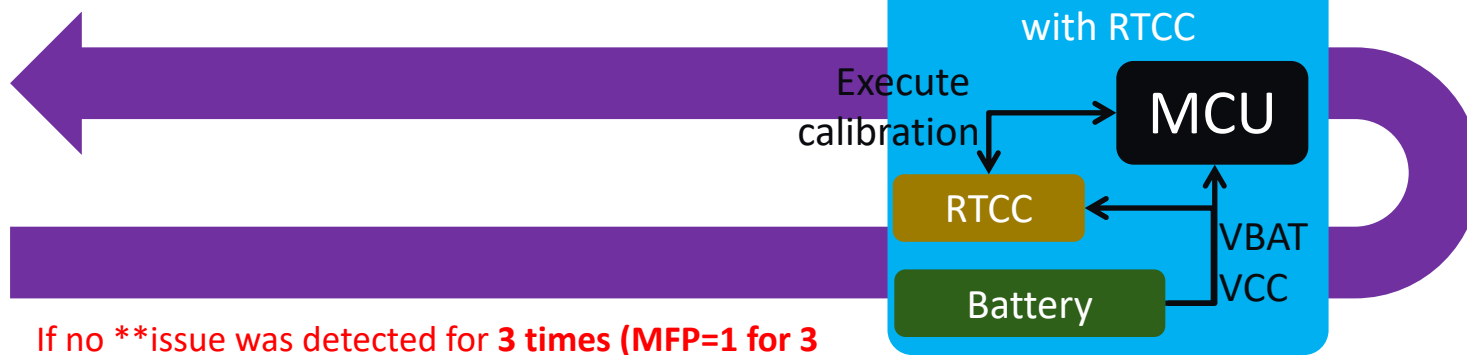
If no **issue was detected for 3 times (MFP=1 for 3 tims), MCU would do 1 time RTCC calibration and then back to hour-alarm mode.

**Issus means RTCHOUR != ALM0HOUR was detected but MFP=1.

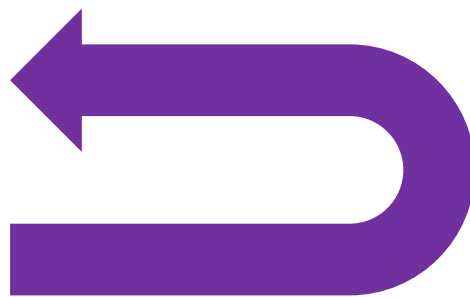
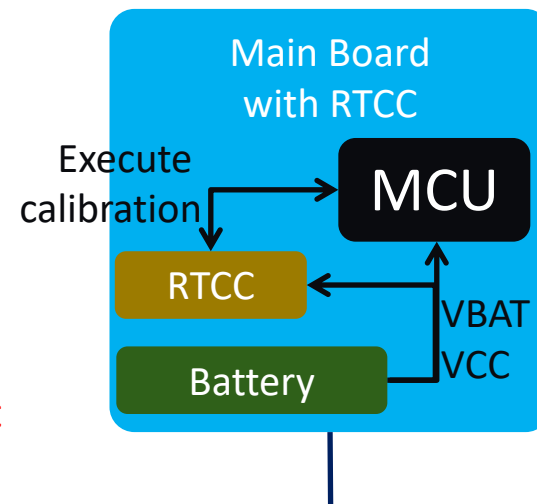
If **issue was detected, MCU would not do RTCC calibration and keep in hour-alarm mode.

**Issus means RTCHOUR != ALM0HOUR was detected but MFP=1.
