# MCP79410 Hours Alarm Issue

Amond Lin  
2024 SEP

# Failure Description

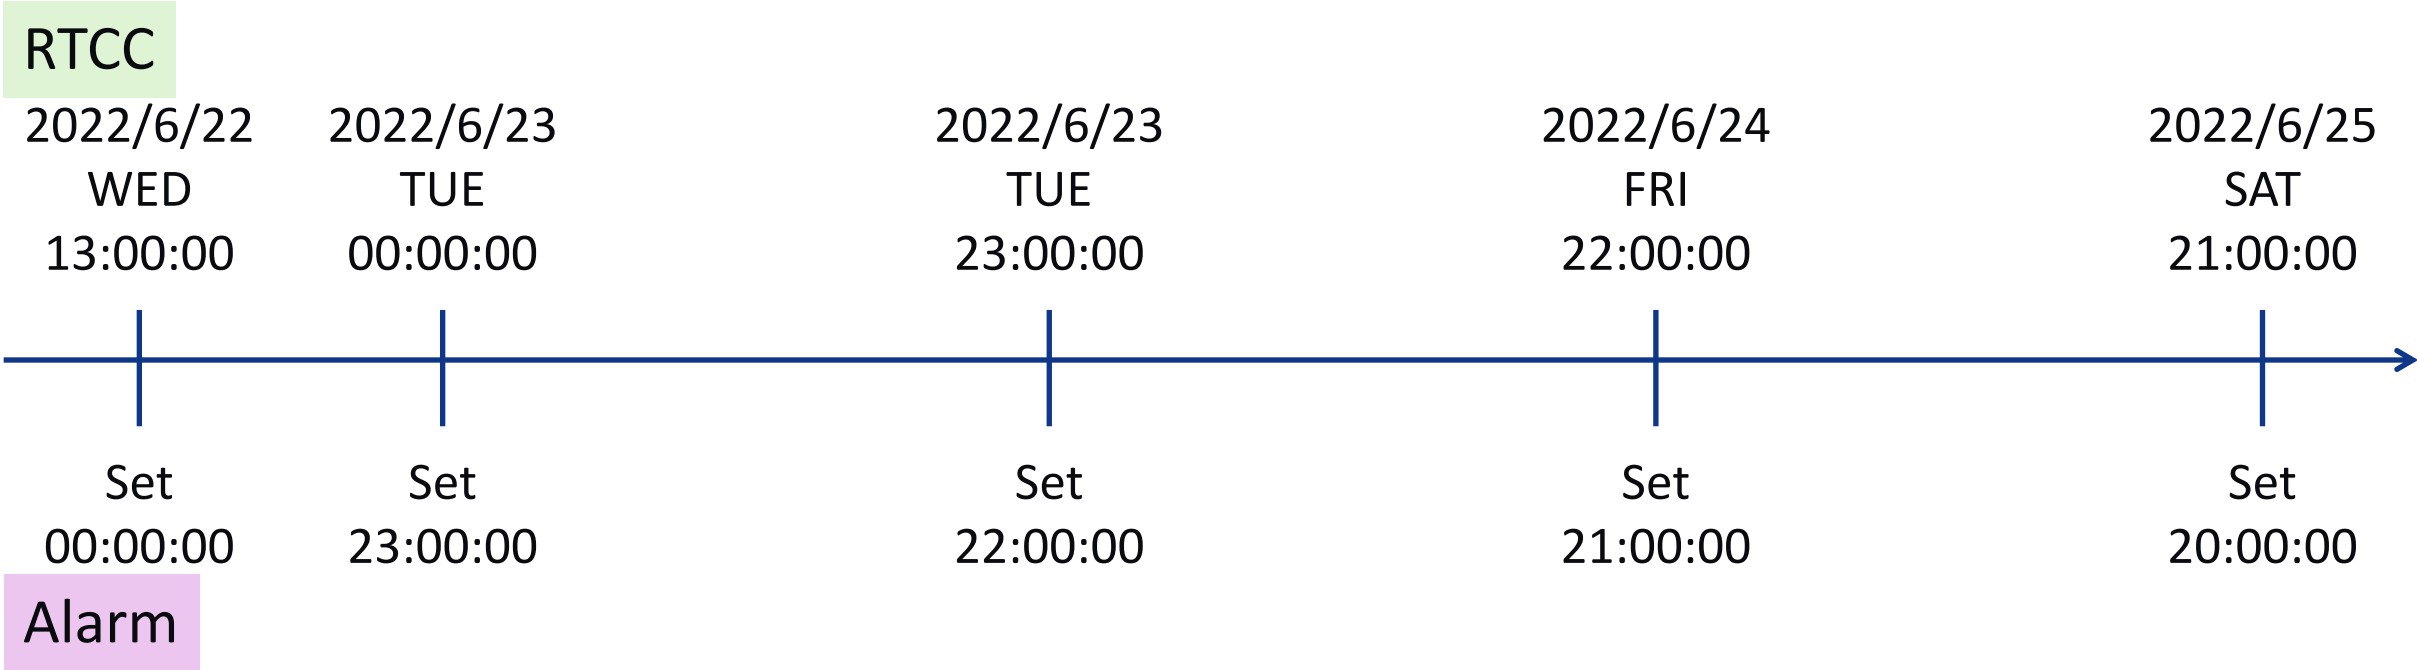
# Time-line : Design operation

- Initialized date/time with present date/time (2022, JUN, 22, Wednesday, 13:00:00)
- **Configure 1st Alarm time at 0:00.**
- When  $ST(RTCSEC \text{ bit } <7>) = 1$ , RTCC would start working.
- When hour-match at 00:00:00,  $ALM0IF = 1$ , MCU would config  $ALM0HOUR = 0x23$  and clear  $ALM0IF$ .
- When next time with  $ALM0IF = 1$ , MCU would be powered up to read and write back  $ALM0HOUR$  (with decreasing 1) and then clear  $ALM0IF$ . And so on, the procedure would be expected with repeating every 23 hours.

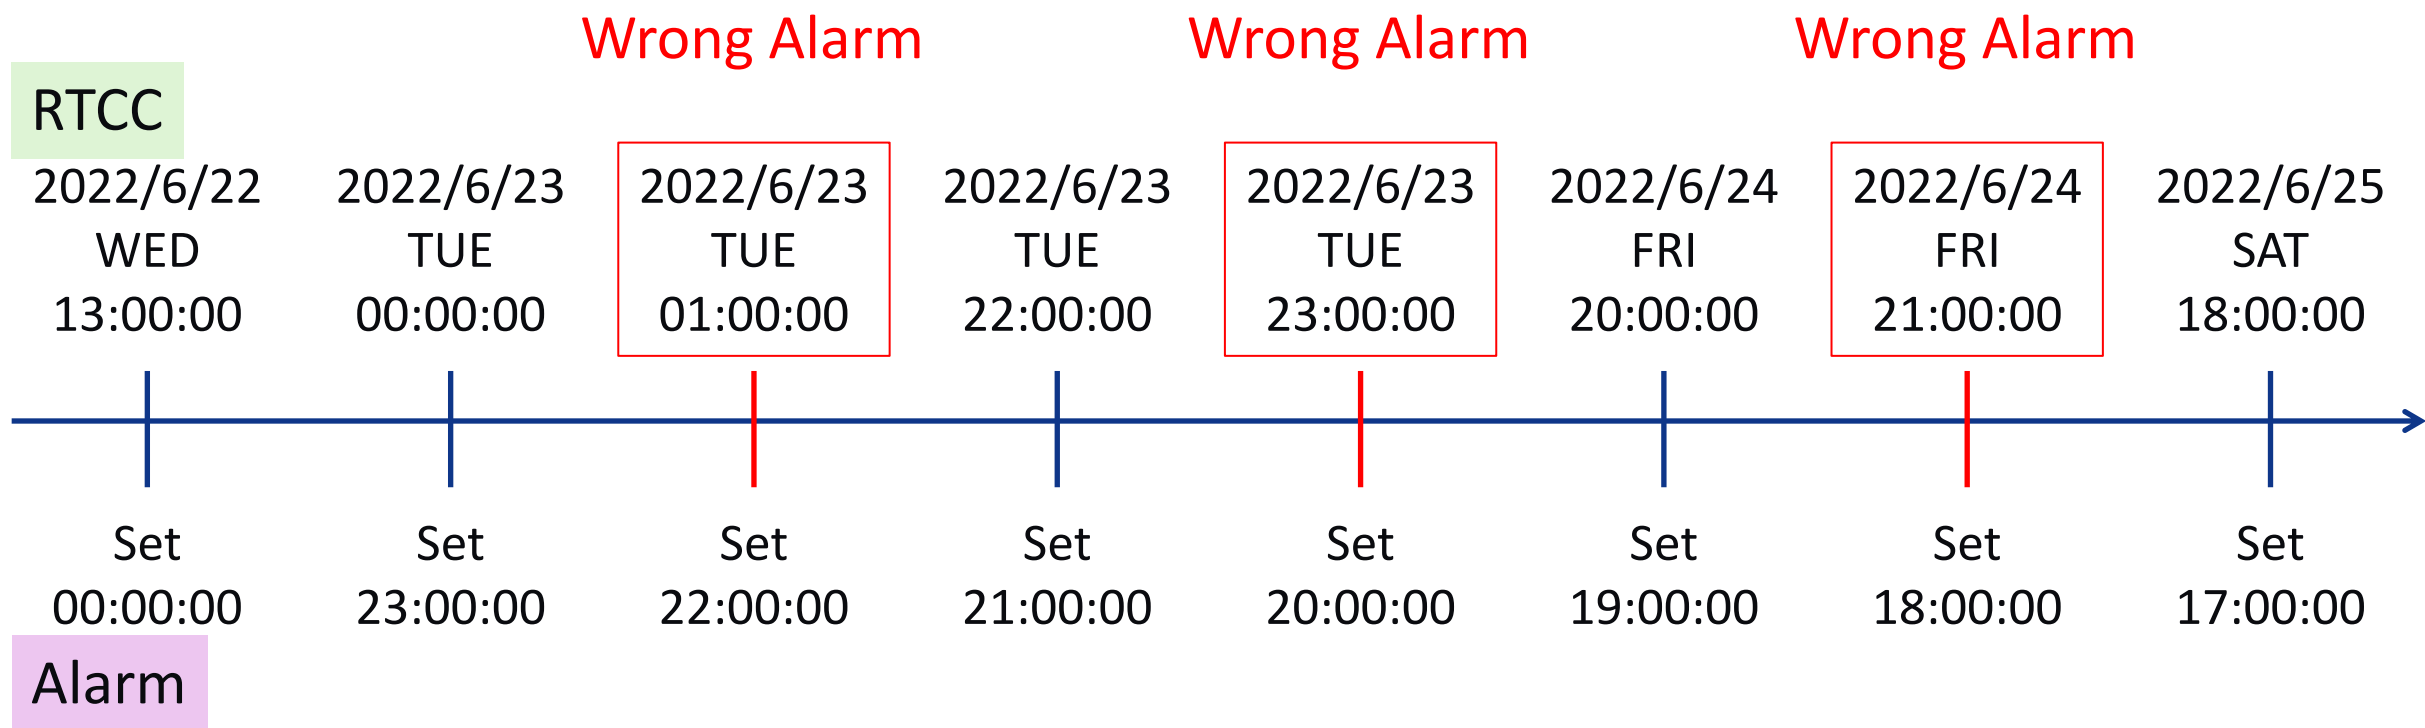
# Time-line : The problem

- Initialized date/time with present date/time (2022, JUN, 22, Wednesday, 13:00:00)
- **Configure 1st Alarm time at 0:00.**
- When  $ST(RTCSEC\ bit\ <7>) = 1$ , RTCC would start working.
- When hour-match at 00:00:00,  $ALM0IF = 1$ .
- MCU would config  $ALM0HOUR = 0x23$  and clear  $ALM0IF$ .
- It was expected to get next alarm (let's call 2<sup>nd</sup> alarm) after 23 hours, but 2<sup>nd</sup> alarm would occur again after only 1 hour ( $RTCHOUR = 0x01$ ). **MCU didn't know that, so MCU read and wrote back  $ALM0HOUR (0x23 - 1 = 0x22)$  again and clear  $ALM0IF$ .**
- 3<sup>rd</sup> alarm would occur properly after 23 hours.
- **4<sup>th</sup> alarm would occur after only hour again.**
- 5<sup>th</sup> alarm would occur properly after 23 hours.
- **6<sup>th</sup> alarm would occur after only hour again.**
- And so so...until MCP79410 was power-down.

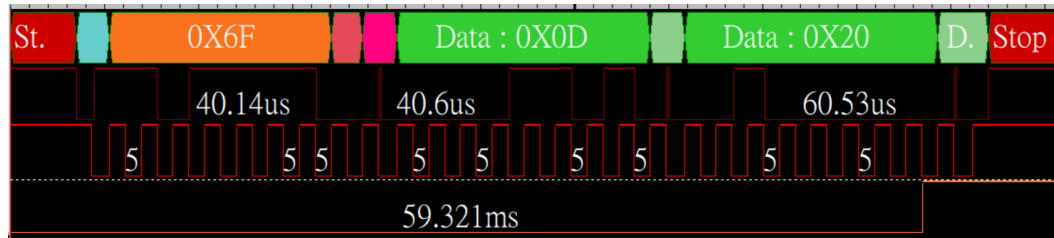
- Q: Once ALM0IF was cleared, MFP would be pull-high immediately. Was the last frame sent completely before MCU was off?

- Ans:
  - Client will compare the last frame timing with MFP pin.

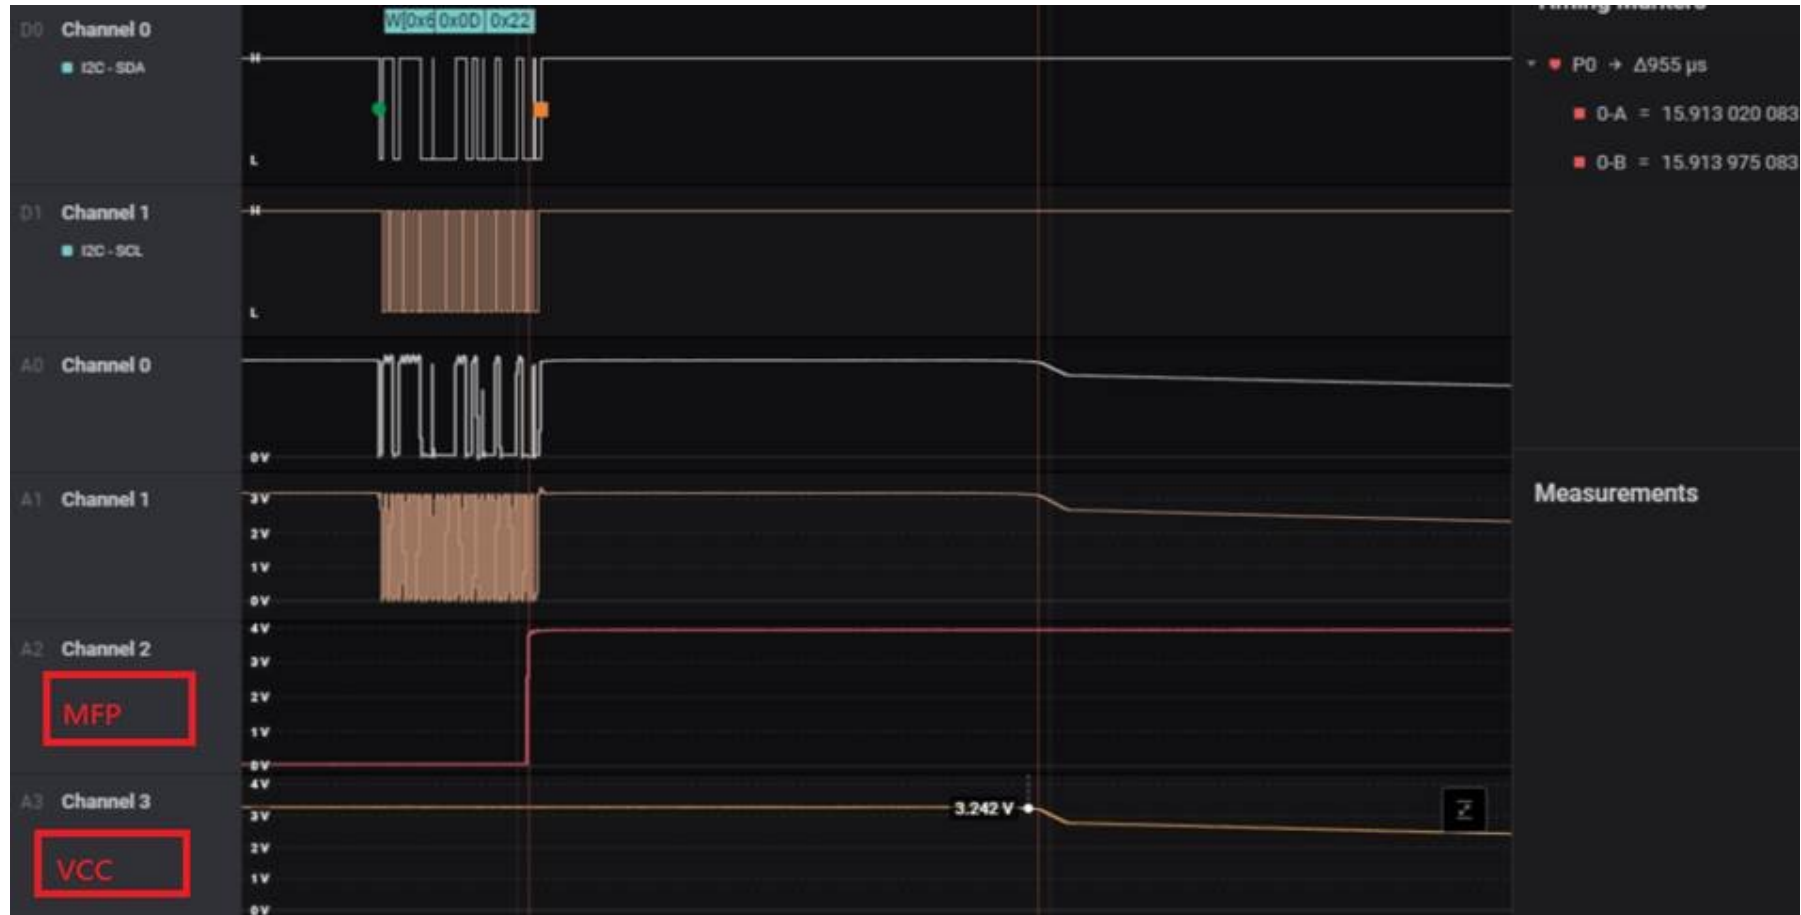
# Timing sequence from client (1/3)

- VCC would start falling down after 955ns with MFP pull-high.

- Slide 22, the VDD falling after MFP going high is OK, slide 23 VDD fall rate is fine, not too fast or too slow, exponential decay is typical for many systems. How long until the power is restored and what does the VDD reach just before it is turned on? Does it really reach 0V?

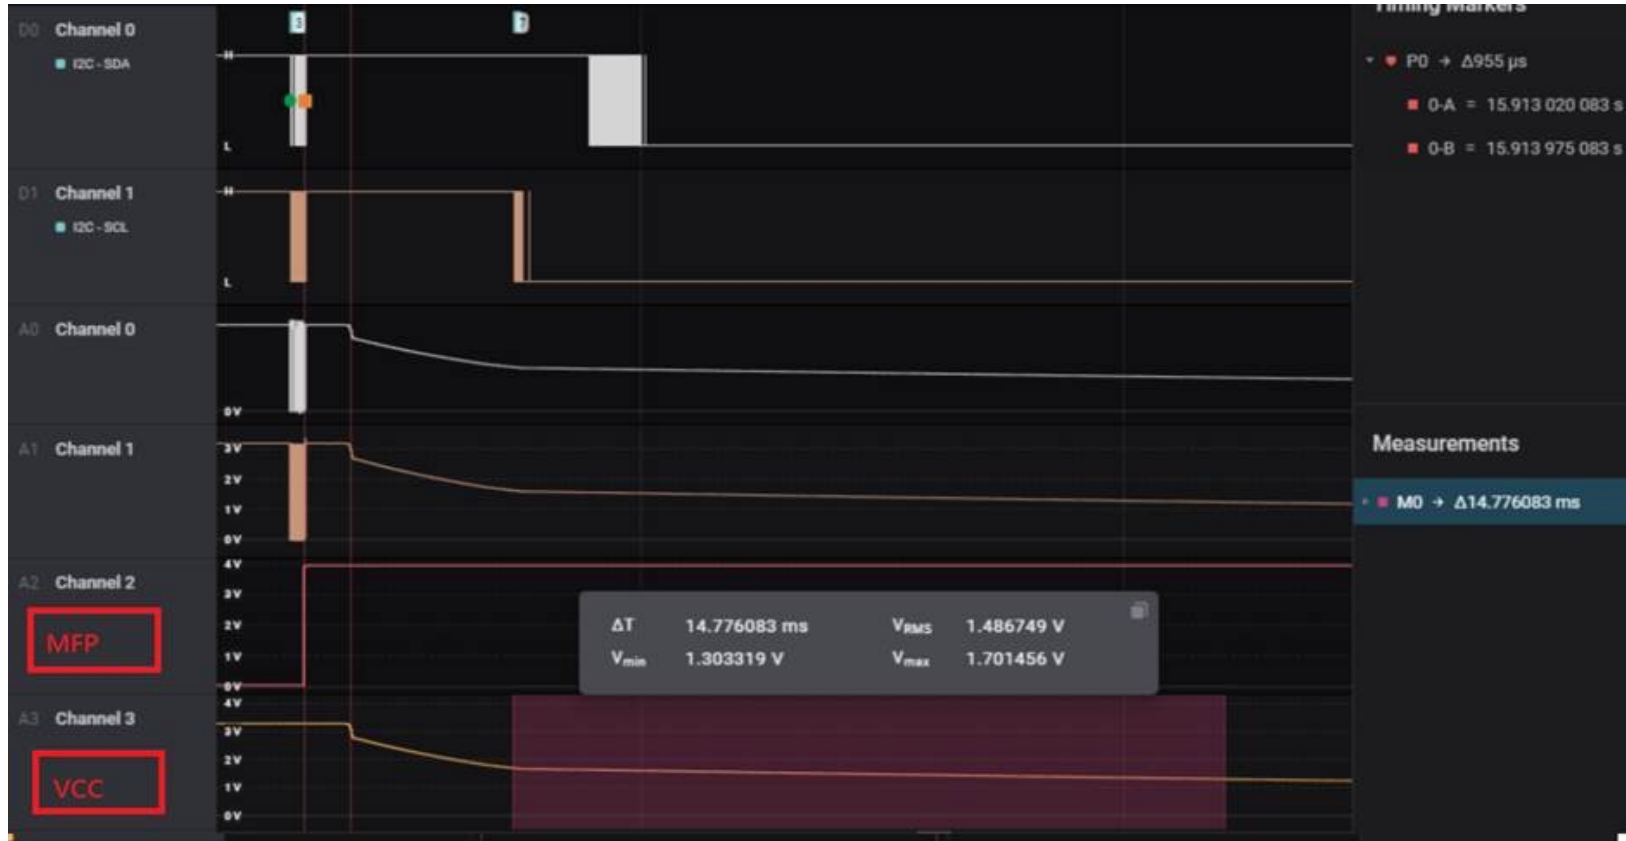
# Timing sequence from client (2/3)

- When VCC was powered down (RTC got to sleep), VCC down from 1.7V to 1.3V would take about 14ms to compare with T15 on data sheet.

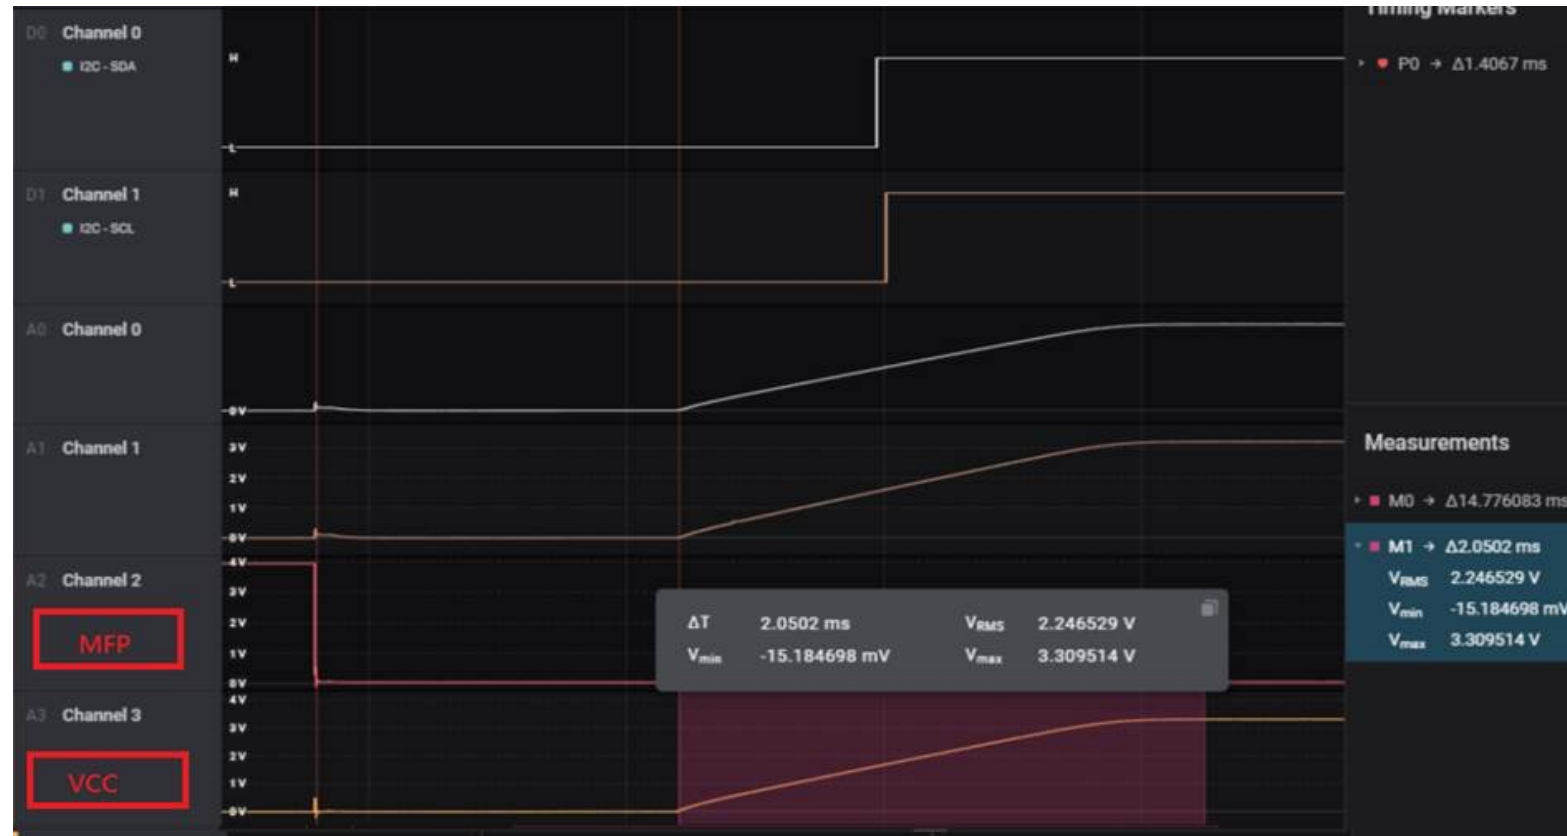
# Timing sequence from client (3/3)

- When RTCC waked up, MFP was low. Right after 14ms, VCC started going up from 0 to 3.3V to compare with T16 on datasheet.

- Slide 24, VDD is powered on and MFP is low. Is this what is expected? If the MFP was high on power down, shouldn't it be high on power up? What changed here to explain this?

- Is the RTCC getting confused, such as if the VBATEN bit is not set? Slide 25 right side seems to show that VBATEN = 1, is this correct? If the bit is set, battery is applied and VDD falls and rises, then the MFP should be the same. Only the PowerFail bit should change and time should change.

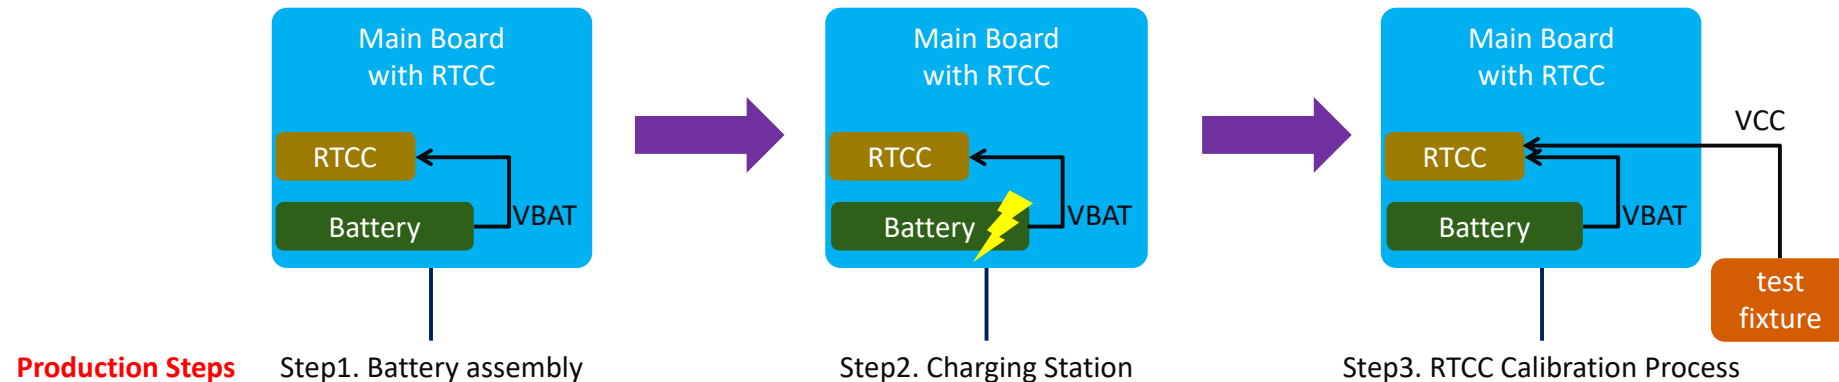
- **Calibration flowchart checking: OK (slide 30).**
  - We coworked to check Weikeng's test code included polling RTCC and initialization. All the process including calibration flowchart matched R&D's requirement.
- **The power-up sequence checking: OK, VCC applied after VBAT**
  - On AcBel production line, during **assembly (step1)**, VBAT will be applied first, and VCC will not be applied until the unit moves to **step3, RTCC calibration process**.

- With the power sequencing manually, OSCTRIM register was always 0x00 (read on Weikeng's test platform). **It seems also not easy to reproduce "Power-on reset" issue as well.** OSCTRIM register was 0x00 or 0xFF (read on AcBel's test platform). **It was uncertain (showed on slide45 as well) whether this difference has any impact.**

- **Remove VCC, VBAT and follow the power sequence.**
  - According to the power sequence, AcBel can observe that the OSCTRIM register is either 0x00 or 0xFF. Therefore, during initialization, if MCU found OSCTRIM was not 0x00, MCU will write 0x00 to OSCTRIM. This process will be used to test whether the issue can be reproduced.
- **Weikeng will implement a new testing method**
  - R&D mentioned that there is a special process which he modified to reproduce the issue. Not sure it is necessary or not, but it is recommended to do the same way.
  - **Set the 1<sup>st</sup> alarm for the next hour, then set another alarm for the next 23 hours when 1<sup>st</sup> alarm occurred.** The purpose is to observe the same situation on the Weikeng test platform compared with AcBel platform. It would be easier to see issue after 1~3 hours (or took more time to see the issue.)
