RECALL ACTION

Recall Action Number:
BD148v3

RE: Reinforce ABS Modulator Pressure Reduction Valve Reaction Plates

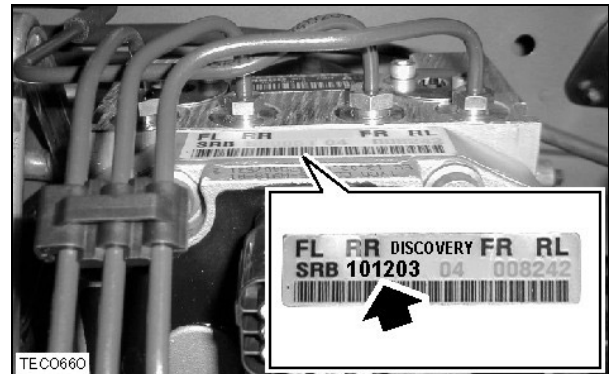
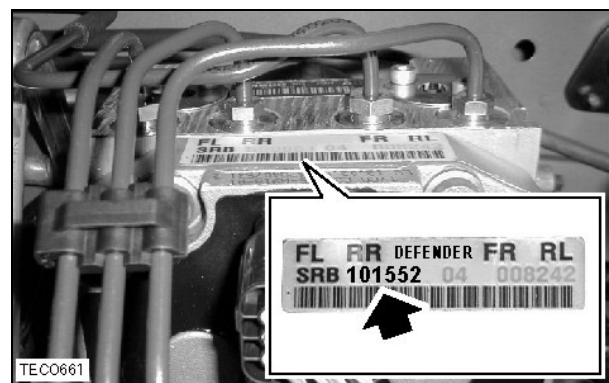
To identify a new specification modulator, note the service part number on top of the modulator (see Fig. 1 and 2). If the following service part numbers have been noted, no further action is required:

- SRB101203 - (Discovery Series II)
- SRB101552 - (Defender)

Also, if the following production part numbers are noted, no further action is required:

- SRB500051 - (Discovery Series II)
- SRB500041 - (Defender)
