SERVICE ACTION

Service Action Number:
Q036

'A' Frame Chassis Brackets	Publication No.	501-Q036v2
	Model	Defender 90, 110, 130
	Model Year	2007MY
	VIN Range	LD736064 to LD752152 (Specific vehicles)
	Date of Issue:	26 February 2009
	Expiry Date	28 February 2010

RE: 'A' Frame Chassis Brackets

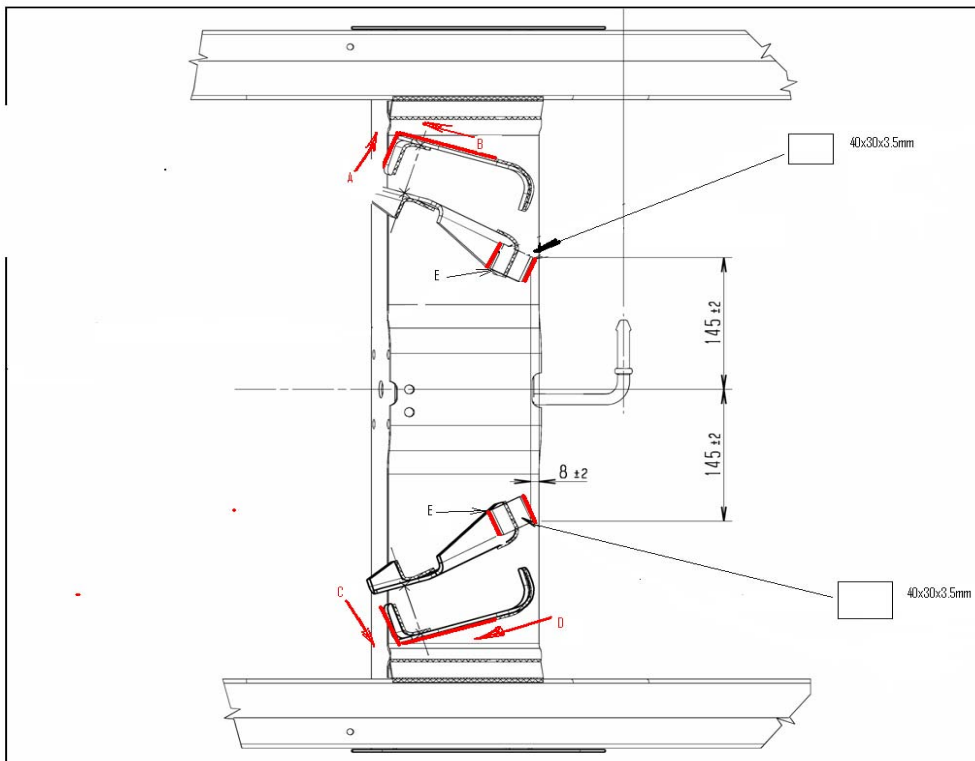
<p>Fig. 1 (left of graphic is the front of the vehicle)</p>	
8	<p>Remove underbody wax coating using suitable cleaning solution.</p>	
9	<p>Remove paint from the areas in Fig. 1, 2 and 3, paying particular attention to the points where the weld runs commence.</p>

7	<p>Note: Additional welds highlighted in red. See Fig. 1 to determine the area to be repaired.</p>
