SERVICE ACTION

Service Action Number:
Q055

Subject: 'A' Frame Suspension Arm	Publication No.:	204-Q055
	Model:	Defender
	Model Year:	2009
	VIN Range:	LD771715 – LD772545
	Date of Issue:	03 February 2009
	Expiry Date:	28 February 2011

RE: 'A' Frame Suspension Arm

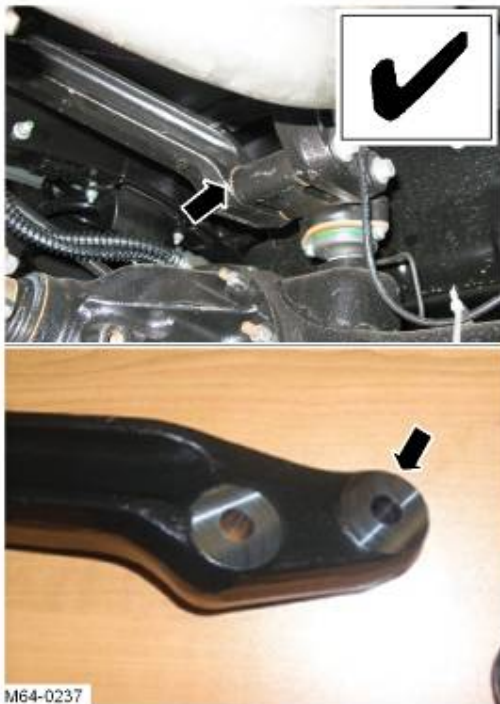
<p>Fig. 1</p>
2	Upper arms with no machined surface at the axle ball joint end inner joint (see Fig. 2).

Item	Description	
1	Inspect both upper arms to see if it has a machined surface at the axle ball joint end inner joint (see Fig. 1).

Both upper arms show a machined surface – no further action required. LH upper arm shows no machined surface – carry on from step 3. RH upper arm shows no machined surface – carry on from step 3. Both upper arms show no machined surface– carry on from step 3.
3	Install new LH/RH or both Upper arms (see Global Technical Reference GTR Workshop Manual, section: 204-02). <ul style="list-style-type: none">• Carry out removal procedure steps 1 to 6, and then the full Installation procedure.
