# SERVICE ACTION

Service Action  
Number: Q043

<b>Subject</b>  <b>Seat Belt Tie Bars</b>	Publication No.	501-Q043v2
	Model	Defender 130 with hydraulic platform conversion
	Model Year	1986 to 2006
	VIN Range	Refer to Appendix 1
	Date of Issue:	22 May 2009
	Expiration Date:	31 May 2010

## RE: Seat Belt Tie Bars

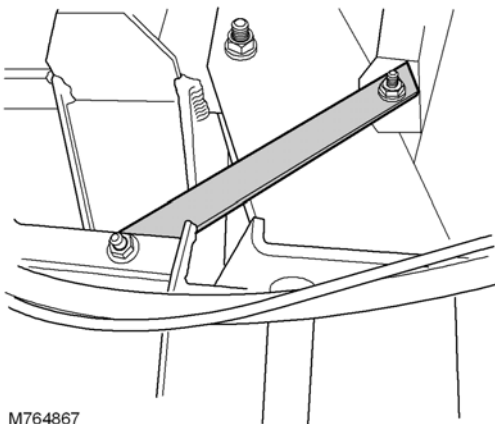
Item	Description	
1	From under the vehicle, inspect for the presence of the seat belt tie bars (see Fig. 1).

<p>M764867</p>
		Fig. 1
	If installed, return the vehicle to customer. If not installed, carry on from step 2.	
2	Raise the front of the vehicle and support with two stands (see Global Technical Reference GTR Workshop Manual, section: 100-02).	
3	<p>If required, drill a new 9mm hole when the existing hole is covered by the Hydraulic Platform mounting leg (see Fig. 2).</p> <ul style="list-style-type: none"> <li>Using a suitable touch-up stick, touch up the affected paintwork in the drilled hole.</li> </ul>
