Technical Service Bulletin

No.LTB00078
13 August 2007

Subject/Concern:	Defender - ABS/TC Warning Lamps Illuminated. (Updated to include ABS Modulator Lower-Level Repair)
-------------------------	--

Models:		
Defender (LD)	1999 on, with ABS	1999 on, with ABS VIN- range: 159810 Onwards

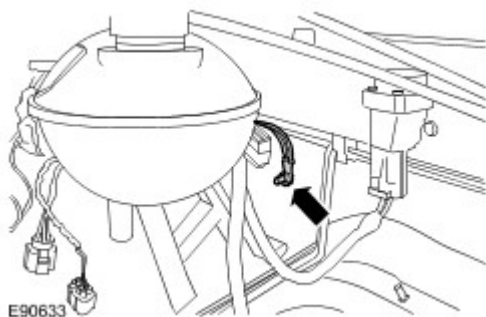
- 1 . With the ignition off:
 - 1 . Check that the ground stud connection (C0434 – Illustration E90633) located on the bulkhead is undamaged and free of corrosion.
 - 2 . Ensure that the ground wire eyelet is clamped on to the ground stud.
 - 3 . Check for continuity between the ground stud (C0434) and the connector on the ABS modulator body (C0500 right-hand drive / C1592 left-hand drive – see Illustration E91091 below). If there is no continuity (or intermittent continuity when the wire is flexed), repair as necessary.

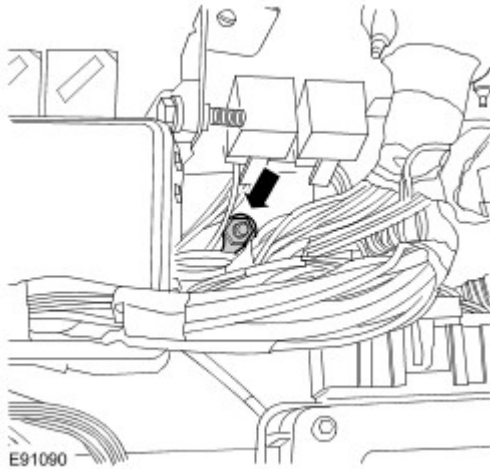
- 6 . Disconnect the 18 pin control module connector (C0504) and check for continuity between pin 12 and the ground wire connector (C0362 – Graphic E91090)
 - 1 . If there is no continuity (or intermittent continuity when the wire is flexed), repair as necessary.

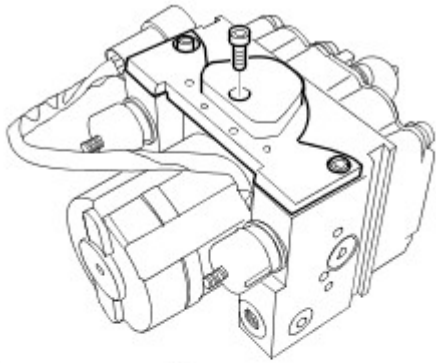
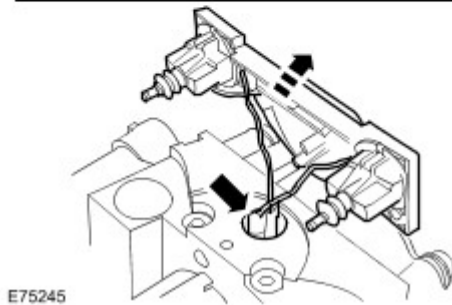
NOTE: Before removing the black plastic shuttle valve switches, inspect to see if brake fluid has been dripping from the switch. A small amount of fluid seepage past the hydraulic shuttles is normal, but there should be no fluid dripping from the cover. When the shuttle valve switches are removed there may be a light covering of brake fluid over its inner surface. This is no cause for concern. DO NOT REPLACE THE ABS MODULATOR FOR FLUID LEAKAGE UNLESS THERE IS EVIDENCE THAT FLUID HAS BEEN DRIPPING, OR THE VEHICLE IS IN FOR A FLUID LEAKAGE ISSUE AND THE MODULATOR IS CONFIRMED AS THE SOURCE OF THE LEAKAGE.

- 2 . The shuttle valve switches are located behind the black plastic cover opposite the hydraulic ports. Remove the black plastic cover:
 - 1 . Remove the three cap-head bolts holding the cover in place.
 - 2 . Carefully pull the cover away from the modulator in order to gain access to the SVS connector behind the cover.
 - 3 . Pull the connector apart and remove the shuttle valve switches and black plastic

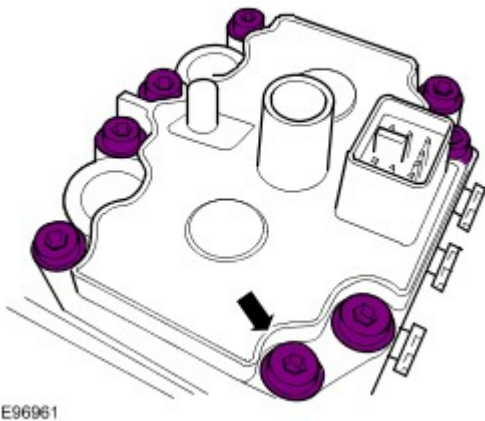
Remove the eight cap-head bolts holding the electrical module in place. **Do not discard the bolts. They will be needed for reassembly**

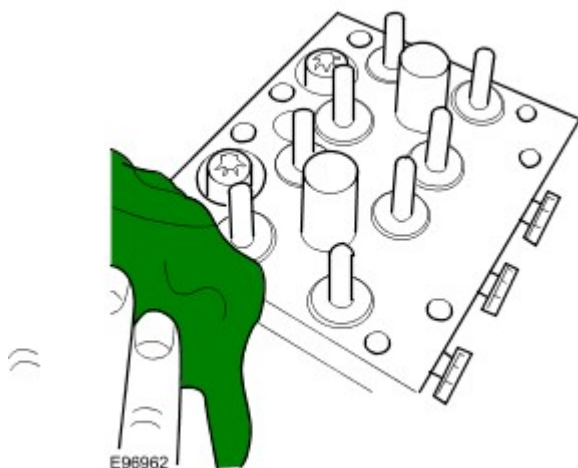
- 4 . Remove the electrical module by pulling simultaneously on all sides. Keep the electrical module square as it is pulled away from the hydraulic block in order to avoid damage to the underlying solenoid valves.
- 5 . Carefully wipe clean the area exposed by the removal of the electrical module.

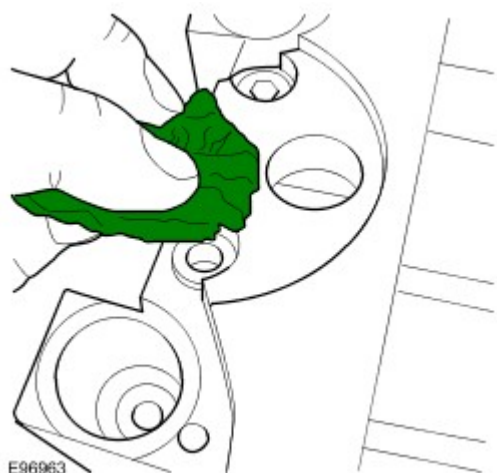
- 6 . Carefully wipe clean the area exposed by the shuttle valve switch unit. Clean any excess residual thread locking compound from the SVS mounting bolt holes.

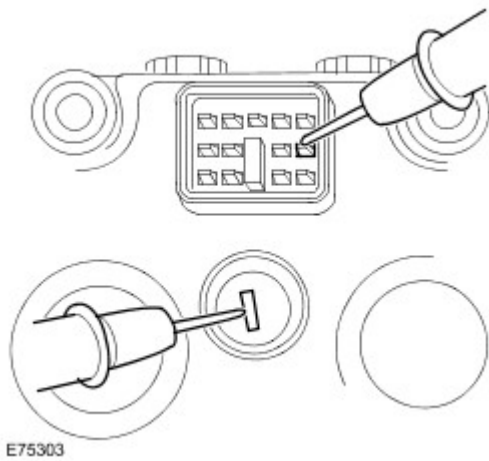
- 1 . Carefully push the electrical module onto the modulator hydraulic block. Take care to keep it square as it is pushed on.
 - 2 . Using a 6mm hexagon torque spanner, secure the electrical module with the original eight cap-head bolts. Tighten these to a torque of 44 Nm (32 lbf/ft).
 - 3 . Install the new shuttle valve switch pack from the service kit. Carefully push the cover into the modulator ensuring that the connector and wires are correctly clipped into the black plastic cover.
 - 4 . Install the three cap-head bolts from the service kit and tighten to 4Nm. (3 lbf/ft)
- 8 . Confirm the electrical connection between the shuttle valve switches and the electrical module.
- 1 . Measure the resistance between pin 9 on the 13-pin modulator connector (C0501-9) and the single adjacent modulator ground pin (C0500-1). The resistance value should be 3020 Ohms +/- 30 Ohms.
