SERVICE ACTION

Service Action Number:
Q049

Engine Oil Pan Damage

Publication No.:	303-Q049v3
Model:	Defender Puma Diesel
Model Year:	2007 and 2008
VIN Range:	LD 732615 – LD 758400
Model:	Defender Puma Diesel (CKD)
Model Year:	2007 and 2008
VIN Range:	See table 1
Date of Issue:	20 March 2009
Expiry Date:	31 July 2010

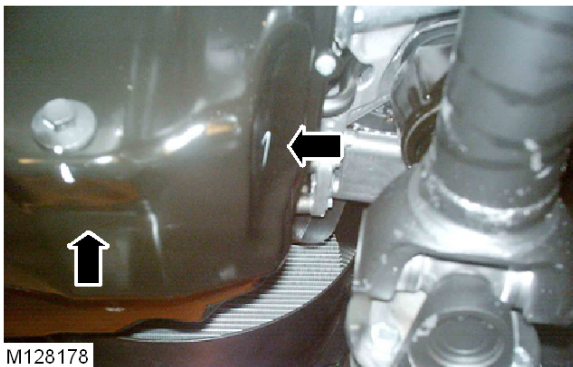
Item	Description	
1	<p>Note: The latest level oil pan has two indentations (see Fig. 1).</p> <p>Visually inspect the oil pan.</p> <ul style="list-style-type: none"> • If the oil pan is the latest level, no further action is required. • If not the latest level, carry out step 2.

<p>M128178</p>
		Fig. 1
2	Install a new oil pan (see Global Technical Reference (GTR) Workshop Manual, section: 303-01).
