SERVICE ACTION

Service Action Number:
Q054

Subject: Brake Pipe Contact with Heat Shield	Publication No.:	206-Q054
	Model:	Defender Right-Hand Drive with ABS
	Model Year:	2007 to 2008
	VIN Range:	LD 732615 – LD 752724
	Date of Issue:	22 October 2008
	Expiry Date:	31 October 2010

RE: Brake Pipe Contact with Heat Shield

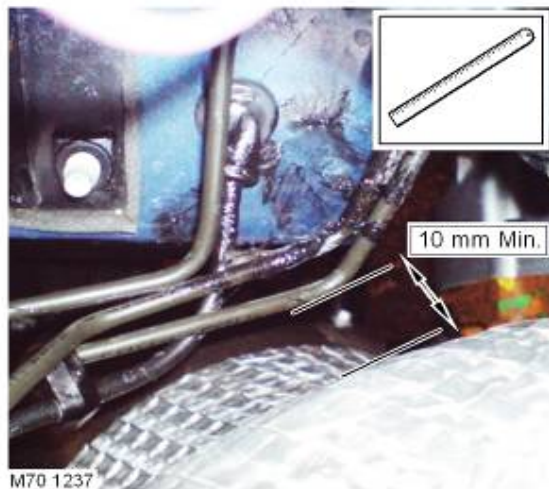
<p>Fig. 3</p>
3	Inspect brake pipe(s) for damage (by the heat shield) and that there is a 10mm gap between the brake pipe and the heat shield (see Fig. 4).

<p>Fig. 4</p>
	<p>If the brake pipe(s) are not damaged, and are correctly routed – no further action required. If the brake pipe(s) are not damaged, and are incorrectly routed, carry on from step 4. If brake pipe(s) are damaged, carry on from step 5.</p>	
4	Unclip brake pipe(s) and re-route to correct position ensuring a 10mm gap between brake pipe and heat shield (see Fig. 1, 2, 3 and 4) - no further action required.
