SERVICE ACTION

Service Action Number:
Q054

Subject: Brake Pipe Contact with Heat Shield	Publication No.:	206-Q054v2
	Model:	Defender Right-Hand Drive with ABS
	Model Year:	2007 to 2008
	VIN Range:	LD 732615 – LD 752724
	Date of Issue:	30 April 2009
	Expiry Date:	31 October 2010

RE: Brake Pipe Contact with Heat Shield

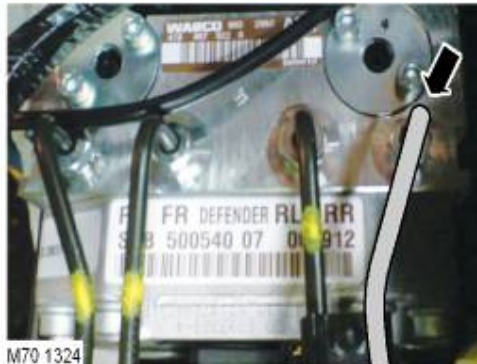
<p>Fig. 1</p>

Item	Description	
1	Open hood.	
2	<p>Note: Correct right-hand brake pipe routing shown (left-hand brake pipe is shown next to right-hand brake pipe).</p> <p>Inspect brake pipe(s) from the ABS modulator for correct routing (see Fig. 1, 2 and 3).</p>

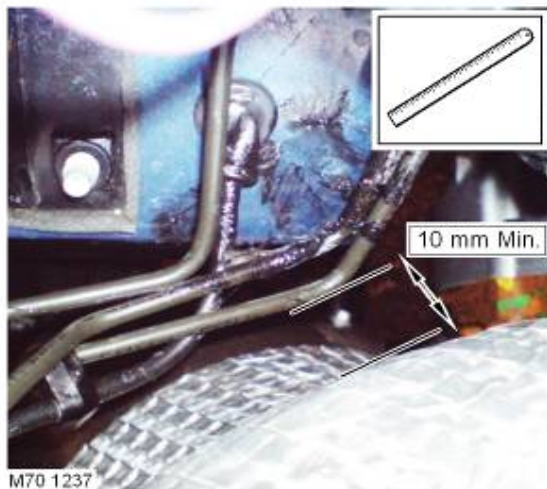
<p>Fig. 3</p>
3	Inspect brake pipe(s) for damage (by the heat shield) and that there is a 10mm gap between the brake pipe and the heat shield (see Fig. 4).

<p>Fig. 4</p>
	<p>If the brake pipe(s) are not damaged, and are correctly routed – no further action required. If the brake pipe(s) are not damaged, and are incorrectly routed, carry on from step 4. If brake pipe(s) are damaged, carry on from step 5.</p>	
4	Unclip brake pipe(s) and re-route to correct position ensuring a 10mm gap between brake pipe and heat shield (see Fig. 1, 2, 3 and 4) - no further action required.
